Technical Service Bulletin

91 MIB2 High: Phone/Audi connect telephone and online services do not work

91 18 08 2051613/2 August 24, 2018. Supersedes Technical Service Bulletin Group 91 number 18-03 dated July 6, 2018 for reasons listed below.

Model(s)	Year	VIN Range	Vehicle-Specific Equipment
A6, A7 and TT	2015 -2016	All	MIB2 High

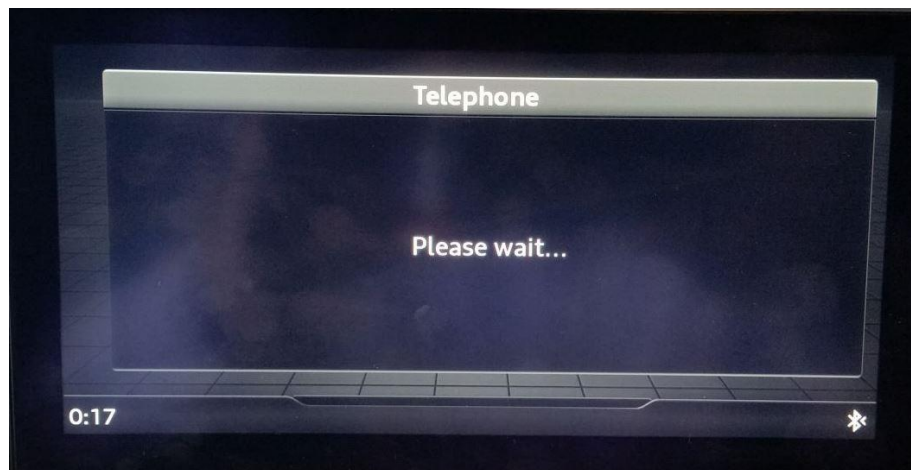
- The message "Please wait ..." is **permanently** shown in the phone menu. Therefore a mobile device cannot be used in the hands-free Bluetooth mode. This message is still shown after the vehicle sleep cycle.

Figure 1. Message shown permanently in phone menu.

The phone module is not initialized and therefore is not recognized in the infotainment control module.

- Check the SIM card reader with a flashlight and magnifying glass or photo for broken or damaged pins. If the card reader is damaged, replace the main unit.
- Remove the fuse for the information electronics control module for at least 30 minutes. If the fault is still permanently present, continue with the TSB. Otherwise, the issue has been resolved.
- Review the *Required Parts and Tools* section of this bulletin.
- Obtain the telephone module retrofit kit listed in the *Required Parts and Tools* section of this bulletin (if required).
- Obtain the software matching the customer's vehicle according to the *Required Parts and Tools* section of this bulletin.

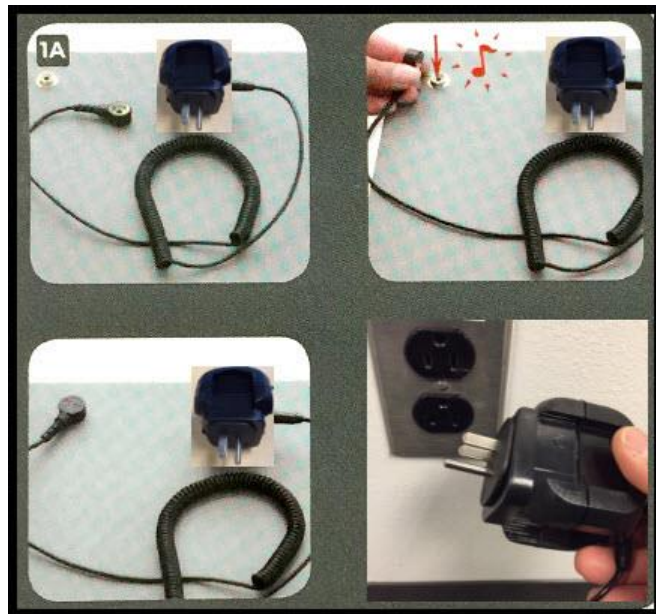
Figure 2. VAS6613 ESD work surface grounding plug.

2. Prepare the ESD work surface by cleaning the work area of all loose debris and then drying the area with a towel. Doing so ensures that no debris will be rolled into the mat when it is rolled up after use, which could cause long-term damage to the ESD work surface.
3. Place the ESD anti-static mat onto the surface. Ensure that all three grounding straps are securely strapped to the ESD mat.
4. Ground the ESD mat by plugging the 110V grounding strap into a wall socket or power strip (Figure 2). If a power strip is used, it must be plugged into a grounded wall outlet (see attached user instructions for VAS6613 titled "VAS6613 ESD Workspace Guide.pdf").

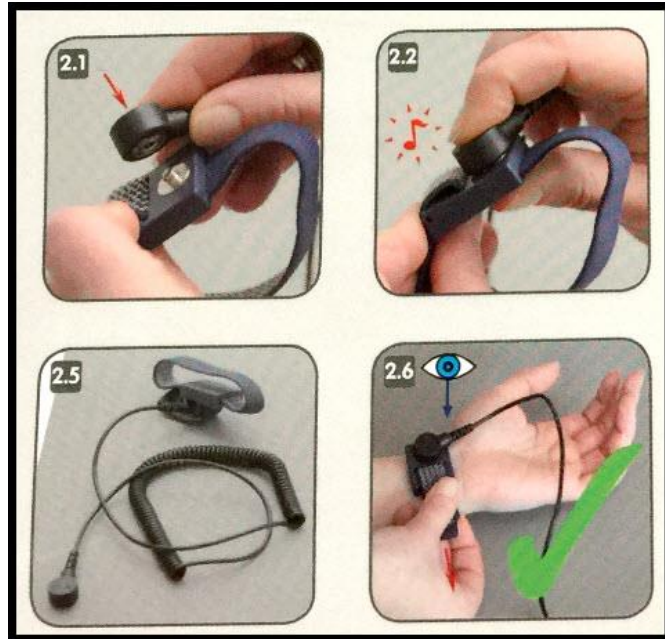
Figure 3. VAS6613 ESD work surface grounding wrist strap.

5. Ground yourself by placing the elastic strap around your wrist. Make sure it is securely touching your skin. It cannot be loose-fitting or over your shirt cuff (Figure 3).

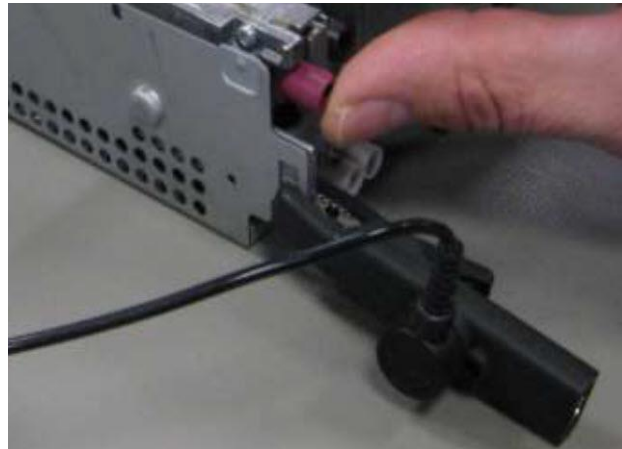
Figure 4. VAS6613 ESD work surface grounding device clip.

6. Ground the MIB main unit by placing an alligator clip on the back, ensuring that it makes contact with the metal housing of the main unit. The most secure location is at the bottom of the metal bracket (Figure 4).

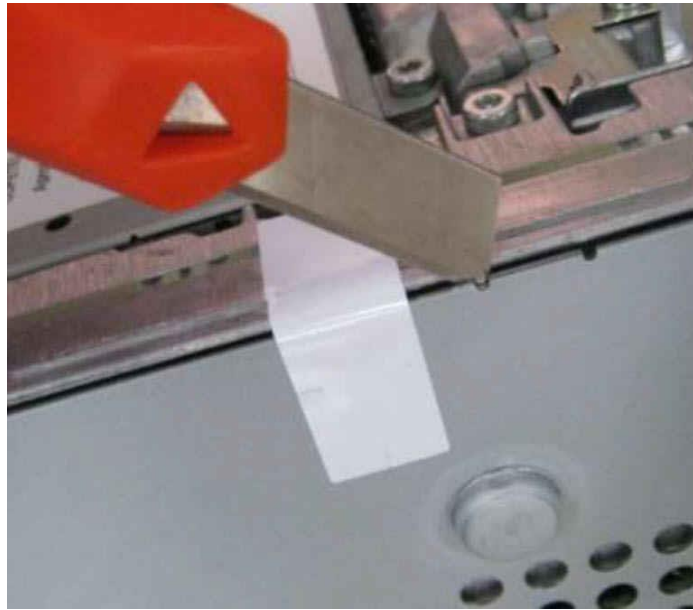
Figure 5. Break the white warranty seal.

7. Start by touching the screw driver to the ESD mat to discharge any static that may be built up in the tool.
8. Break the white warranty seal on the back of the main unit (Figure 5).

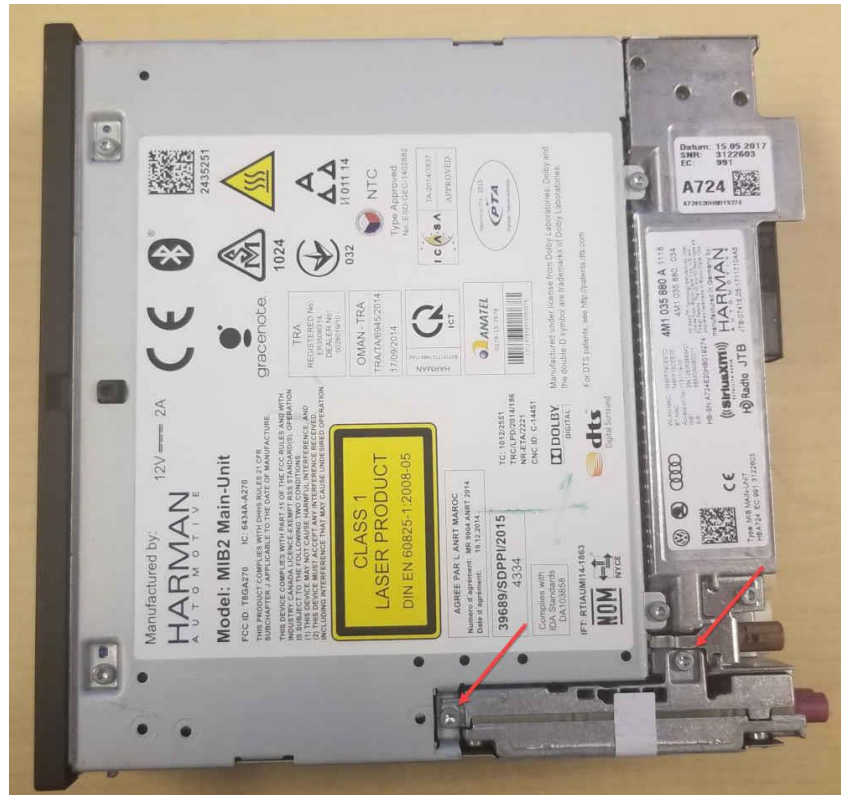
Figure 6. Telephone module retaining screws indicated by the red arrow.

9. On the top of the main unit, remove the two retaining screws that hold the telephone module in place (Figure 6).

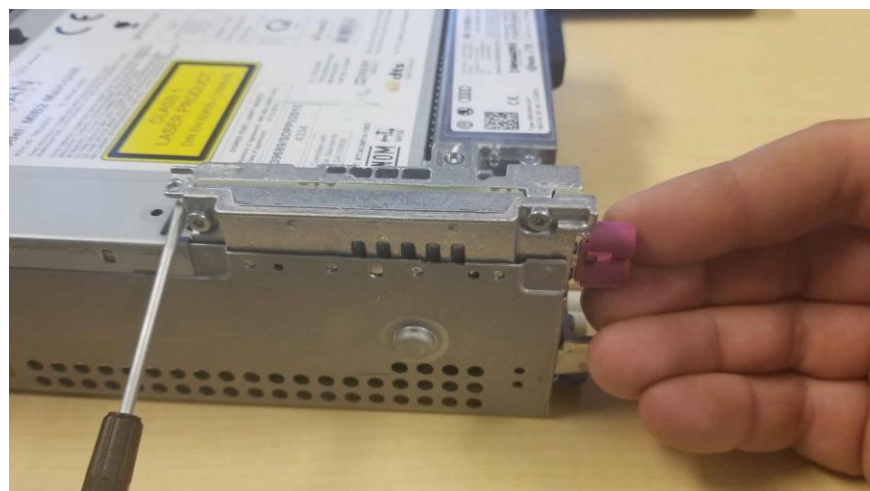
Figure 7. Lift up on both ends of the telephone module.

10. Carefully lift up the telephone module, using both ends as points of contact when pulling up. Use a flathead screwdriver to lift the forward flange (Figure 7). The module is held in place with a computer socket-type attachment and will release when enough force is used.

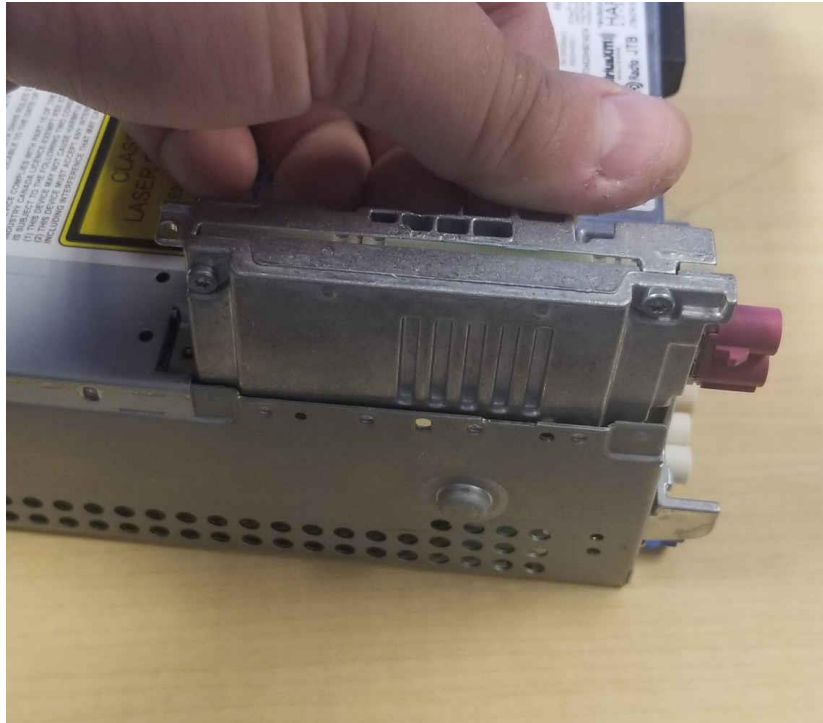
Figure 8. Do not press down using the purple FAKRA connector.

11. Place the new telephone module into the socket, making sure it is level before snapping it into place. Use both ends of the telephone module when pressing it into place. Do not press down using the purple FAKRA connector (Figure 9).

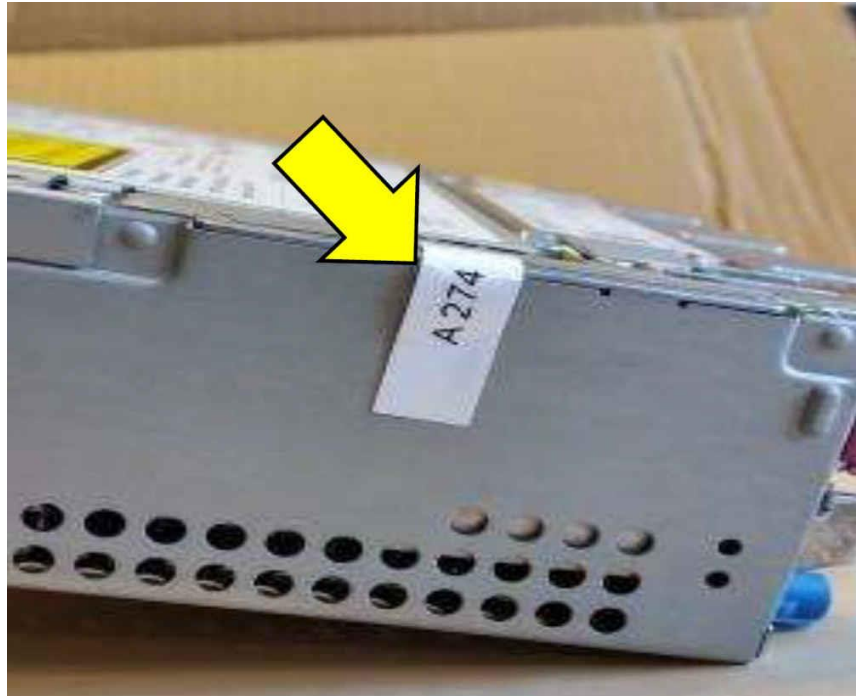
Figure 9. Place the new warranty seal over the location indicated by the yellow arrow.

13. Place the new warranty seal from the retrofit kit over the original warranty seal (Figure 9).
