ATU (Audi Technical Update)

Summer 2018

4.0 TFSI – Camshaft Diagnosis

A3 e-tron refuelling issue

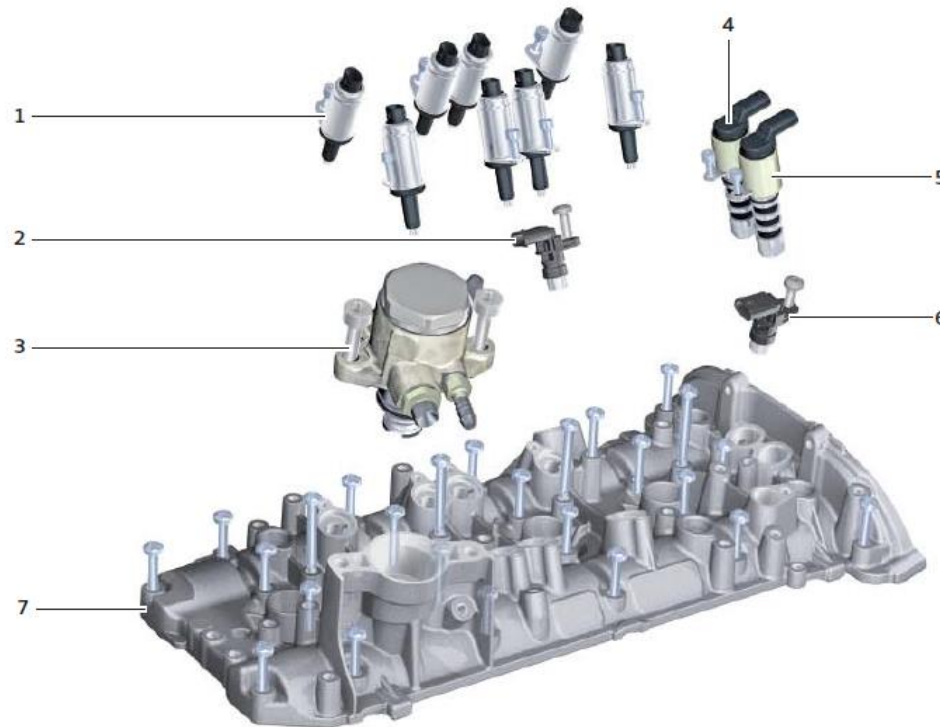
There is a distinction between problems with actuators for COD, camshaft control valves and problems with camshaft adjuster!

1. Actuators for COD (cylinder on demand).
2. Hall sender (G40).
3. High-pressure fuel pump.
4. Camshaft control valve 1 (N205).
5. Exhaust camshaft control valve 1 (N318).
6. Hall sender 2 (G163).
7. Cylinder head cover.

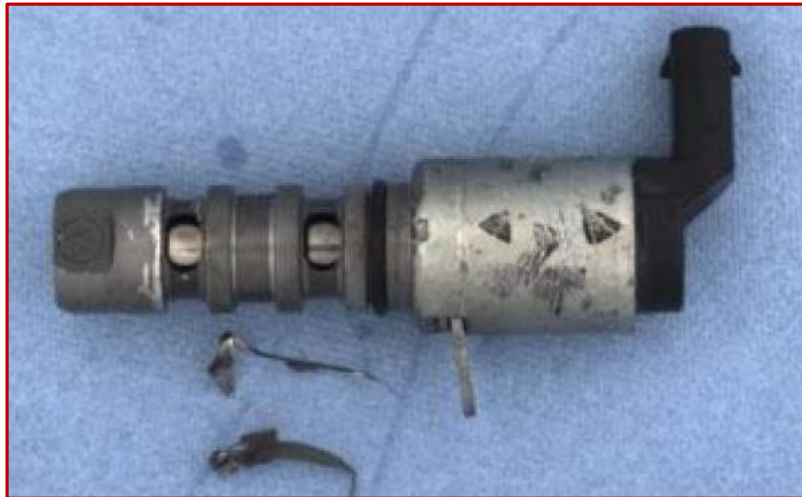
- › Damage:
 - › Broken filter element on camshaft control valve.

Strainer missing

- › Check control valve for damage to filter element:
 - › Filter element OK → Recommendation: Clean oil passage between control valve and camshaft control valve with compressed air and replace camshaft adjuster on affected cylinder bank (as shown in DTC).
 - › Filter element not OK → Replace the control valve.
 - › **Important:** Identify optimized camshaft adjuster based on the production code on camshaft adjuster!
 - › **Important:** The chain drive glide rail part number 079109470A should be checked when replacing the camshaft adjuster. Replace the glide rail if it is not part number 079109470A.

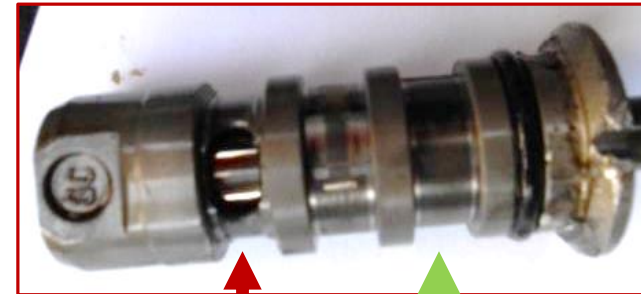
Strainer OK
