# Technical Service Bulletin

## 24CH UPDATE – ECM Software Update (FED\_EMS)

August 10, 2018

Model(s)	Year	VIN Range	Vehicle-Specific Equipment
A8	2015 – 2016	See Campaign/Action screen in Elsa	W12 Engine

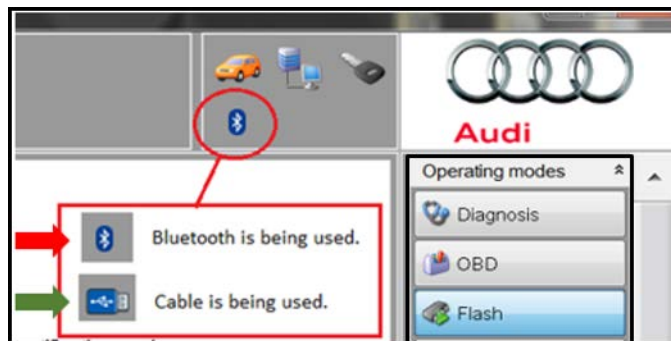
1. Follow all instructions in TSB 2011732: *00 Software Version Management (SVM), operating instructions*.
2. Attach an appropriate battery charger to the vehicle.
3. Attach the scan tool to the vehicle using a USB cable.
4. Confirm that the scan tool is communicating with the diagnostic head by USB <Green Arrow>. If the Bluetooth symbol is shown <Red Arrow> then disconnect the diagnostic head from the vehicle and then reattach the USB cable to the diagnostic head and then reattach to the vehicle.

5. Using **“Flash”**, perform the update using the SVM action code, **24CHA192**.

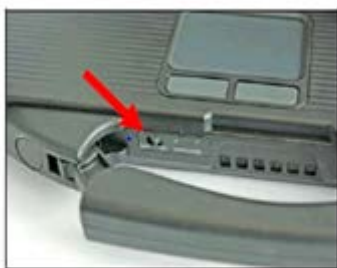
**VAS 6150 & VAS 6150A**  
(Front panel behind handle)

The Bluetooth function of the scan tool **MUST BE PHYSICALLY SWITCHED OFF** prior to performing this update. <See pictures>
