Technical Bulletin

55 18 01 July 25, 2018 2045277 Supersedes Technical Bulletin 55-16-14 (V551614) dated September 28, 2016 to remove outside material line from warranty table and include an additional model year applicability.

Rear Lid - Possible Water Ingress, Rear Lid Cannot be Opened

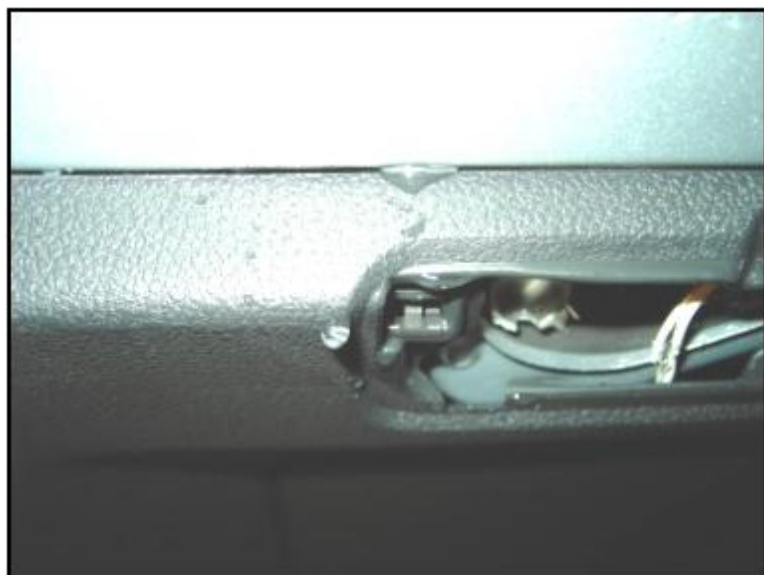
Figure 1

1. Rear lid does not open using the locking system.
2. Corrosion around license plate light.
3. License plate light inoperative.
4. When rear lid is opened, water dripping into the trunk from the rear lid (Figure 1).

Water may enter into the rear lid cavity via openings in the fine-seam seal around the inner taillight and causes the rear lid release button to malfunction.

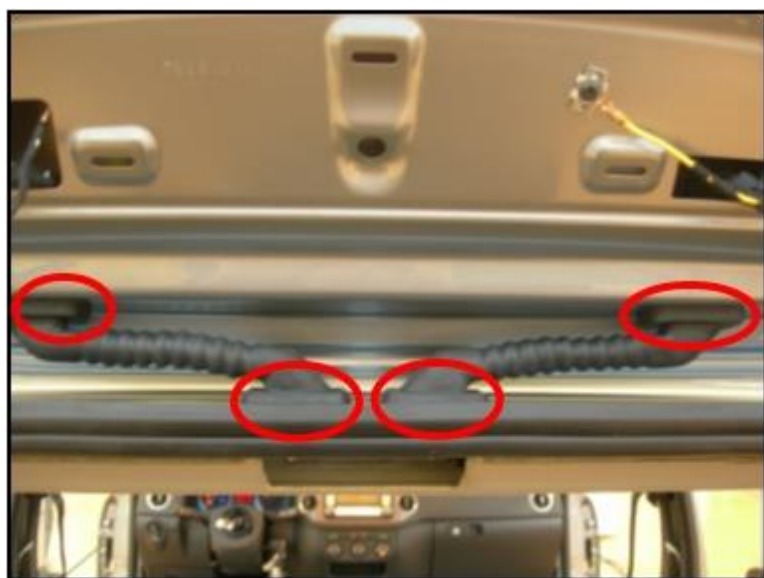
Figure 2

Water may enter into the rear lid via leaking wiring harness grommets or high mounted brake light (3rd brake light) seal.

- Inspect the rear lid wiring harness grommet(s) installation to the rear lid and the body to ensure that they are locked in position correctly (Figure 2, red ellipses).
- If loose, re-secure grommet(s) properly.
