This Service Information bulletin supersedes SI B12 21 10 **dated October 2014**.

N51 Engine: Service Engine Soon Lamp Illuminated - Loss of Power and Various Faults Stored in the DME

All vehicles produced to 6/2011

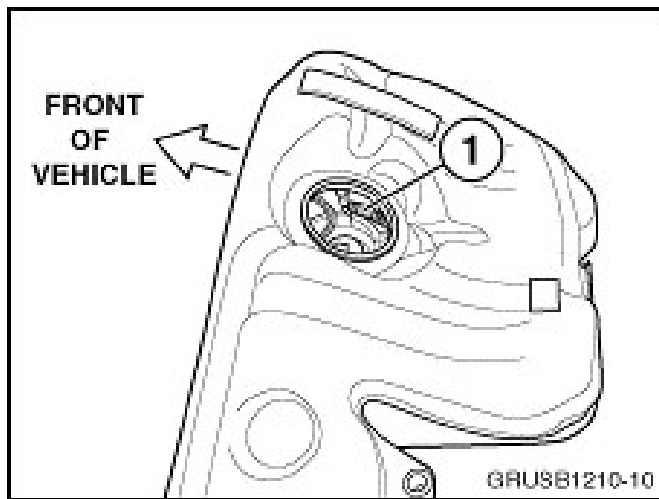
| | <ol style="list-style-type: none"> 2. If no fuel pressure is present then remove the right side fuel tank access cover to inspect the fuel hose (1) for disconnection or damage. Refer to Repair Instruction REP 16 14 010 Removing and installing the fuel pump. |

For the clarity of the picture, this is a photo of a fuel tank removed from the vehicle. Do not remove the fuel tank for the hose inspection.

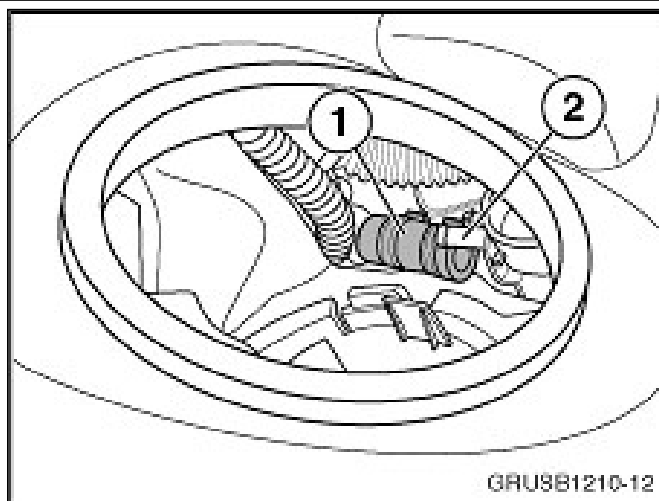
3. Inspect the fuel hose connection (1) on the pressure regulator (2). If the fuel hose is found to be disconnected from the fuel pressure regulator, replace the fuel tank. Do not attempt to replace or re-secure the fuel hose inside the fuel tank.

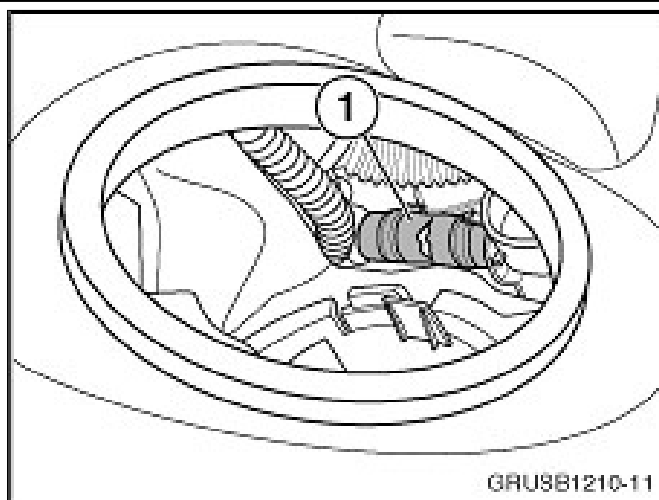
4. Inspect the fuel hose (1) for splitting. It might be necessary to inspect the entire circumference of the fuel hose with a small mirror. If the fuel hose (1) is found to be split, replace the fuel tank. Do not attempt to replace or re-secure the fuel hose inside the fuel tank.
