SI B11 05 16
Engine

Service Action: S63 Engine – Replace Crankcase Vent Connecting Line

E70 (X5 M)

E71 (X6 M)

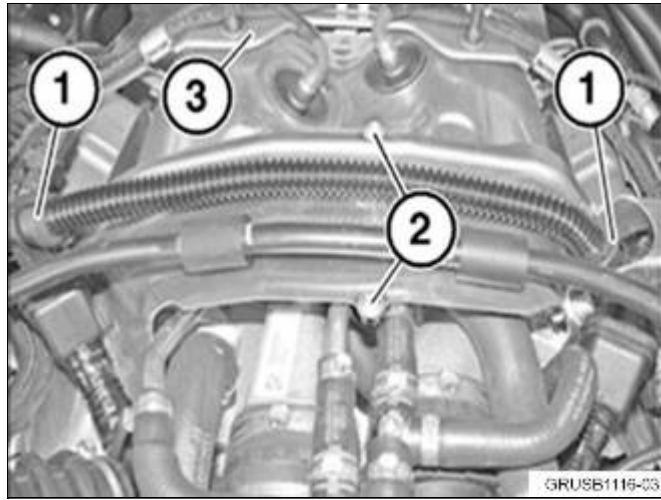
The crankcase ventilation connection line may deteriorate prematurely causing any of the following:

- vacuum leak
- various fault codes related to mixture control stored in the DME
- customer complaints about rough idle speed
- Check Engine Light illumination.

<ol style="list-style-type: none"> 2. Replace the connecting line
--	--

between crankcase ventilation hose of bank 1 and bank 2 (release the quick connections at positions 1).
