**Front Propeller (Drive) Shaft: Limited Warranty Extension to 10 Years/120,000 Miles**

E70 (X5 xDrive35i, X5 xDrive50i, X5 M, and the X5 xDrive35d)

E71 (X6 xDrive35i, X6 xDrive50i, and the X6 M)

E72 (X6 xDrive50i Hybrid)

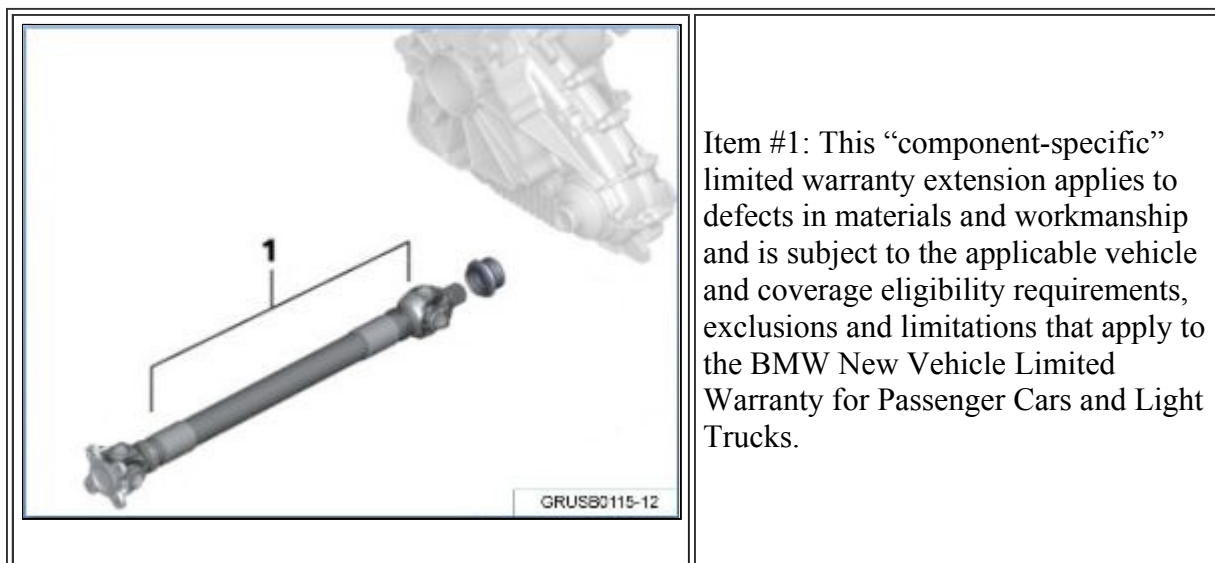
- **Front propeller (drive) shaft to 10 years/120,000 miles as determined by the vehicle’s original in-service date**
