Technical Service Bulletin: TSB180166	Released Date: 27-Nov-2018
Simultaneous Knock Fault Codes on All Six Cylinders

- ISX12 G CM2180 EJ
- ISL G CM2180

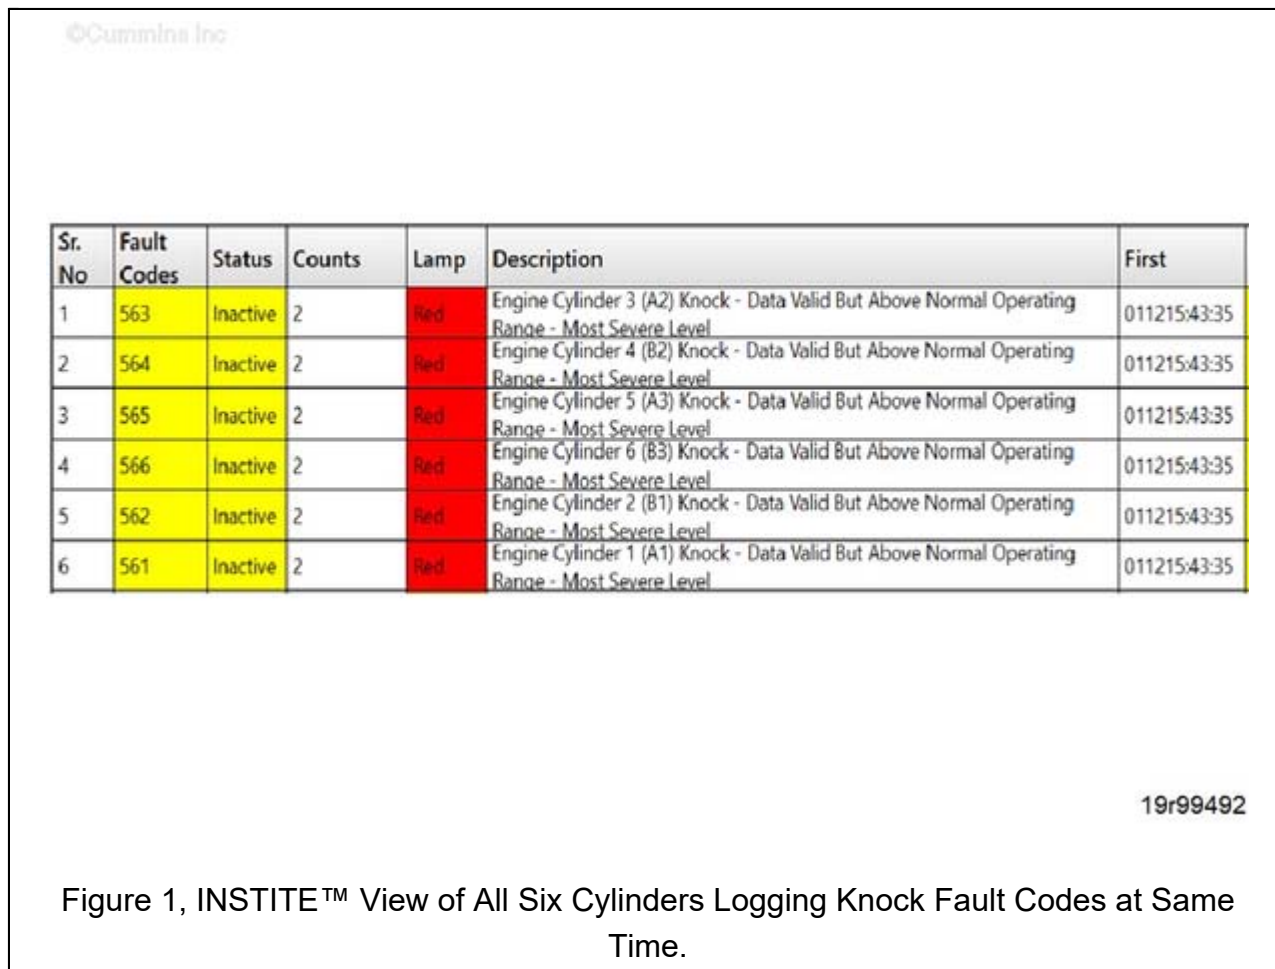
Internal malfunction of the knock control chip in the engine control module (ECM) causing intermittent false knock signal on all six cylinders simultaneously. Malfunction usually occurs when the engine is warm, logging all six cylinder knock fault codes either moderate, severe, or both.

Using INSITE™ electronic service tool: Verify that knock fault codes for all six cylinders have the same time stamp. See Figure 1 below.

Replace ECM. See corresponding Service Manual. Reference procedure 019-031.
