Preliminary Information

PIP5495H Check Engine Light On With P0299 Or P0234

Models

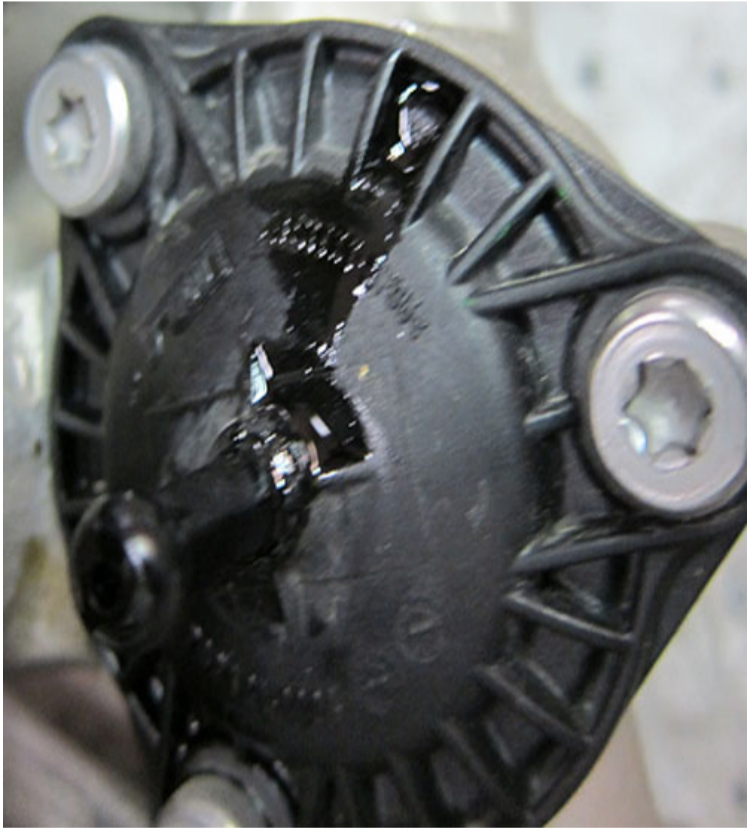
Bypass (recirculation) valve cover port broken or water/oil found inside the valve (clean the components, if necessary replace bypass (recirculation) valve assembly - released for service)

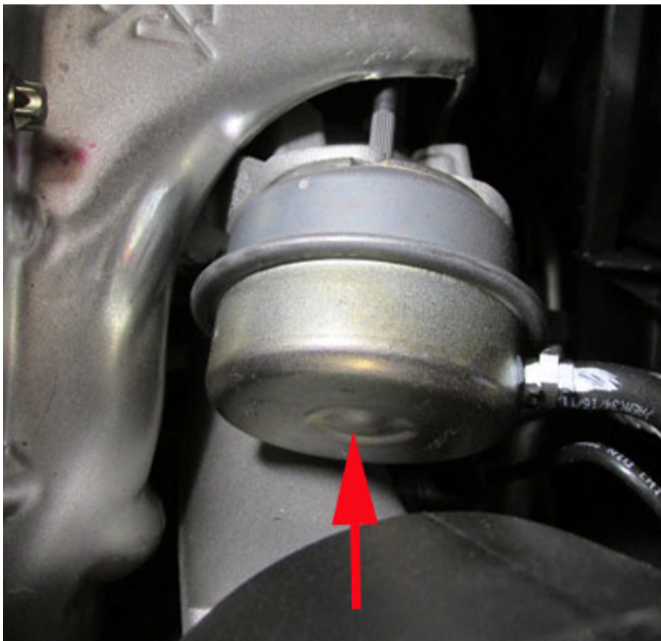
The updated design actuator shown below has a stop that is not recessed and allows 5mm more travel in the closed direction.

With this updated design, it is very unlikely that an insufficient preload issue exists.

Updated design.
