PIT5427B Service Messages on DIC and/or SES MIL

Brand:	Model:	Model Years:	VIN:		Engine:	Transmissions:
			from	to		
Chevrolet	Equinox	2010 - 2017	All	All	All	All
GMC	Terrain	2010 - 2017	All	All	All	All

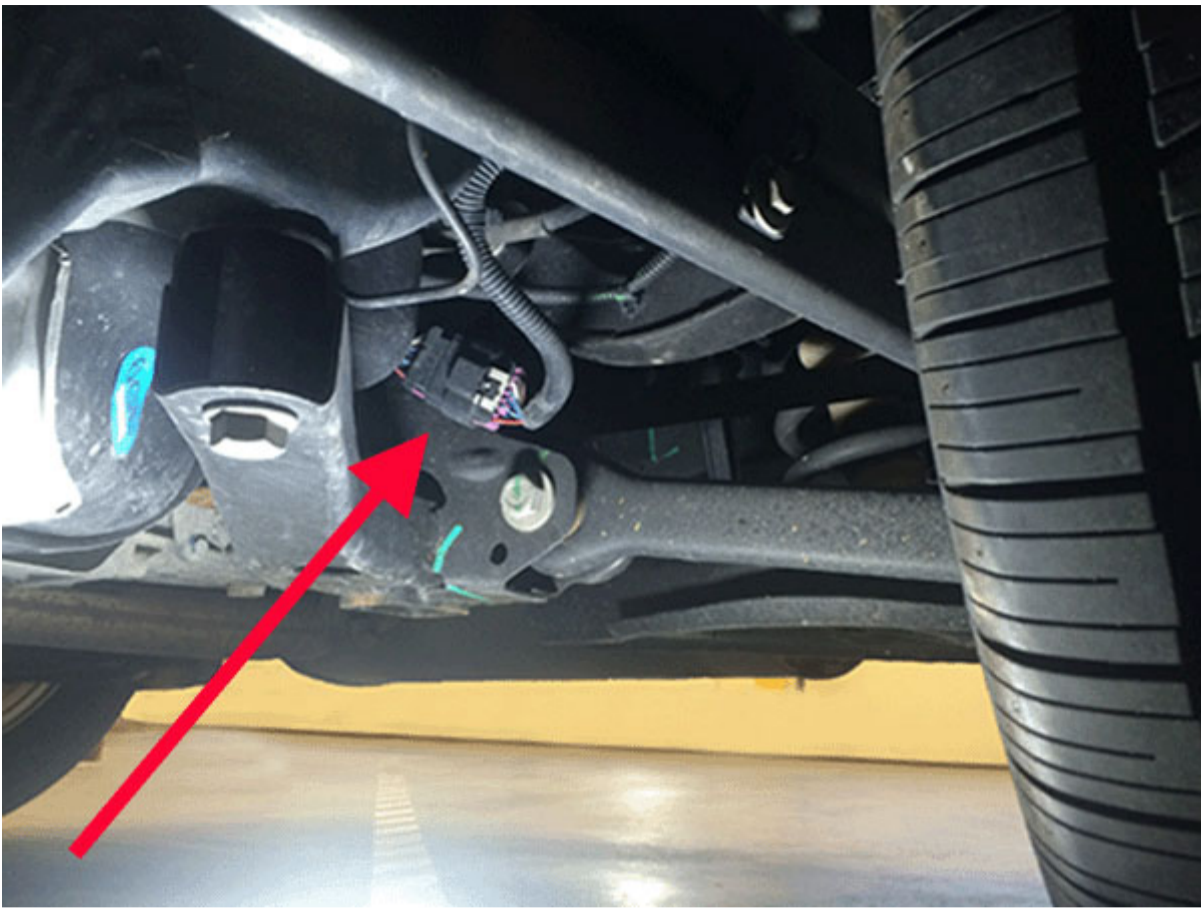
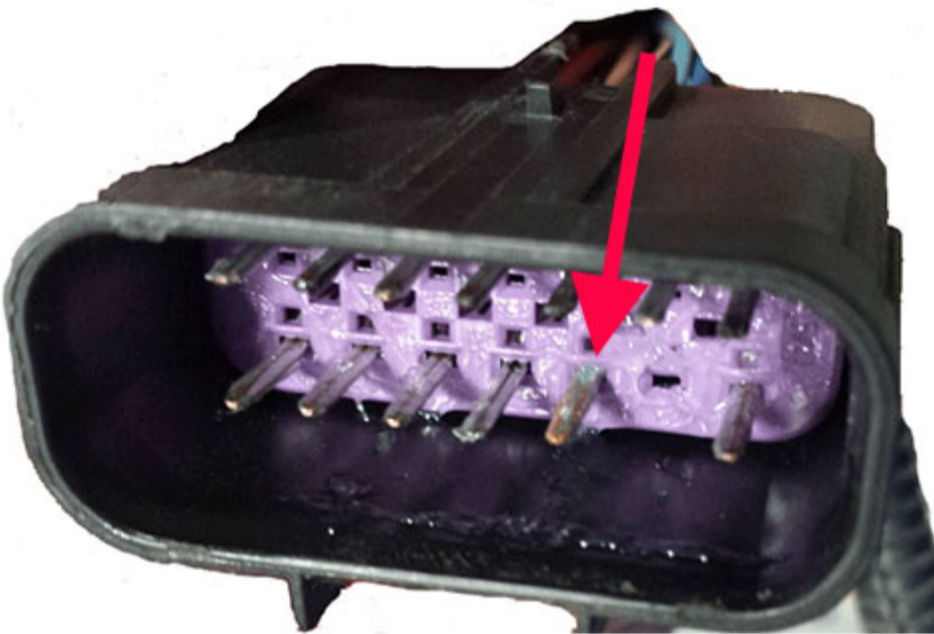
These concerns may be caused by corrosion in the X411 connector located under the rear of the vehicle, behind and to the left of the fuel tank.

To correct concern, please replace the appropriate terminals / connector at X411 as needed.
