Preliminary Information

PIP5570A Tick Noise Inside Vehicle While Driving

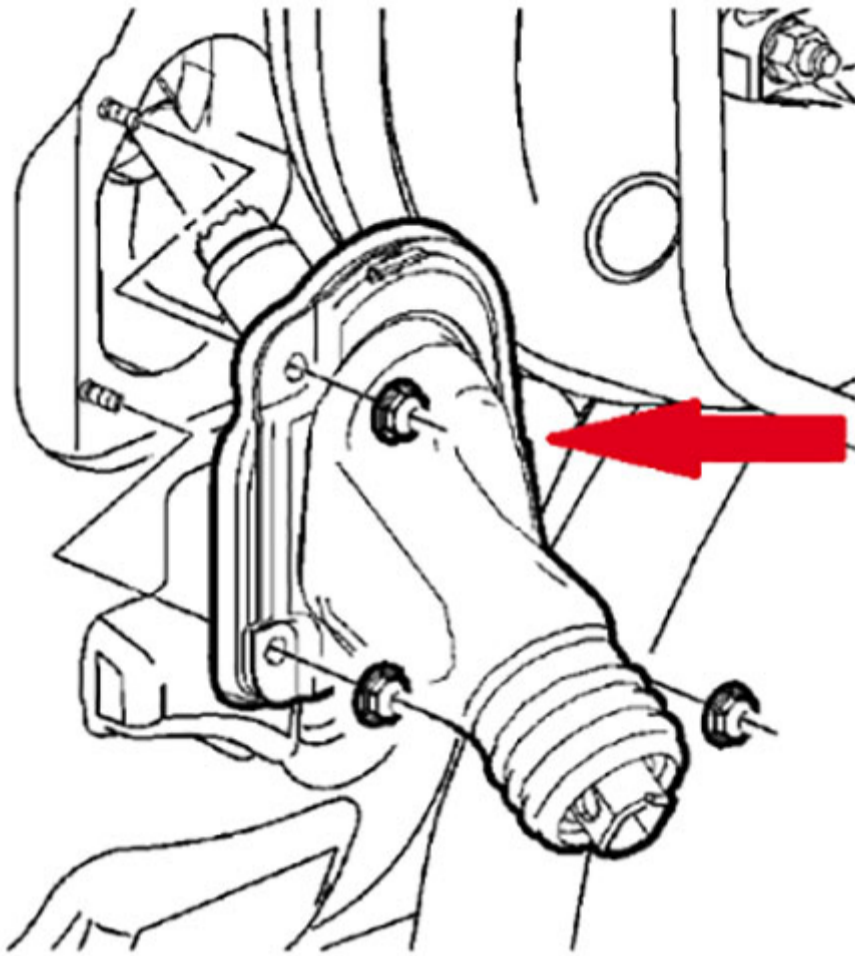
In rare instances it has been found that the steering shaft seal (intermediate shaft seal) is allowing unfiltered sound from the engine compartment into the vehicle cabin.

Inspect the steering seal for proper seating/installation (see below), adjust as needed.

If no obvious issues are identified, remove the steering seal and inspect for any deformation, replace as needed.
