Preliminary Information

PIC5822F Water on Front Floor and/or Carpet

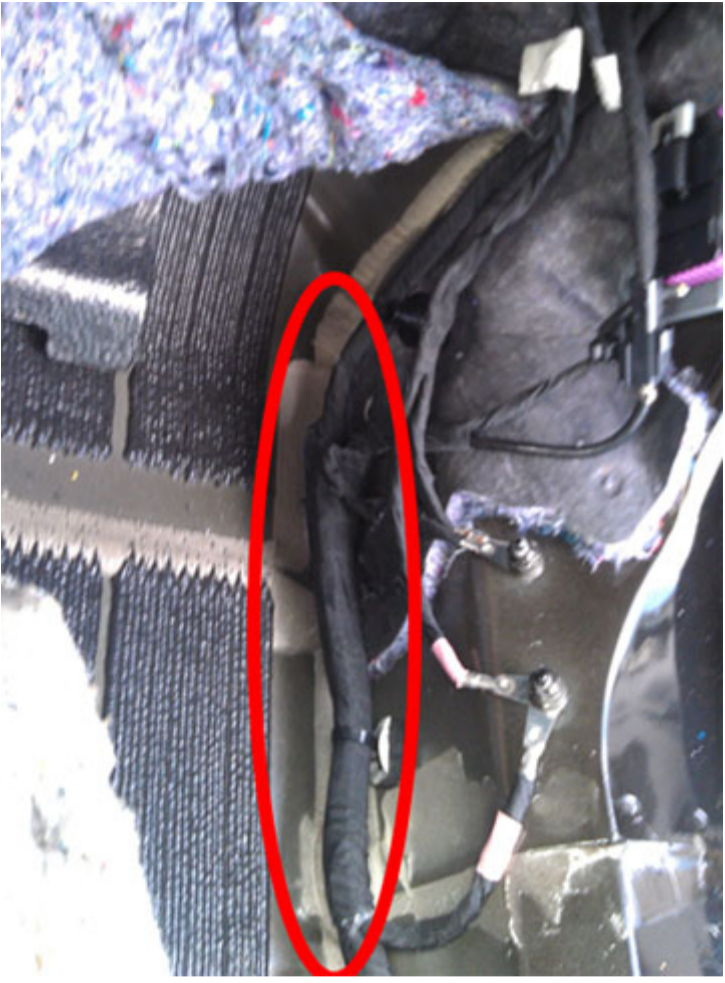
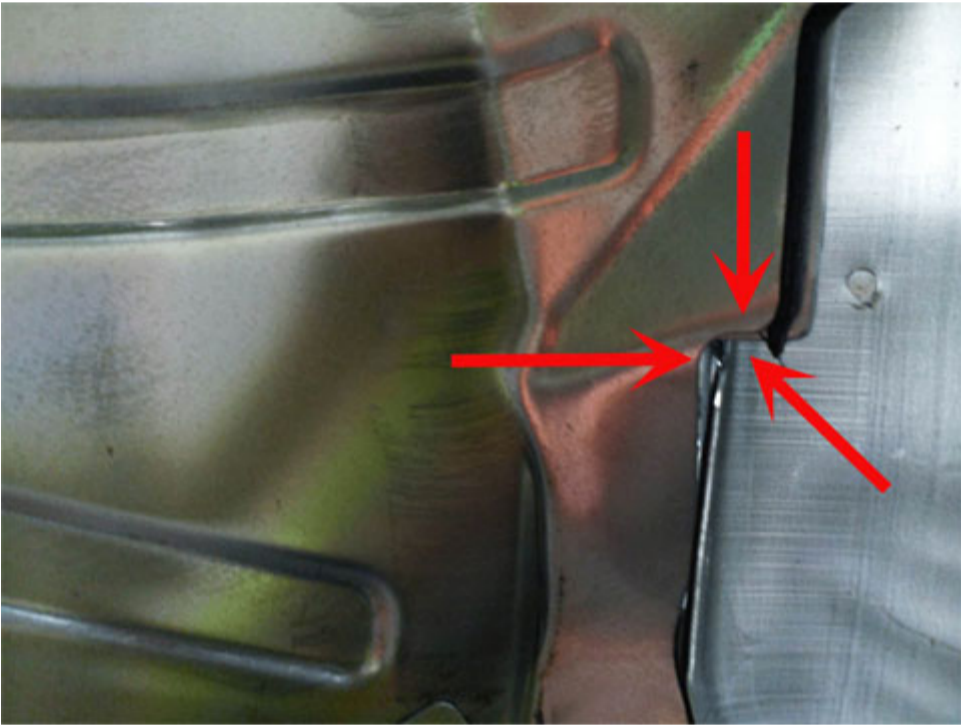
Technician should pull back carpet and insulator as shown in pictures below for the suspect side of the vehicle (passenger side shown). Remove the front wheelhouse liner and spray water into the wheelhouse of the affected side and check for water in the area indicated in photo shown below.

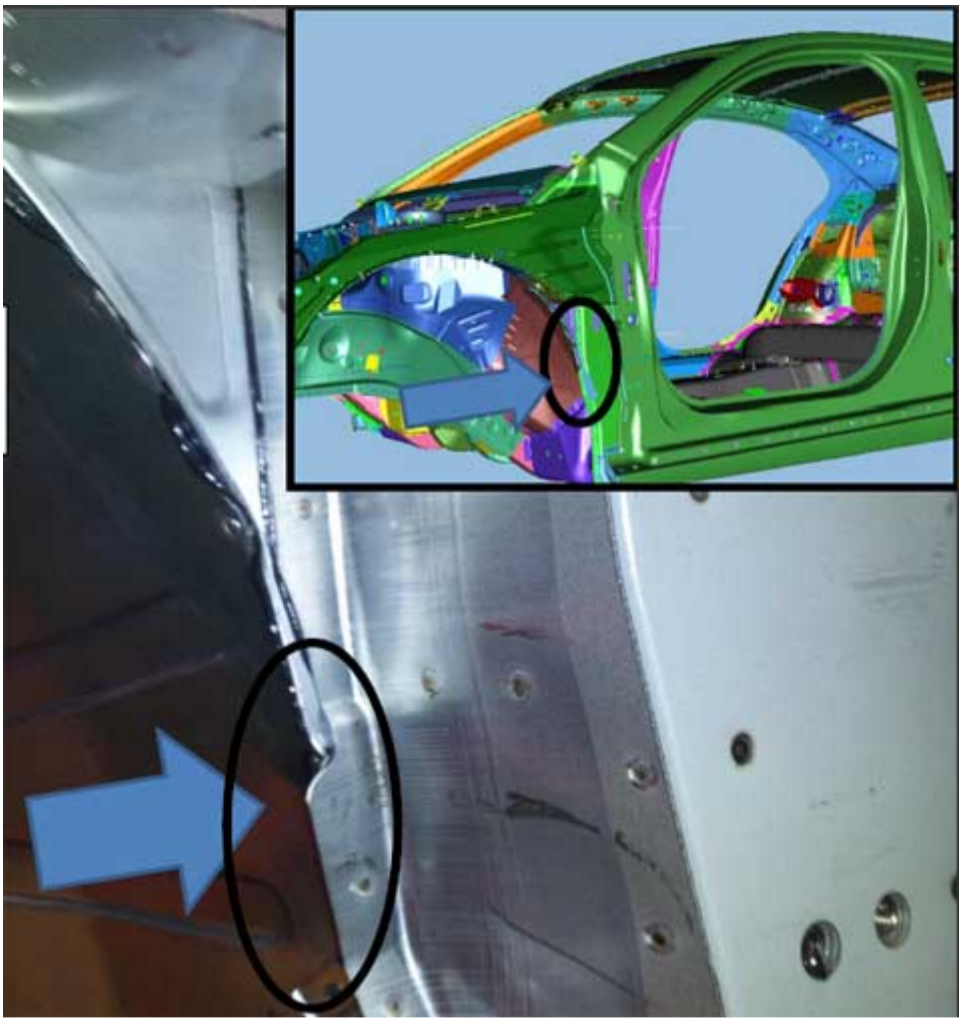
Water will enter around applied sealer as cavity fills. The front wheel house flange may have a void in the sealer. Seal the void using a thumb grade sealer (service manual calls for "heavy-bodied caulking material") pushed into the void from the wheel opening. For location of flange please reference the graphics below.
