## Automatic Transmission Housing Cracked: Damage Resulting From Cracked Diesel Particulate Filter Bracket

Topic number	LI49.00-N-067929
Version	4
Function group	49.00 General
Date	06-04-2018
Validity	Model 906 with engine 651, transmission 722.9 and code G42 (7G-TRONIC PLUS)
Reason for change	Distribution adjusted.
Reason for block

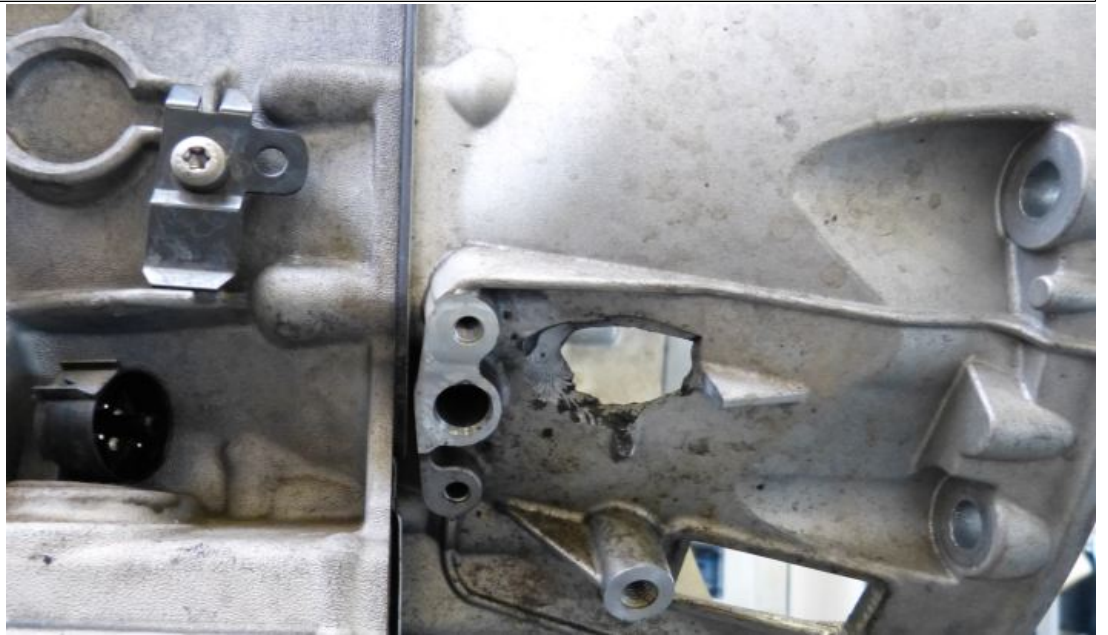
01.jpg:

Torque converter housing cracked in area of diesel particulate filter bracket (see pictures 01 and 02). May be accompanied by banging or clunking noise.

Damage is likely due to excessive loading caused by failure of diesel particulate filter mount..

If the diesel particulate filter mount has cracked and caused damaged to the transmission mounting location (see example photos), ONLY the torque converter housing is to be replaced.

- 
- #1 - Uninstall torque converter housing with multidisk brake B1 and oil pump still attached - (AR27.50-D-0601WE).
  - #2 - Remove multidisk brake B1 and oil pump (AR27.50-D-0721WE) from original bell housing.
  - #3 - Replace torque converter housing and reinstall multidisk brake B1 and oil pump - (AR27.50-D-0721WE). Please refer to EPC for correct part number.
  - #4 - Reinstall new torque converter housing.
-
