Seat cushion fore/aft adjuster seat cushion cover becomes detached

Topic number	LI91.18-P-049463
Version	3
Function group	91.18 Seat covers
Date	07-31-2018
Validity	BR204 and 207 with SA code 409 (Multicontour seat) and BR212 with SA code 409/432 (Multicontour seat/active multicontour seat) BR 205 and 213 with SA code P65 (Seat cushion fore/aft adjustment) and with 275 (Electrically adjustable driver seat with memory function) or 241 (Electrically adjustable front seats) or 242 (Electrically adjustable front passenger seat with memory function)
Reason for change	BR213 added
Reason for block

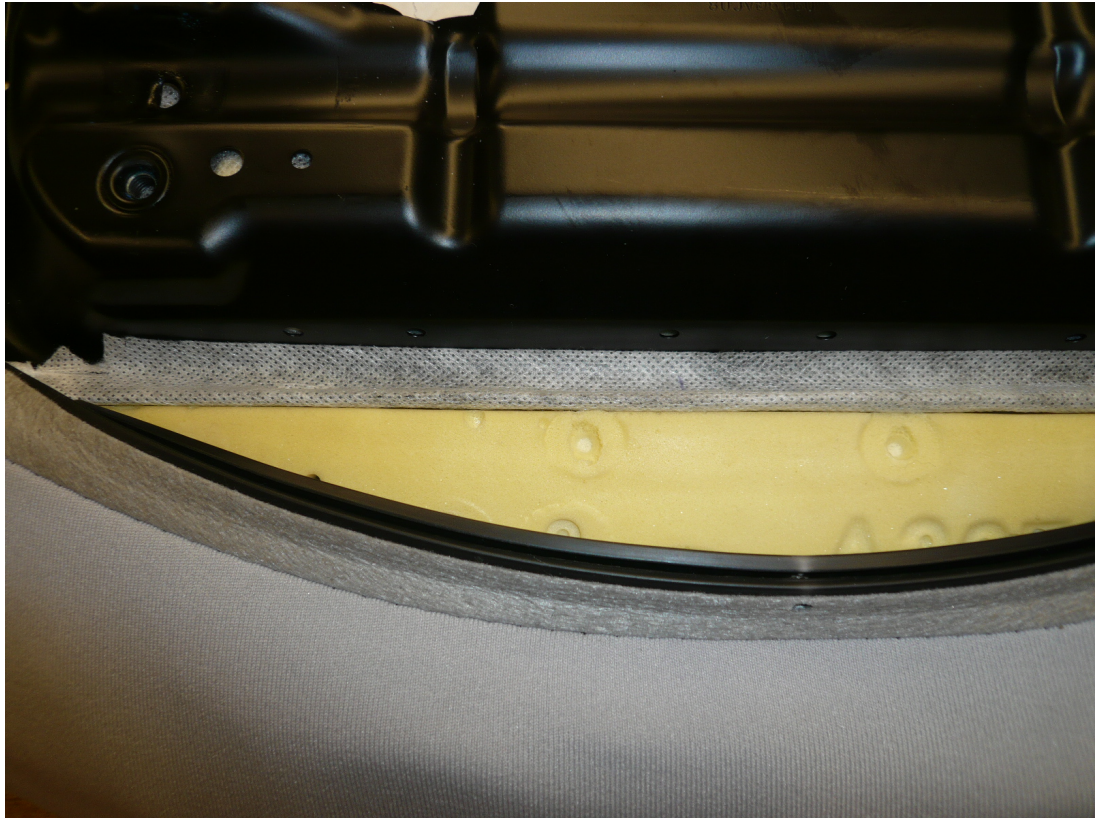
P1040937.JPG:

- Model series 204 and 212: Insufficient holding ability of the fastening strip
- Model series 207: Matting incorrectly positioned. (See picture P1040937)
- Model series 205 and 213: Insufficient holding ability of the fastening strip

Attachments	
File	Description
P1040937.JPG	Matting trapped in profile

! Remove the folded matting from the fold, reattach the cover accurately and make sure that the fastener clicks firmly into place !
- Model series 205 and 213:
 - Remove front seat cushion as per AR91.10-P-3310LWA
 - Remove cover from front seat cushion as per AR91.18-P-1800LW
 - On the base plate (13) of the seat cushion fore/aft adjuster, position 2x retaining clips approx. 5mm from the marking and press in flush with the edge of the base plate (Pic3)
