Service Campaign Bulletin

Campaign No. 2018070011, August 2018

SUBJECT: **MY17-18 GLE-Class (Model 166) and GLE-Coupe (Model 292)**
Check Front Left Underbody, Rework if Necessary

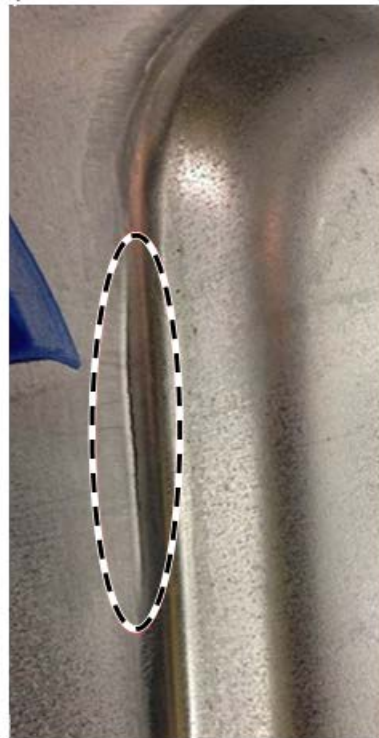
1. Check front left underbody for cracks.
 - i** There must be no cracks in the underbody (**A, figure 2**).
 - a. If there is a crack: Carry out work procedure.
 - b. If there are no cracks: End measure.

Figure 2 (with visible crack, not ok)

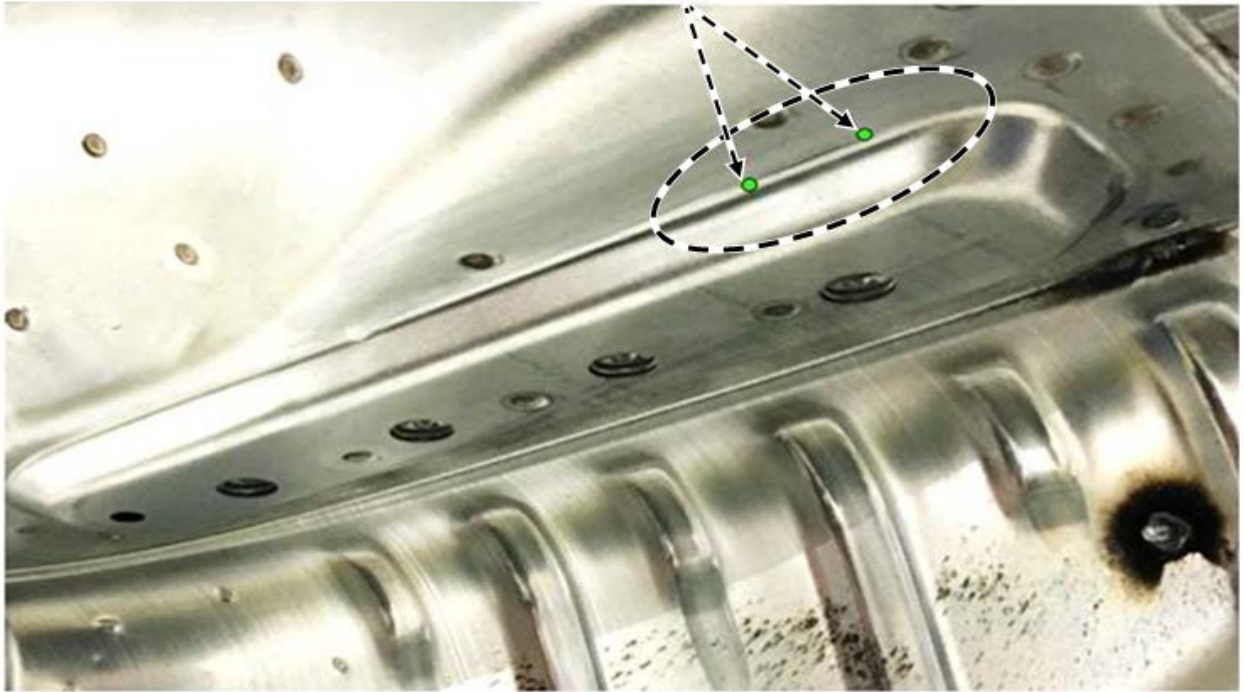
Figure 3 (with visible crack, **not ok**)

2. Drill out to the left and to the right of the crack using a twist drill bit (**3 mm**) (**figure 3**).

i Note: The sheet metal is double-layered in this area. Do not drill deeply. Drill no more than 1 mm deep. Do not drill through the sheet metal.

3. Seal repair area using body sealant (**A 002 989 63 98**).
4. Apply cavity preservation agent to the reworked area.
5. Reattach cross-member.
