Surface removal at frame of stowage box/ashtray

Topic number	LI68.20-P-068649
Version	1
Function group	68.20 Center console
Date	08-09-2018
Validity	Valid for vehicles of model series 205/253/213/238 with automatic transmission. Not valid for vehicles with world manufacturer code LE4.
Reason for change	
Reason for block

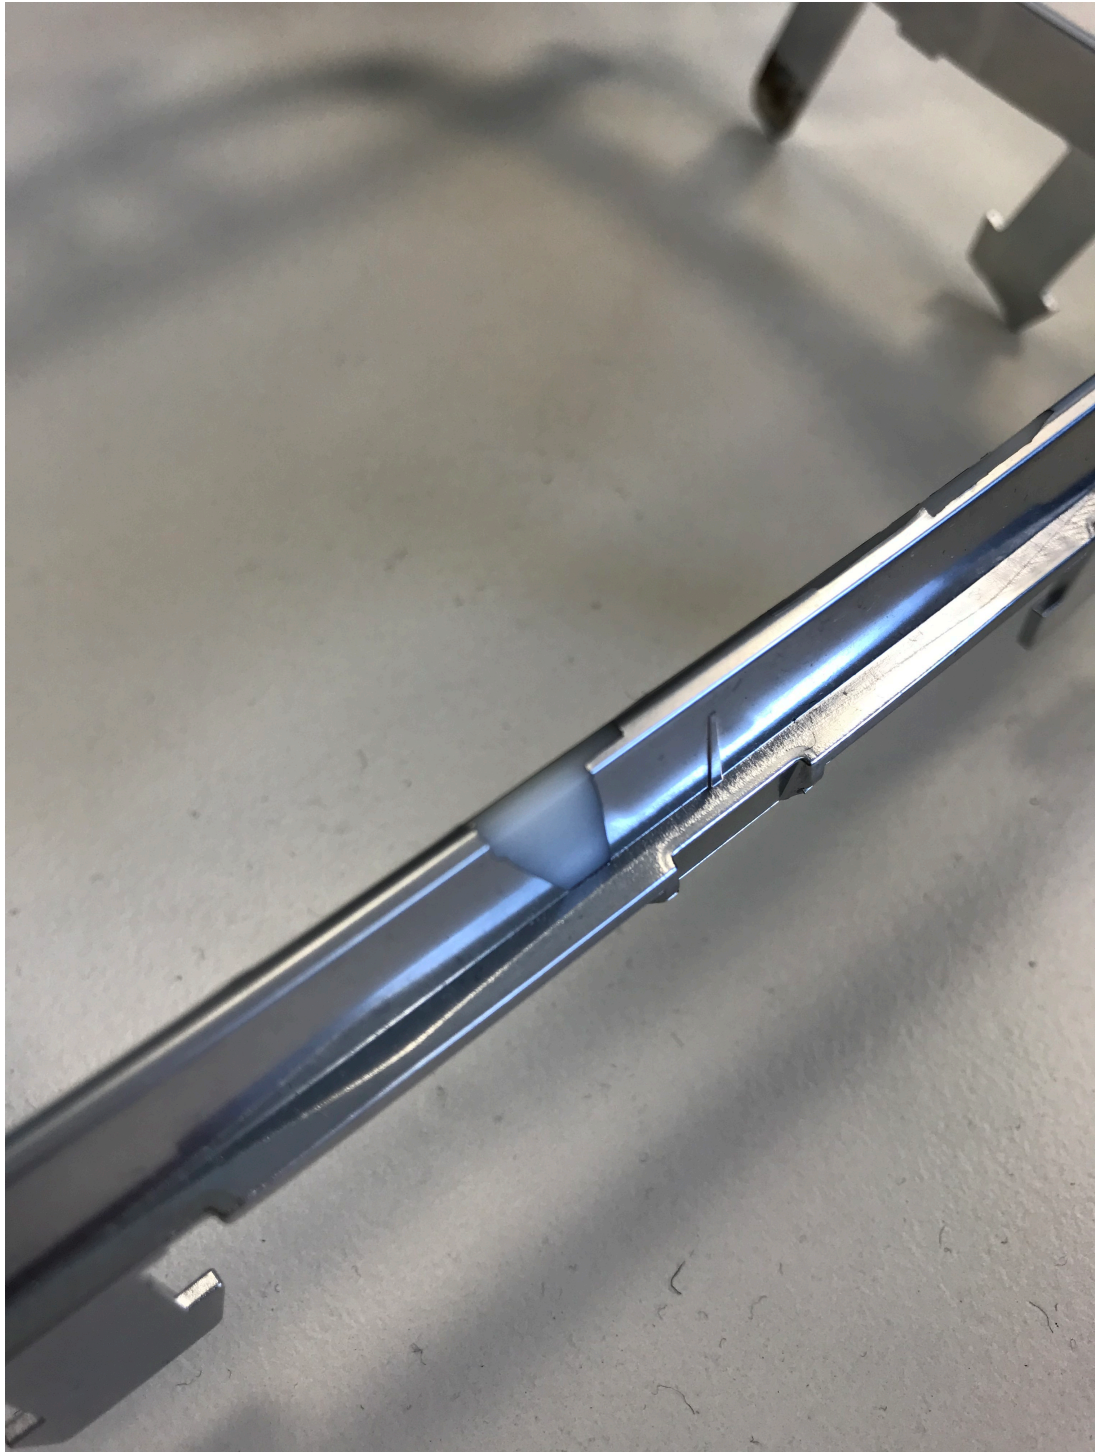
IMG_0103.jpg:

Surface removal at frame of stowage box/ashtray.

Insufficient connection of base material to surface material.

Replacement of damaged frame with optimized component parts.

The replacement is done as per WIS document AR68.20-P-0002LWE.
