N221NAS2

# TECHNICAL BULLETIN

Service Action: Windshield Water Leaks

MODEL:	MODEL YEAR:	VIN:
Range Rover Evoque (LV)	2015-2018	055105-260364
Discovery (LR)	2017	000128-022488

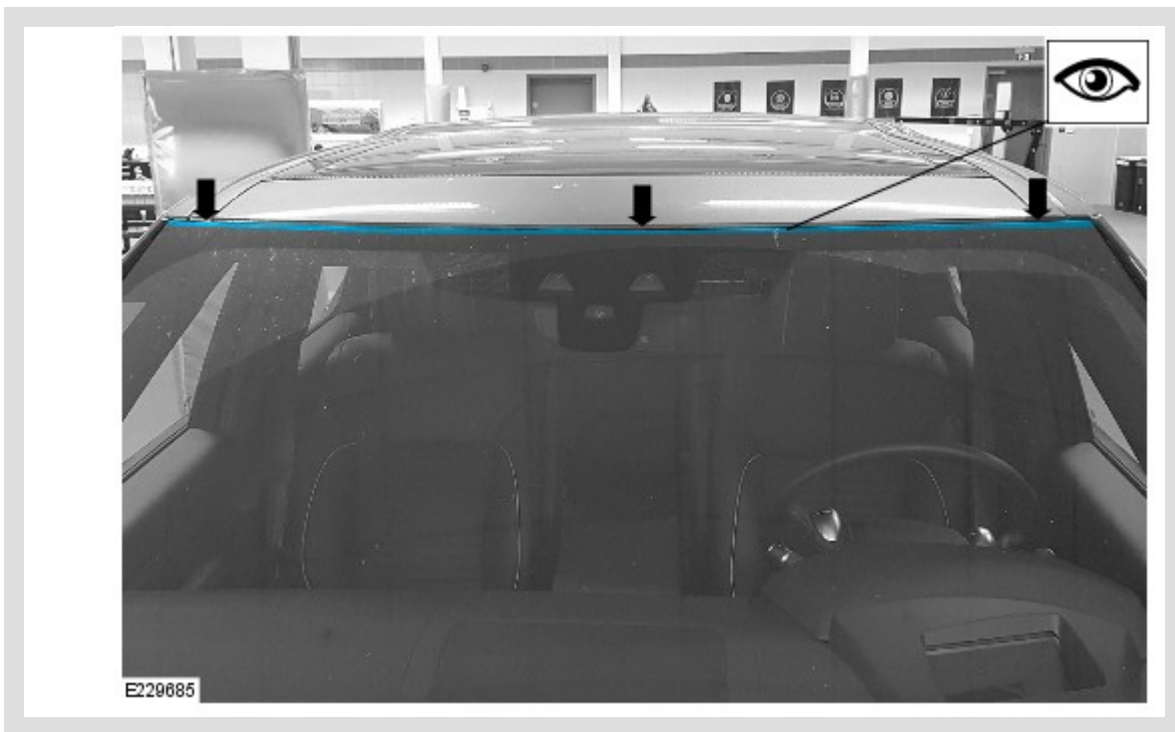
1

Apply soapy water to the affected area as shown and inspect the windshield.

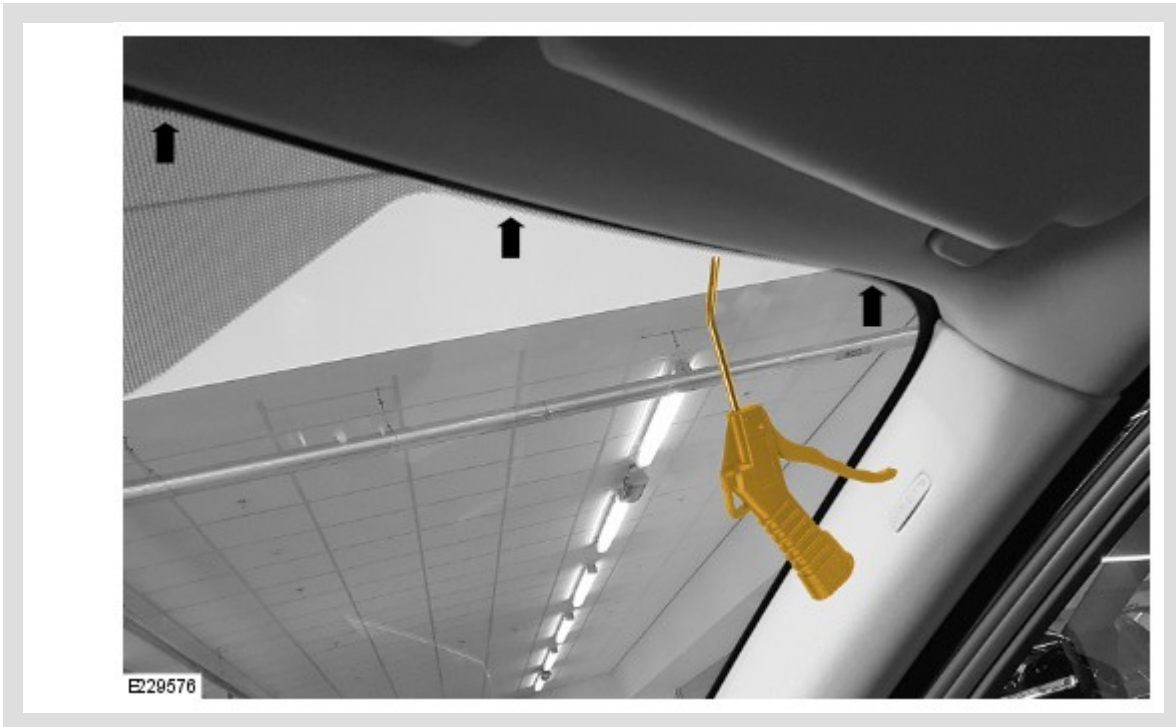
2

Use an air blower to blow compressed air around the edge of the inner side of the windshield as shown.

- 1 While continuing to blow air around the inner edge of the windshield, apply gentle pressure by hand to the top section of the windshield from inside the vehicle.
