KNOCKING NOISE FROM FRONT SUSPENSION WHEN DRIVING OVER BUMPS AT LOW SPEEDS

Bulletin No.: 02-017/18

Last Issued: 11/02/2018

2016-2017 Mazda2 (Mexico spec)

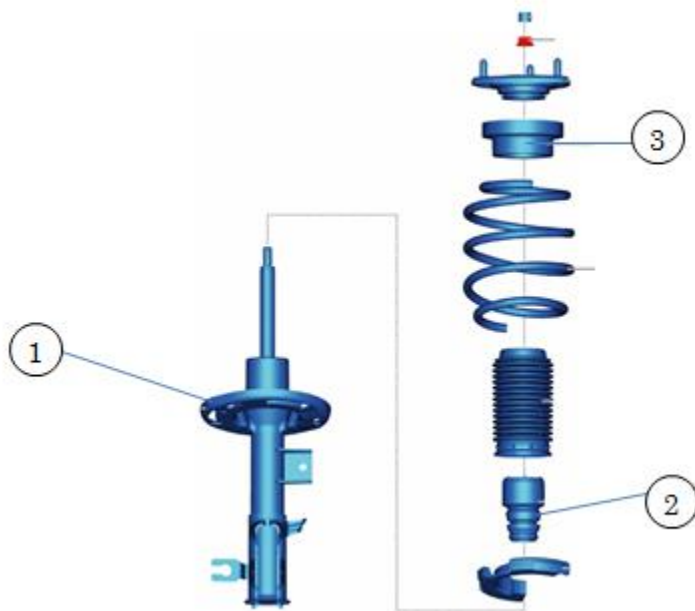
This is caused by the bump stopper (2) contacting the strut bearing (3) when the front shock absorber (1) is compressed.

To eliminate this concern, the shape of the bump stopper has been modified.
