GROUP Product Improvement	MODEL 2011-2014MY Optima (QF/TF) 2012-2014MY Sorento (XMa) 2011-2013MY Sportage (SL)
	NUMBER PI1803W/X	DATE November 2018
PRODUCT IMPROVEMENT CAMPAIGN		
SUBJECT: ENGINE REPLACEMENT INSTRUCTIONS FOR DTC P1326 (PI1803W/X)

This bulletin provides information related to the Technical Service Bulletin previously published in November 2018 ([PI1803](#)) titled “Knock Sensor Detection System - ECU Logic Improvement”. Specifically, this bulletin provides instructions on which procedures to follow if, after installation of the KSDS, any one of the subject vehicles below returns to the dealer with Diagnostic Trouble Code (“DTC”), P1326.

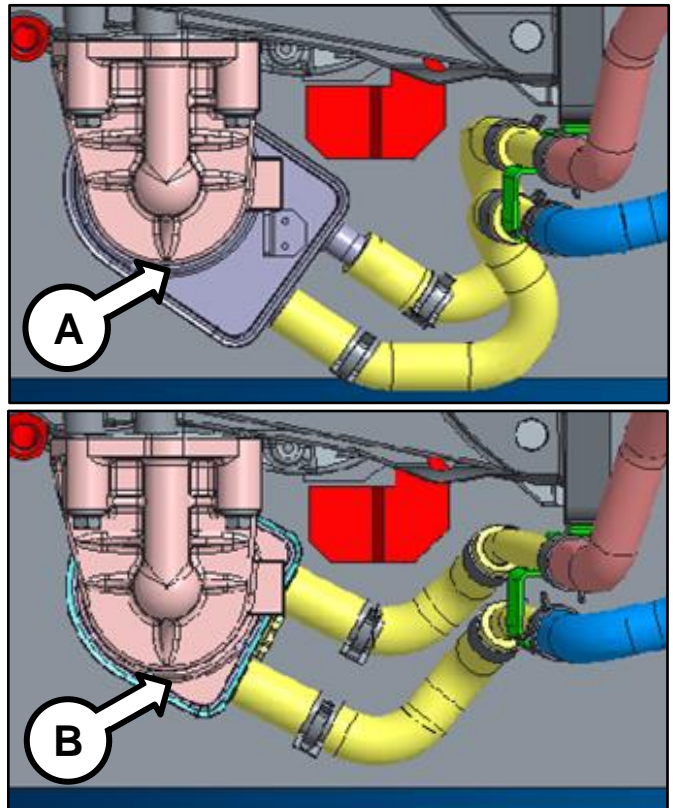
New engines may be supplied with a different oil cooler. Use steps below to determine the need for a replacement oil cooler tube assembly.

- If the new engine's (bigger) oil cooler (A) does not match the old engine's (smaller) oil cooler (B), replace the oil cooler tube assembly with the improved part. See parts table on page 15.
- If the new engine's (bigger) oil cooler (A) matches the old engine's (bigger) oil cooler (A), reuse the old engine's oil cooler tube assembly.
- If the new engine's (smaller) oil cooler (B) matches the old engine's (smaller) oil cooler (B), reuse the old engine's oil cooler tube assembly.
