Mack Model GR-Granite , PI-Pinnacle , AN-Anthem , CHU-Pinnacle, Axle back , CXU-Pinnacle, Axle forward , GU-Granite , TD-Titan

Volvo Model VNR , VT , VNX , VNL , VNM , VHD , VAH

Title Automated Manual Transmission Gearbox Will Not Shift To High Range After Gearbox Repair; MID 130 PSID 24 FMI 1, P1072-92 Unintentional Disengagement Of High Range - **US07 And Newer Emissions, Model Year 2008 And Newer**

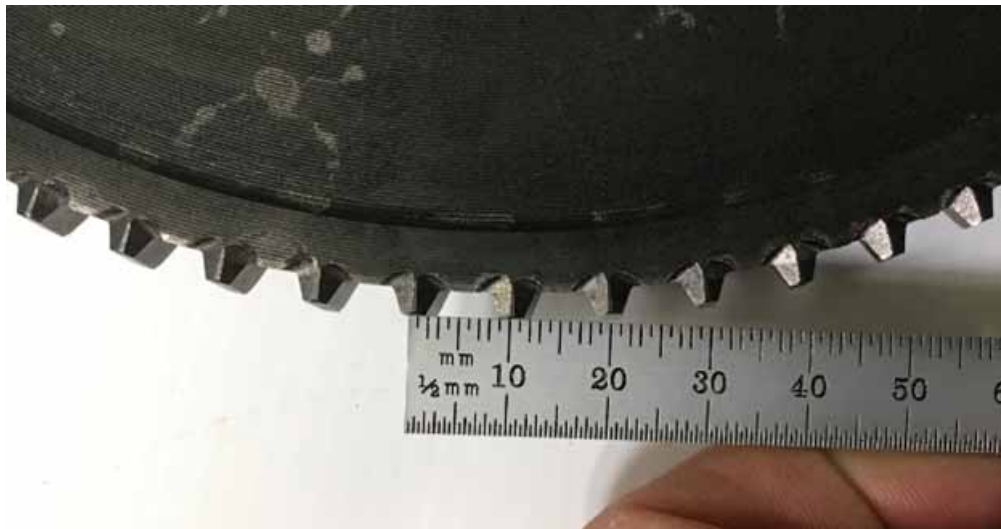
The correct tooth spacing is approximately 10 millimeters from the center of each tooth on the high range synchronizer center hub.

Solution Inspection of the tooth spacing for the components prior to installation will eliminate any potential mismatch of components and extended diagnostic time resulting from the incorrect components.

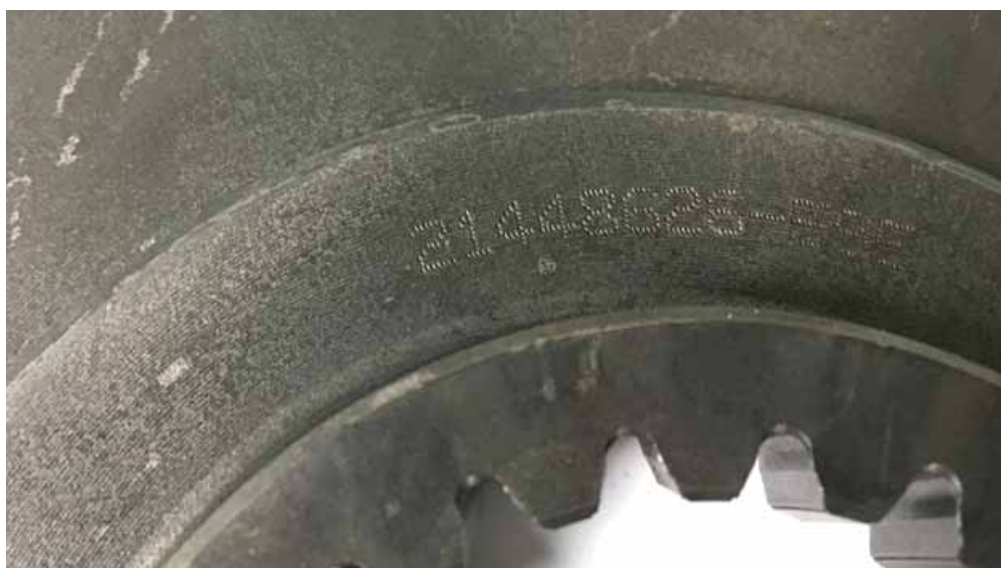
The Part Number for the correct center hub is 21448626.

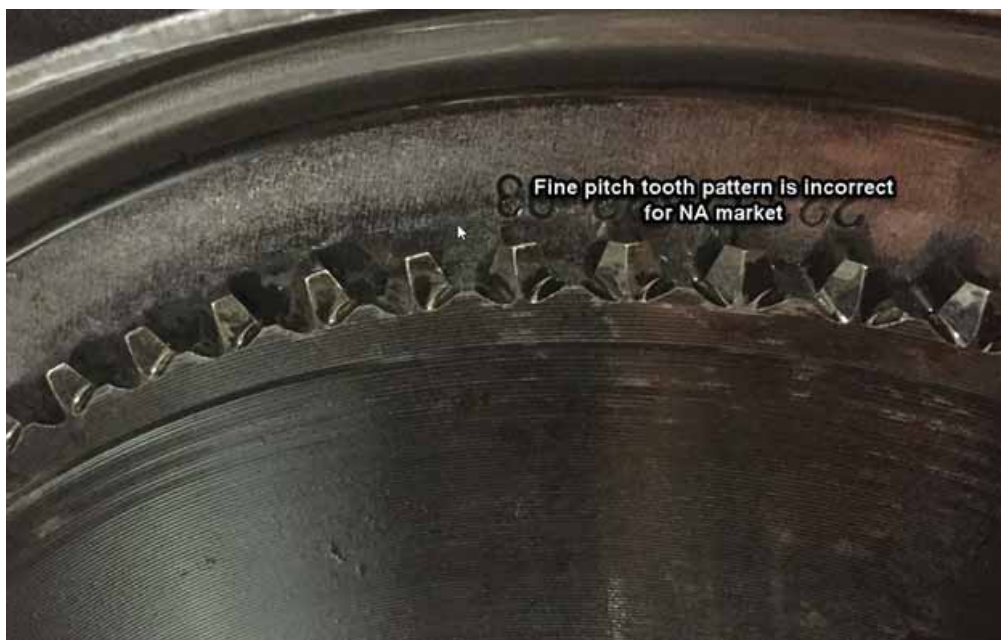
The incorrect fine tooth hubs have a Part Number of 21753650.

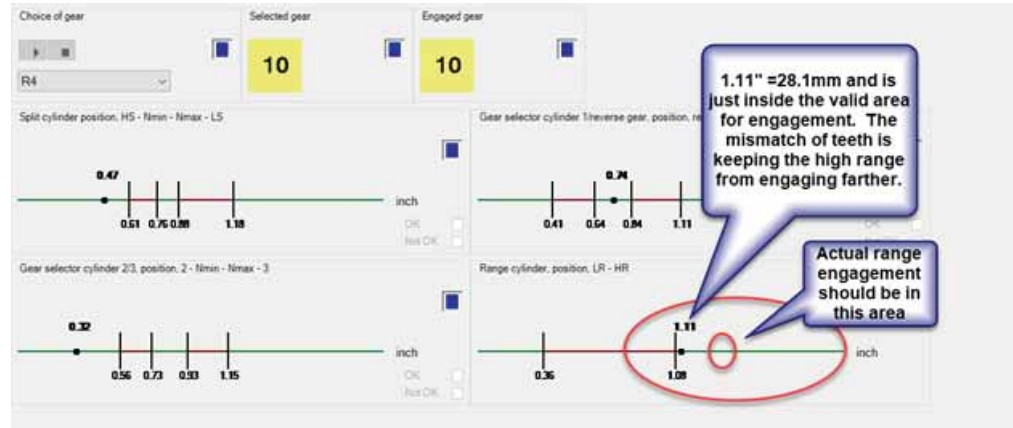
What you will see in Tech tool if the unit gets assembled this way.

Reviewing the Gears Test (4311-08-04-01) , calibration values (4320-07-03-01) or the Range Solenoid Test (4320-08-03-02) screens, the high range engagement will show to be barely within the valid calibration/engagement area. The teeth will mesh just enough to allow a good calibration and test results however the teeth are not engaged and the torque applied to the unit will force the range out of gear.

The average high range engaged position is 33 mm (1.31 inches) range.
