Solution K53357197 Thursday, December 6, 2018 8:40:54 PM CET

** SOLUTION **	
Title	Dignostic Trouble Code (DTC, Fault Code) MID 140 PSID 210 FMI 12, Faulty Unit or Component Present On DTC Readout; Vehicle Operation Not Affected: No Physical Symptoms Or Warning Lights In Instrument Cluster - US17+OBD2016 Emissions, Model Year 2018
Cause	Note that this code does not cause any physical symptoms. There is no effect to vehicle operation and this code does not set any warning lights on the instrument cluster. It will only appear on a DTC readout if one is performed. Any physical symptoms or other fault codes present should be diagnosed as normal.
	Model year 2018 and 2019 vehicles may experience DTC MID 140 PSID 210 FMI 12 with a significant number of occurrences logged when a DTC readout is reviewed. It has been determined that the code is logged due to an Instrument Cluster Watchdog ECU timeout, a function embedded in the cluster's main software. It is also possible that a third party module may be causing communication interference on the J1587 Data Link.

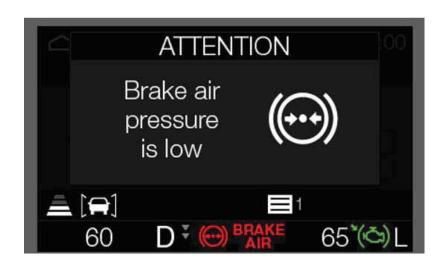
NOTE: This software update will also add a new function to the display. Following the update, the Brake Air Low icon will now appear in the information display when the correct conditions are met. The new icon can be seen below.
