## CR165 – Tightening torque of eccentric hub fastening screw update

Panigale V4 (all Model years and versions)

Technical Service Bulletin SRV-TSB-18-018

Date: November 27, 2018

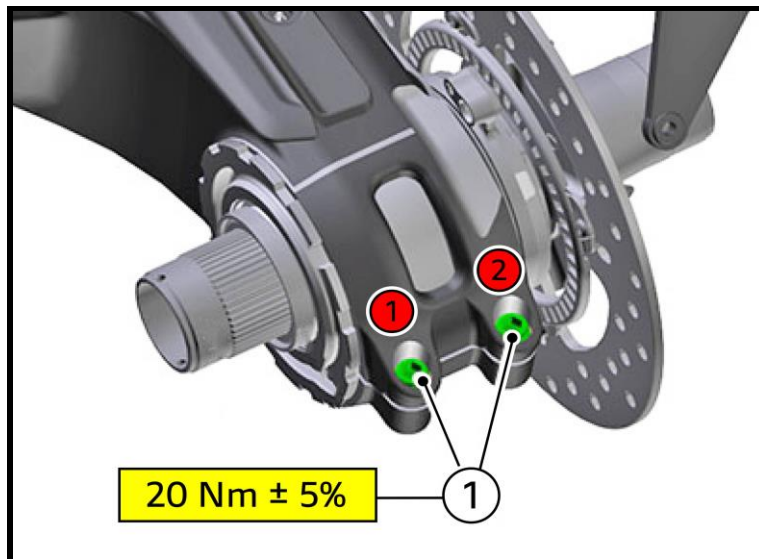
Ongoing product quality tests have detected a potential noise coming from the rear eccentric hub. This noise presents as a "clicking" sound that can be heard by handling the motorcycle by hand and with engine off.

The described condition is not safety related and does not cause any problem to vehicle operation.

The solution is to reduce the tightening torque of the two M10x35 screws fastening the eccentric hub to the swingarm on all the concerned motorcycles. It is necessary to update the tightening torque of the **2 M10x35 screws (1)** to the value of **20 Nm  $\pm$  5%** by following the sequence **1-2-1** for all affected units. (the previous tightening torque was 25 Nm  $\pm$  5%)

Whenever final drive chain is tensioned, always comply with the new tightening torque of the two M10x35 screws fastening the eccentric hub to the swingarm.
