HYUNDAI Technical Service Bulletin	GROUP CAMPAIGN	NUMBER 18-01-041
	DATE DECEMBER, 2018	MODEL(S) VELOSTER (JS)
SUBJECT: HIGH BEAM ASSIST (HBA) VARIANT CODING (SERVICE CAMPAIGN T3L)

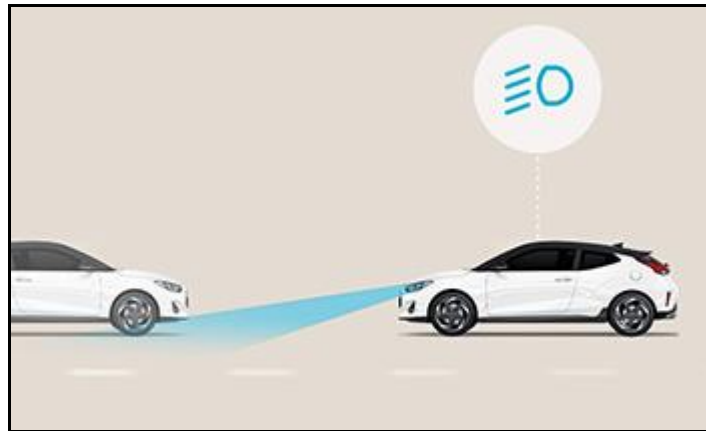
Description: Some 2019 Veloster (JS) vehicles equipped with High Beam Assist (HBA) feature may not function. This bulletin provides the service procedure to variant code the front view camera to turn ON the High Beam Assist (HBA) feature.
