Technical Service Bulletin

FAILSAFE MODE OCCURS DUE TO FROZEN RELAYS

No: TSB-18-13-003

DATE: December 2018

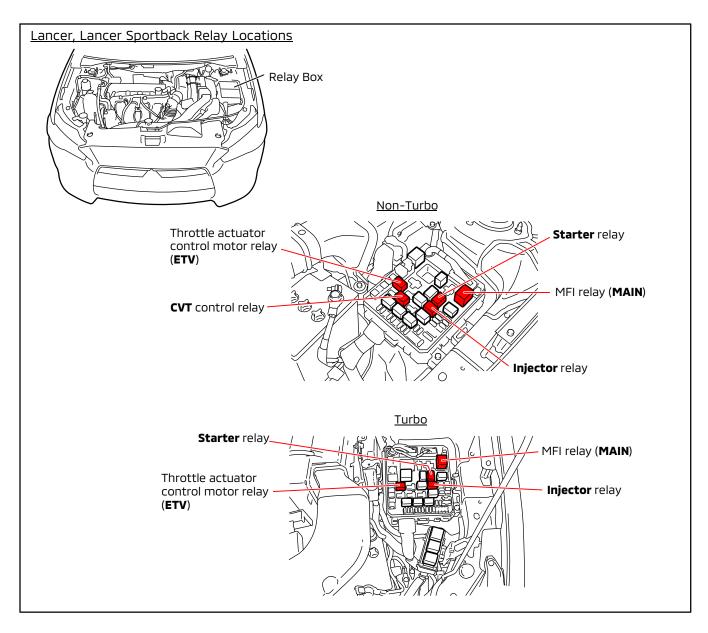
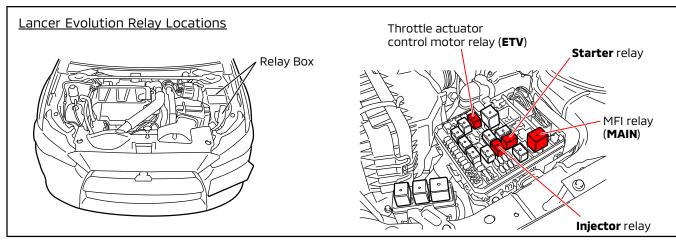
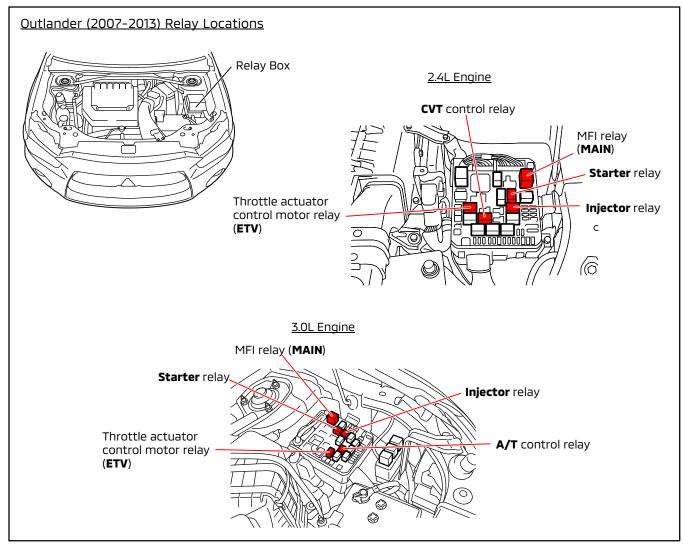
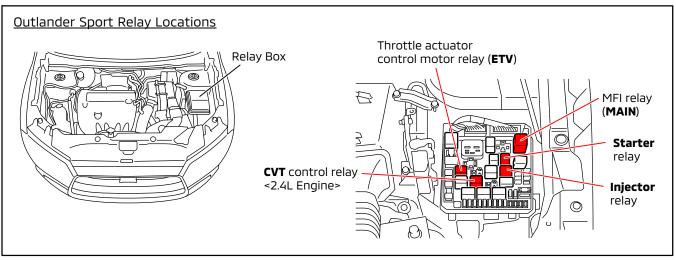
NOTE: Refer to the following illustrations for relay locations.

If <u>ALL</u> DTCs listed above are present for the systems and vehicles shown, replace the following relays with the anti-freezing type listed below.

RELAYS TO REPLACE	PART NUMBER (anti-freezing type)	PART NAME	RELAY TYPE	QTY
MAIN	8627A050		Mini ISO	1
ETV	- 8627A049	RELAY, POWER	Micro ISO	1
A/T (CVT)*				1
INJECTOR			1411C1 0 130	1
STARTER				1

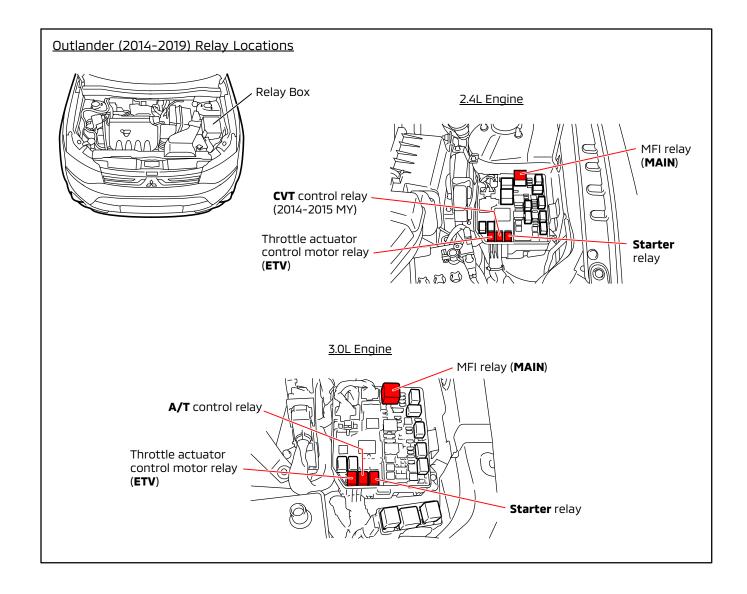
NOTE: Refer to the following illustrations for relay locations.

If \underline{ALL} DTCs listed above are present for the systems shown, replace the following relays with the anti-freezing type listed below.

RELAYS TO REPLACE	PART NUMBER (anti-freezing type)	PART NAME	RELAY TYPE	QTY
MAIN	8627A050		Mini ISO	1
ETV				1
A/T (CVT)*	8627A049	RELAY, POWER	Micro ISO	1
STARTER				1

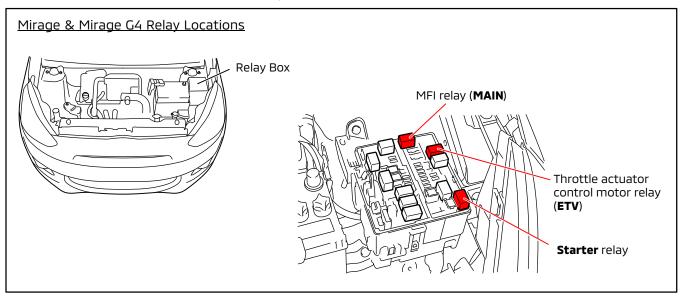
NOTE: Refer to illustrations below for relay locations.

If <u>ALL</u> DTCs listed above are present for the systems and vehicles shown, replace the following relays with the anti-freezing type listed below.

RELAYS TO REPLACE	PART NUMBER (anti-freezing type)	PART NAME	RELAY TYPE	QTY
MAIN	8627A050		Mini ISO	1
ETV	8627A049	RELAY, POWER	Micro ISO	1
STARTER	0027A049		14110130	1
