Technical Service Bulletin

SUBJECT:			No: TSB-18-21-001
TORQUE UPDATES: UNITS OF TIGHTENING TORQUE & NUMERICAL VALUE FOR CLUTCH - SERVICE MANUAL REVISION			DATE: December 2018
			MODEL: 2008 -2014 Lancer Evolution
CIRCULATE TO:	<input type="checkbox"/> GENERAL MANAGER	<input checked="" type="checkbox"/> PARTS MANAGER	<input checked="" type="checkbox"/> TECHNICIAN
<input checked="" type="checkbox"/> SERVICE ADVISOR	<input checked="" type="checkbox"/> SERVICE MANAGER	<input checked="" type="checkbox"/> WARRANTY PROCESSOR	<input type="checkbox"/> SALES MANAGER

This TSB updates the Clutch section of the affected Service Manuals to correct the tightening torque for the clutch fluid air bleeding nipple.

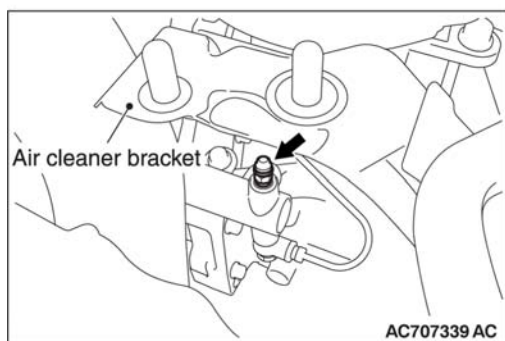
Tightening torque: 11 ± 1 N·m (~~8 ± 1 ft·lb~~) <Incorrect>

1. Remove the air cleaner element, air cleaner intake duct, and air cleaner body. (Refer to GROUP 15, Air Cleaner.)
2. Remove the cap. Then, connect the air bleeding hose to the air bleeding nipple.
3. Loosen the air bleeding nipple.
4. Perform the air bleeding by depressing the clutch pedal.
5. Remove the air bleeding hose. Tighten the air bleeding nipple to the specified torque. Then, install the cap.

97 ± 8 in·lb <Correct>
