Technical Service Bulletin

SUBJECT:		No: TSB-18-22-001	
TORQUE UPDATES: UNITS OF TIGHTENING TORQUE & NUMERICAL VALUE FOR MANUAL TRANSAXLE - SERVICE MANUAL REVISION		DATE: December 2018	
		MODEL: 2008-2014 Lancer Evolution	
CIRCULATE TO:	<input type="checkbox"/> GENERAL MANAGER	<input checked="" type="checkbox"/> PARTS MANAGER	<input checked="" type="checkbox"/> TECHNICIAN
<input checked="" type="checkbox"/> SERVICE ADVISOR	<input checked="" type="checkbox"/> SERVICE MANAGER	<input checked="" type="checkbox"/> WARRANTY PROCESSOR	<input type="checkbox"/> SALES MANAGER

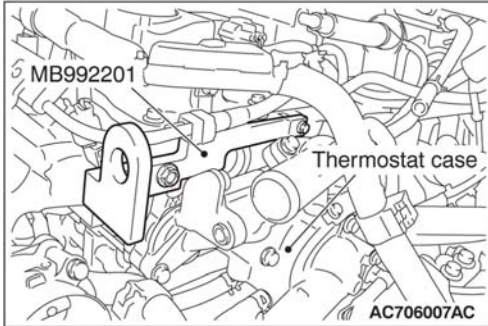
<<G>> ENGINE ASSEMBLY SUPPORT

1. Remove the vacuum pipe assembly (refer to GROUP 14 – Water Hose and Water Pipe), and install the engine hanger plate (Special tool: MB992201), then tighten the bolts to the specified torque.

Tightening torque: 11 ± 1 N·m ~~**(8 ± 1 ft·lb)**~~ **<Correct> (97 ± 8 in·lb)**
