# Technical Service Bulletin

SUBJECT:			No: <b>TSB-18-32-001</b>
<b>TORQUE UPDATES: UNITS OF TIGHTENING TORQUE &amp; NUMERICAL VALUE FOR POWER PLANT MOUNT - SERVICE MANUAL REVISION</b>			DATE: <b>December 2018</b>
			MODEL: <b>See below</b>
<b>CIRCULATE TO:</b>	<input type="checkbox"/> GENERAL MANAGER	<input checked="" type="checkbox"/> PARTS MANAGER	<input checked="" type="checkbox"/> TECHNICIAN
<input checked="" type="checkbox"/> SERVICE ADVISOR	<input checked="" type="checkbox"/> SERVICE MANAGER	<input checked="" type="checkbox"/> WARRANTY PROCESSOR	<input type="checkbox"/> SALES MANAGER

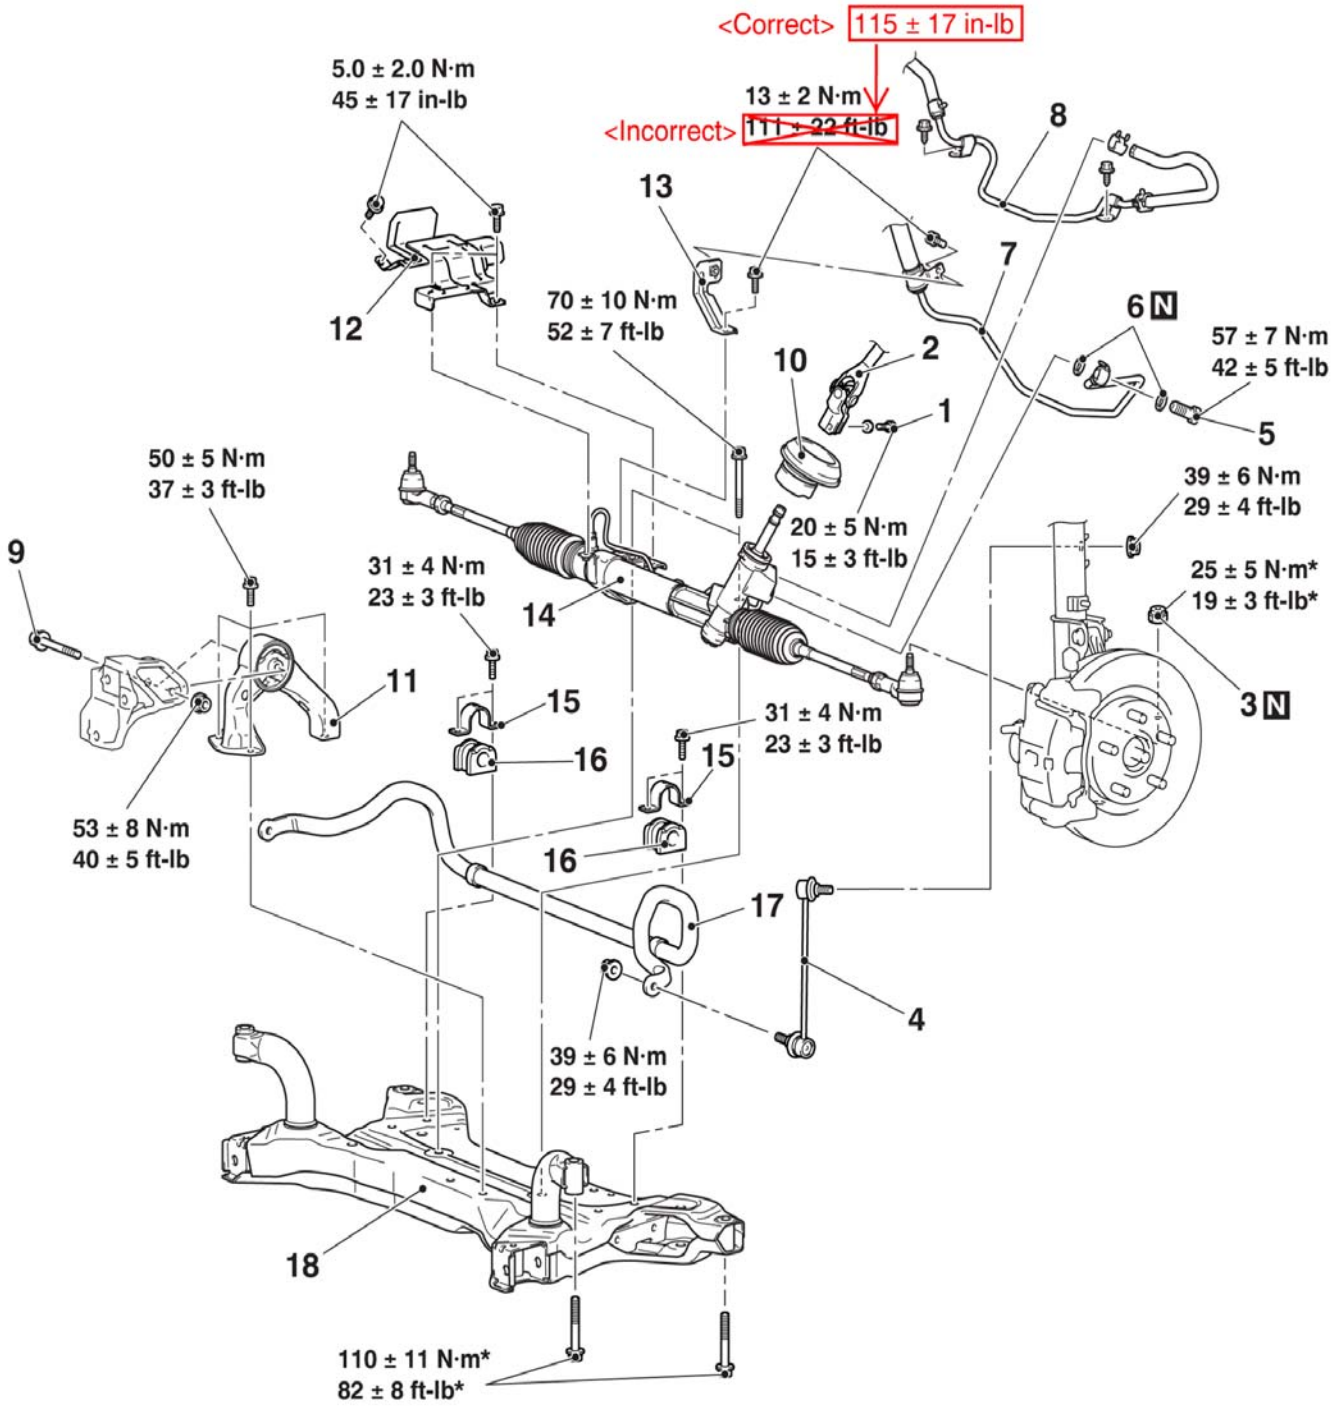
This TSB updates the Power Plant Mount section of the affected Service Manuals to correct the tightening torque for the Crossmember Removal Service Points.

Please make the indicated changes to the 2008 - 2010 Lancer, 2009 & 2010 Lancer Sportback, 2011 Lancer/ Lancer Sportback Evolution Service Manual, Group 32 - Power Plant Mount -> Crossmember -> Removal Service Points.
