Mack Models

CH , RB , DM , CHN , CL , CT , CV , CX , CXM , LE , MR , RD

Title V-MAC III Service Software Displays Runtime Error 400 - Form Already Displayed (Modality)

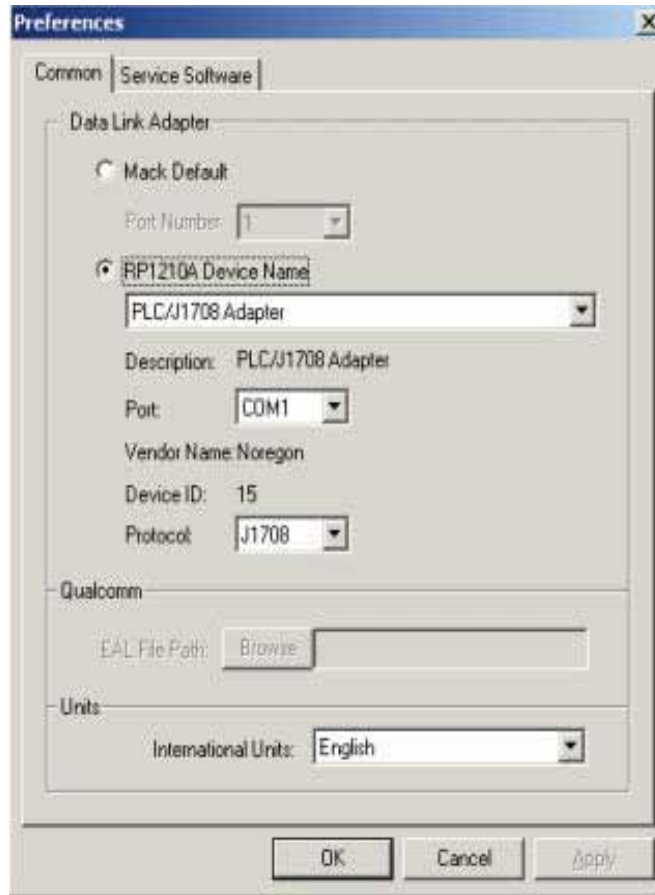
- a. Select OK and let the offending application terminate abnormally.
- b. Navigate to the C:\Program Files\Mack Trucks, Inc\Shared directory.
- c. Double-click on the file Mack Configuration Manager.exe ; you will see the following data link adapter selection dialog box:

- d.** Set all data link adapter selection criteria properly (this will vary according to the data link adapter and operating system employed).
- e.** Select Apply, and then OK.
- f.** Close the computer browser, connect the PC to any Mack chassis, and attempt to launch the offending application once again. Diagnostic application operations should proceed normally at this point.
