Mack Model TE - TerraPro , LR , MRU - TerraPro , AN - Anthem , GR - Granite , PI - Pinnacle ,
CHU - Pinnacle, Axle back , CXU - Pinnacle, Axle front , GU - Granite

Volvo Model VNL , VNM , VNR , VNX , VAH , VHD

Title Diagnostic Trouble Codes (DTC) [P0087](#) Fuel Rail/System Pressure Too Low, [P016F](#) Closed Loop Fuel Pressure Control At Limit - Pressure Too Low, [P228F](#) Fuel Pressure Regulator Exceeded Learning Limits - Too High; Damaged Lip Seal On Secondary Fuel Filter; Possible Uneven Operation - [US17+OBD16 And Newer Emissions \(Common Rail Fuel System\)](#), [Model Year 2018 And Newer](#)

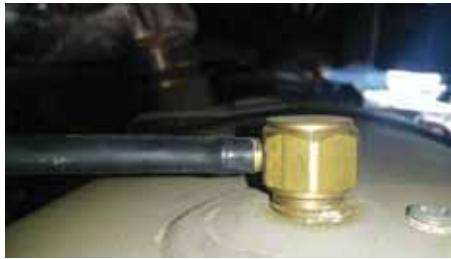
Fuel tank connection

3.2.2. **Take pictures** of the vent filter hose connection at the filter housing and at the fuel tank. An example of the pictures required can be seen below:

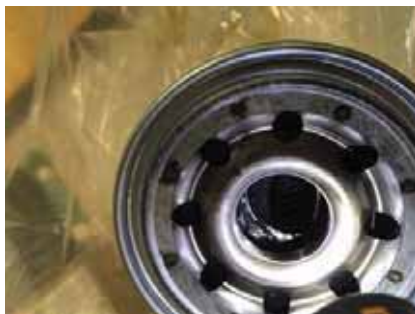
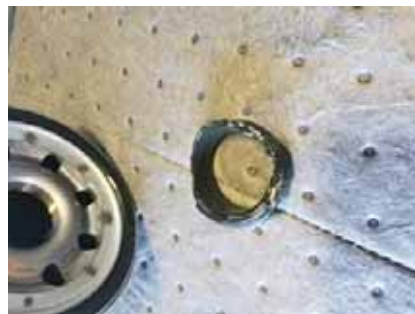
Cause A compromised lip seal on the secondary fuel filter may result in unfiltered fuel bypassing the filter and entering into the high pressure fuel system. This may result in fault codes or other symptoms related to fuel pressure.

3.3.1. Inspect the condition of the fuel filter lip seal. **Note findings in the eService case.** An example of a filter with a damaged lip seal and the lip seal appearance can be seen below:

3.3.2. **Take picture(s)** of the top of the filter with a clear view of the lip seal similar to the angle shown in the example above.
