**Mack Model** Conventional , CHU - Pinnacle, Axle back , GU - Granite

**Title** Draft Mack Chassis - Models GU / CHU Steering Wander, Will Not Center

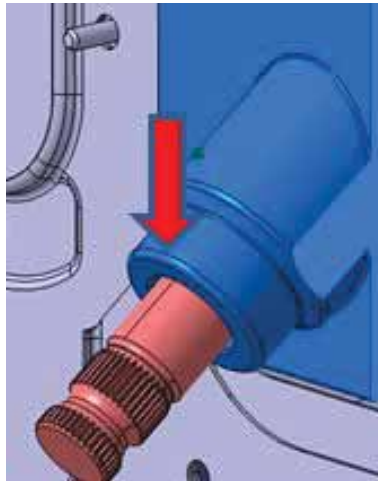
- For vehicles produced **prior** to 1<sup>st</sup> week of January 2017. A change of the upper steering column happened in November of 2014 (4mm shorter). With this change we believe an interference may have been created with the column boot on the cab wall. This may create undue pressure on the column shaft as it comes out of the cab wall.

- Pressure from the boot may be applied to the steering column shaft restricting it from turning freely. To check, disconnect upper steering shaft at base of column shaft. Remove boot (there may be a noticeable movement upward of the shaft). Reassemble steering shaft to steering column and test drive. If problem is resolved replace boot with 84723313 (Introduced into production 2017w01). Test drive after boot replacement to ensure problem is resolved before returning truck to customer.
