Vehicle Technical Info

GROUP 00 - General

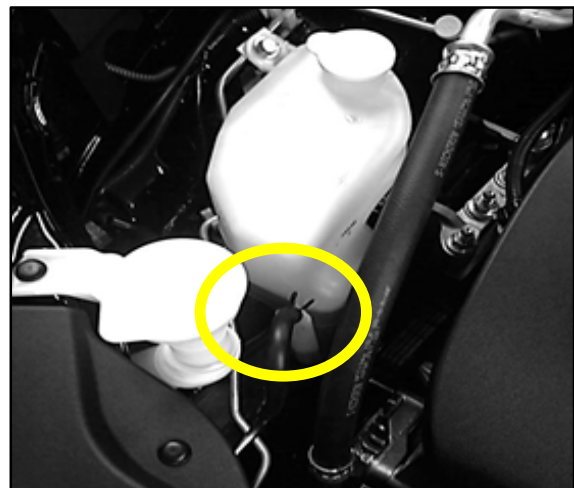
✓ **RADIATOR CONDENSER TANK HOSE FITTING COOLANT SEEPAGE/LEAK** – 2013-15 Outlander Sport/RVR.

If a vehicle is leaking coolant from the radiator condenser tank at the hose connection, remove the hose from tank and inspect the hose fitting for flash or other condition that inhibits the hose from sealing to the hose fitting. If necessary, repair the hose connection to ensure a good sealing surface. It is very important to obtain a good sealing surface between the hose and hose connection as the clip installed on the hose from the factory is for retention only, and not for sealing of the hose to hose connection. Once the hose connection has been repaired, reinstall the hose to tank using an appropriate hose clamp.

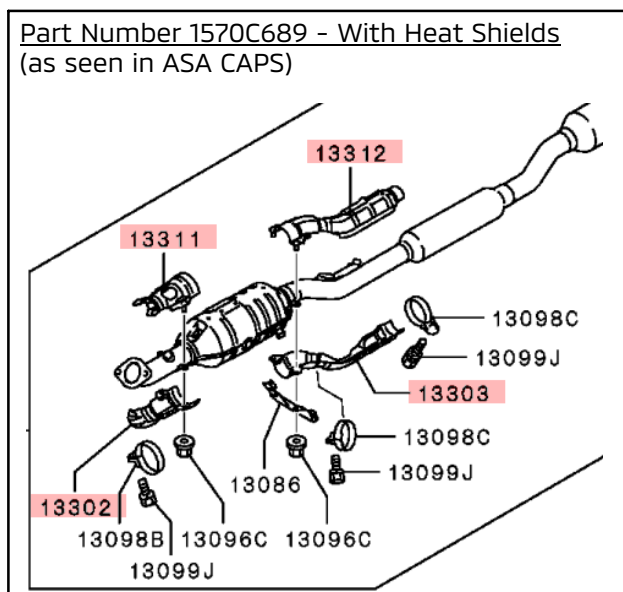
CENTER EXHAUST PIPE – 2015 Outlander Sport/RVR - AWD, April 2015 Production Only.

ASA CAPS may list the center pipe on 2015 Outlander Sport AWD models that were produced in April 2015 as Part Number 1570C892. However, due to the parts transition timing on the production line, the part on the vehicle may be 1570C689. The pipes are bent differently and the hanging brackets may not align. The earlier part, 1570C689, requires a clamp on the heat shields while 1570C892 does not. If the heat shields require replacement on such a vehicle, compare the ASA CAPS diagrams to confirm that the part is 1570C689 and order the appropriate heat shields from that ASA CAPS diagram (shown in the following illustration).

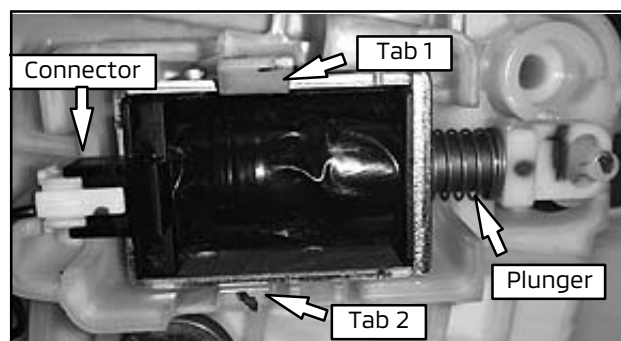
CVT WILL NOT SHIFT OUT OF P (PARK) POSITION – 2013-15 Outlander Sport/RVR.

Remove the RH console side panel. While watching the movement of the shift lock solenoid, have someone apply the brake pedal with the ignition ON to determine if the solenoid retracts. If the solenoid does not retract or retracts slowly, it may be due to foreign material, identified as a sugary drink (e.g., Cola) residue built up in the solenoid plunger bore and on the solenoid plunger.

This prevents the solenoid from retracting and the shifter cannot be moved from Park.

- Remove the solenoid from the shifter assembly by GENTLY releasing TAB 1.
- Carefully wedge a small screwdriver into the channel of TAB 2 to release the lower locking tab.
- Remove the solenoid by pulling it straight out.
- Unplug the electrical connector.
- Remove the spring and plunger and clean them with soap and water.
- Dampen a wet paper towel or lint-free rag with water and insert it into the bore of the solenoid to clean it.
- Reattach the electrical connector and re-install the solenoid to the shifter in reverse order of removal.
- Confirm solenoid and shifter operation and reinstall the console side panel.

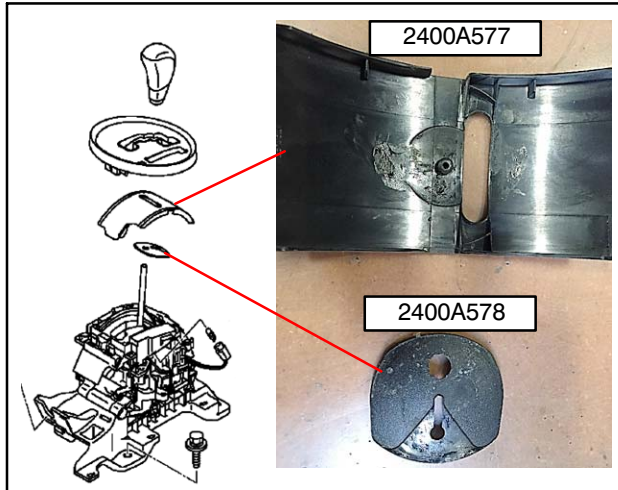
➤ **SHIFT LEVER DIFFICULT TO MOVE** –
2013-15 Outlander Sport/RVR.

If the shift sliders become contaminated or damaged it can cause the shift lever to become difficult to move. It is no longer necessary to replace the complete shift lever assembly if the repair can be completed with replacement of the gearshift lever cover (P/N 2400A577) and A/T shift indicator slider (P/N 2400A578). These parts are available as service parts. Be sure to engage the slider into the lever cover pin.
