Fuel Tank Band Bolt Dealer Inventory

Reference: P8337
Date: January 17, 2019

P8337 – ROGUE SPORT FUEL TANK BAND BOLTS

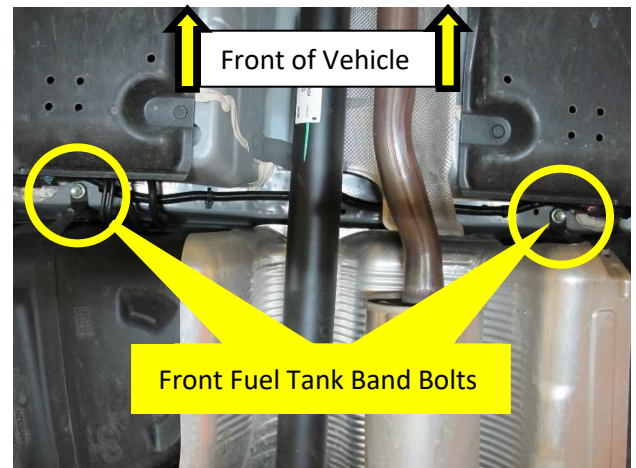
Figure 2

2. Locate the FRONT fuel tank band bolts.

NOTE: AWD vehicle shown, 2WD is similar
