Technical Service Bulletin

91 MMI 3G+ MMI inop; blank screen at startup; various technical issues (K0942 ZUG update; supersedes K0814 update)

91 17 50 2030465/12 September 11, 2017. Supersedes Technical Service Bulletin Group 91 number 17-45 dated August 22, 2017 for reasons listed below.

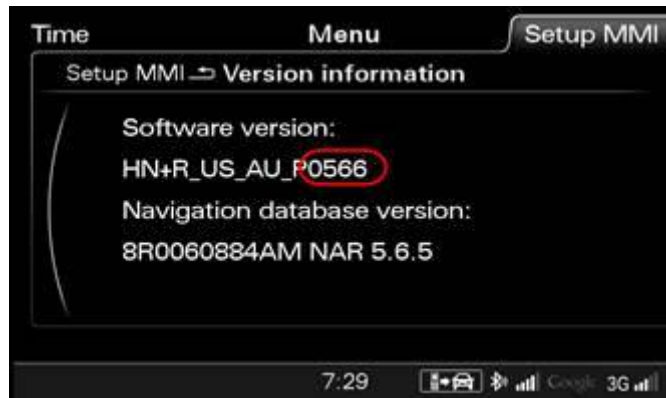
Tip: The MMI software version can be found under *Menu >> Setup MMI >> Version Information*. The software version will show the 4-digit software version number with a "P" or "K" prefix ("P" for Production and "K" for Service") (Figure 1).

Figure 1. Example showing MMI software version (0566).

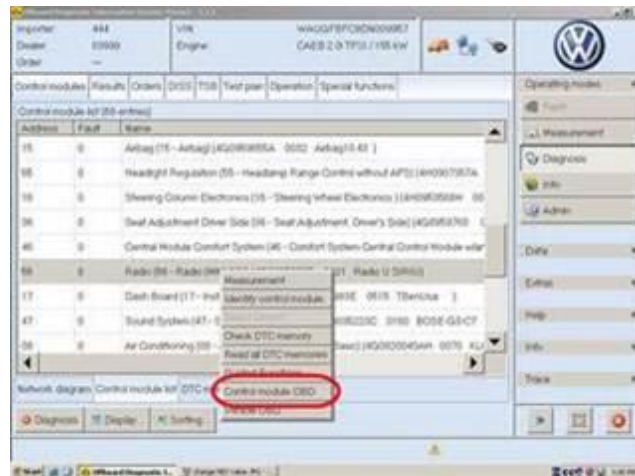
Figure 2. Radio self-diagnosis.

2. Using ODIS, right-click on 56 – *Radio* in the Control module list, and select *Control Module OBD* (Figure 2).

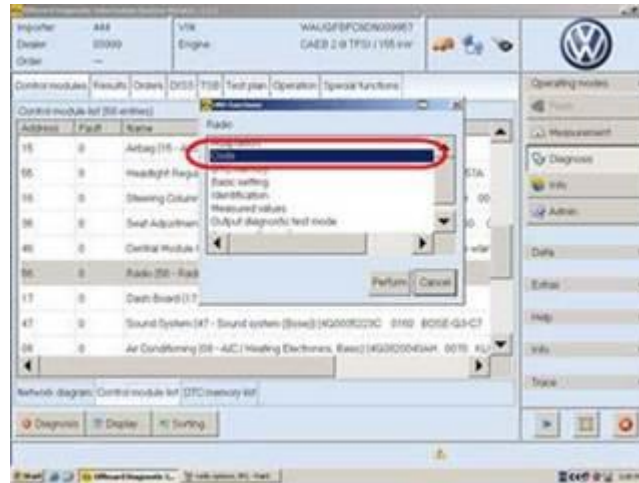
Figure 3. Code radio option.

3. Select Code (Figure 3).

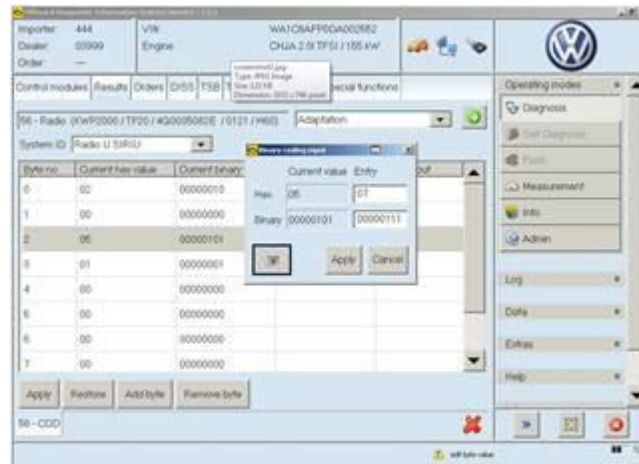
Figure 4. Changed radio coding.

4. Verify the coding in byte 2 is HEX 07.

- If it is not HEX 07, change the coding to HEX 07. Apply changes (Figure 4).

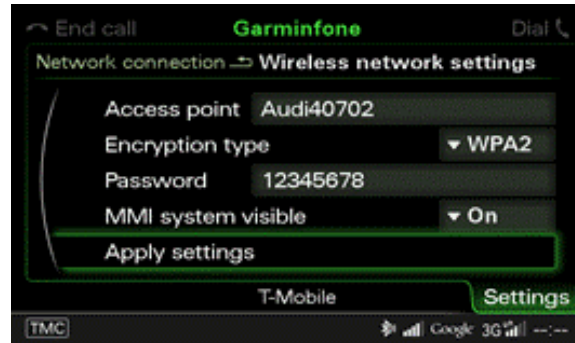
Figure 5. Wireless network settings.

6. As part of the update, wireless settings and paired devices will be deleted. All devices will need to be re-paired after the update, and all wireless settings restored to the customer's settings. To access the Wireless network settings on the MMI (Figure 5), press *TEL >> Settings >> Wireless network connection >> Wireless network settings*. Record all settings so they can be re-entered at the end of the update.

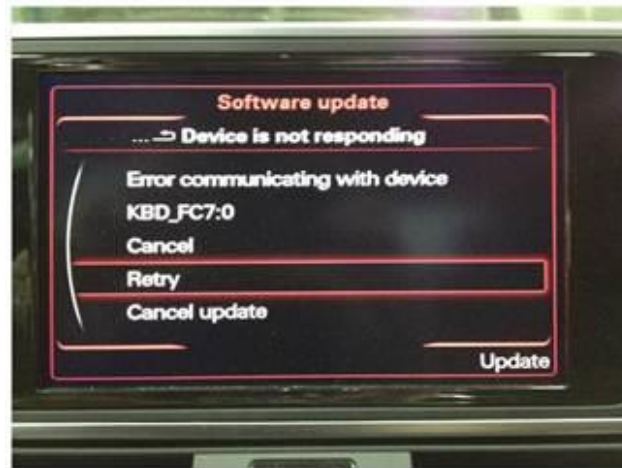
Figure 6. A device requiring a 'Cancel' selection.

Some earlier model year 2012 vehicles, or vehicles equipped with Bose® sound systems may experience certain modules that will not update properly during Step 16 of TSB 2028141. If this should occur, either choose 'Cancel' (Figure 6), or 'Skip device' (Figure 7), depending on the type of error. Do *not* choose 'Cancel update', as this may cause the software update to fail entirely. After the update is finished and the summary page is shown, select 'Retry' at the bottom of the list if it is available to attempt to update the modules again. If 'Retry' is greyed out, then the software update was successful. Select 'Continue' to proceed. In some cases 'Retry' may have to be repeated two or three times to get all modules to update successfully.

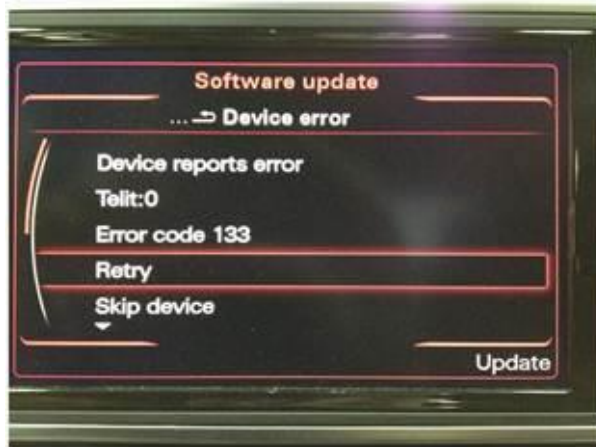
Figure 7. A device requiring a 'Skip device' selection.

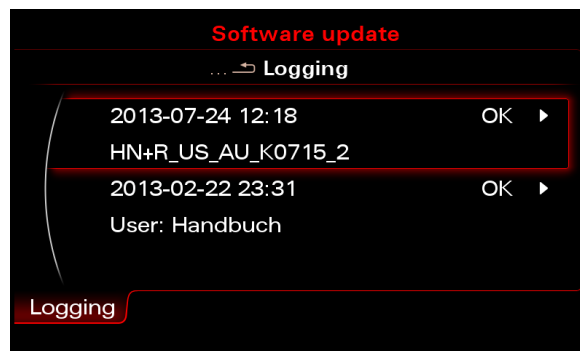
Figure 8. Software update log showing a successful software installation.

- Verify that the software update has been completed successfully by accessing the logging page (Figure 8). To access this screen, proceed to step 8 in TSB 2028141 and press the lower left softkey. A successful update will show the date the update was performed and the software that was installed (HN+R_US_AU_K0715_X), with 'OK' listed on the right (example 0715 installation). The 'X' may be one of several different numbers. If K0715_X does not have any rows with 'OK', the update must be retried until it is

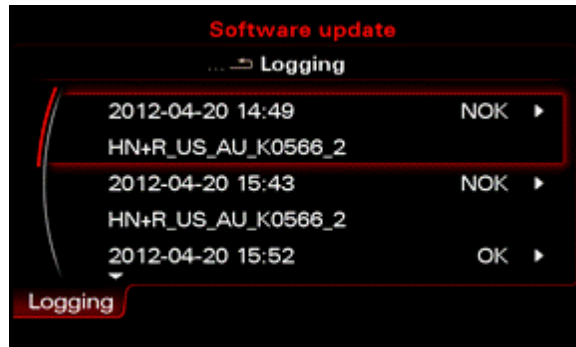
Figure 9. Software update log showing 2 failed attempts before a successful installation.

Tip: If the update must be performed two or more times due to modules not updating correctly, a screenshot of the software update log is required (Figure 9). This should be kept on-hand for warranty auditing purposes. To take a screenshot, insert an SD Card into slot 1. For A6/A7/A8/Q7, press and hold the left and right arrow keys at the same time. For A4/A5/Q5, press and hold the bottom two softkeys at the same time. All 4 softkeys will flash when the screenshot is taken. A screenshot should be taken of each page in the logging display.
