Technical Service Bulletin

13 Engine oil loss from crankshaft seal (transmission side)

13 18 07 2052943/1 November 28, 2018.

Model(s)	Year	VIN Range	Vehicle-Specific Equipment
R8 Coupe	2008 – 2018	All	Not Applicable
R8 Spyder	2010 - 2018	All	Not Applicable

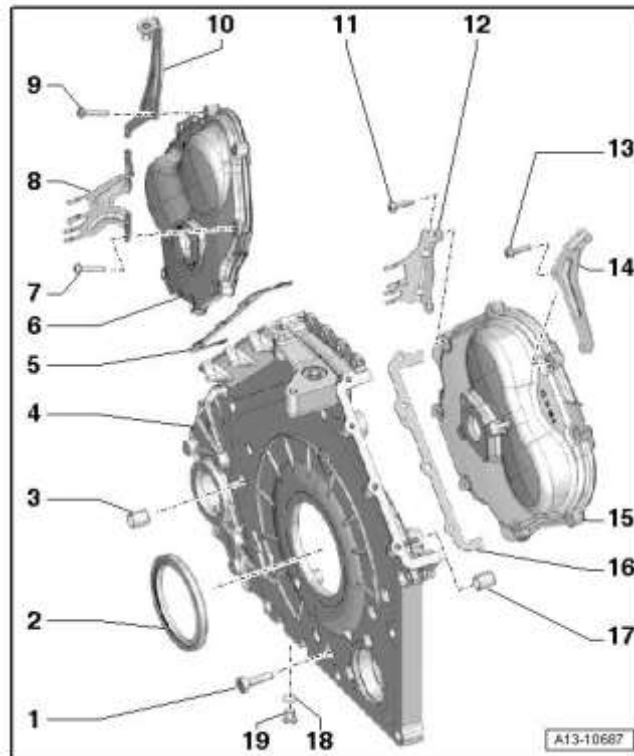
Figure 1. Timing cover area.

1. Check if previous repairs have been carried out in the timing cover areas numbers 6, 15, and 4.

2. If, for example the left, right, or lower cover of the timing chains has been removed and resealed, an excessive application of sealant could block the oil pump strainers number 1 through 8 of the oil pump (Figure 2). This causes a leak at the rear crankshaft seal number 2 (Figure 1), due to an increased oil level in the lower timing cover when the engine is switched off.

3. In this case, remove the oil pump and check the oil strainers for a blockage.
4. Replace all oil strainers and clean engine of all residual oil and recheck for oil leaks after starting and driving vehicle to normal operating temperature.
5. If no leaks are reproduced, then vehicle can be released. The rear crankshaft seal does not need to be replaced.

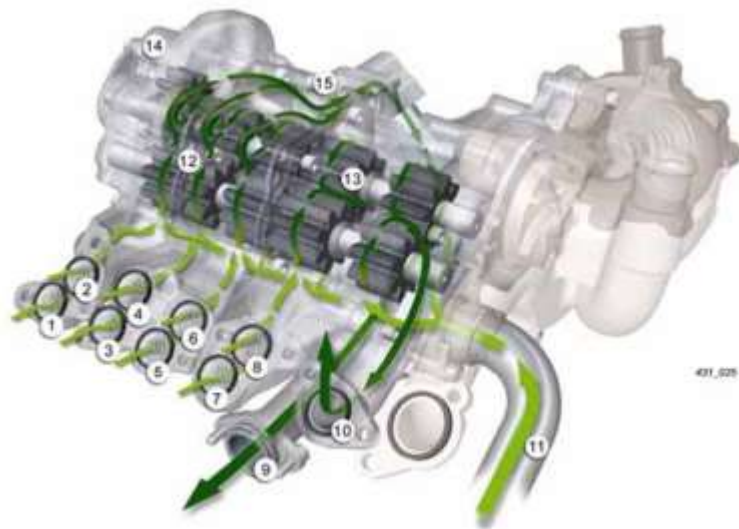
Figure 2. Potential leak near crank.

Excessive sealant application used as part of previous repair.
