Technical Service Bulletin

40 Noises from front end when steering

40 18 88 2053136/1 November 30, 2018.

Model(s)	Year	VIN Range	Vehicle-Specific Equipment
A3	2015 - 2019	All	Not Applicable

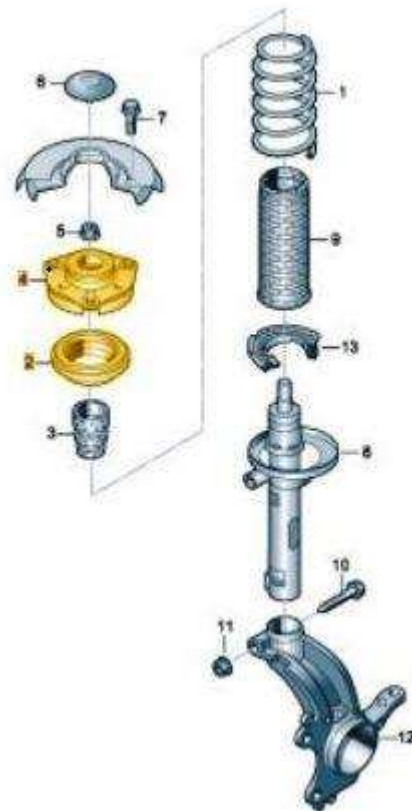
There is overlapping of axial deep-groove ball bearing and suspension strut mounting. Over time the overlapping can cause noises.

Figure 1. Suspension strut mounting and axial deep-groove ball bearing.

Tip: Axial deep-groove ball bearing and suspension strut mounting must always be replaced together. The two components must always be replaced on both sides (right and left).

1. Replace the axial deep-groove ball bearing (Figure 1, position 2) and the suspension strut mounting (Figure 1, position 4) according to the Elsa Repair Manual.

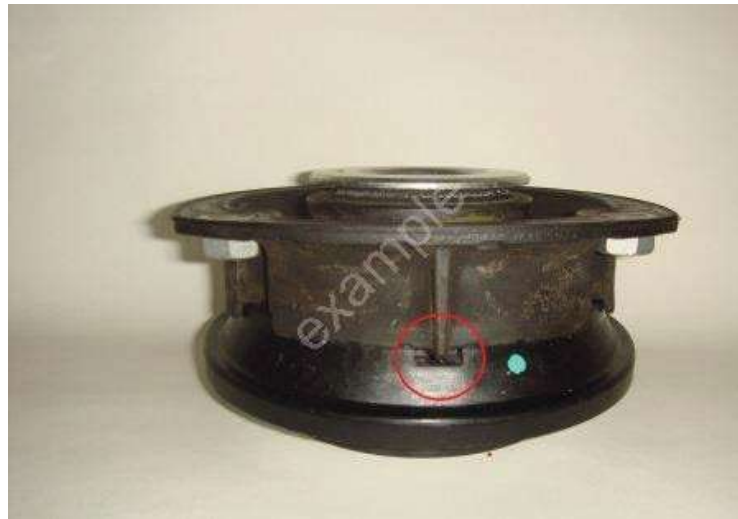
Figure 2. Correct installation position of suspension strut mounting and axial deep-groove ball bearing.

2. Ensure the correct installation position when assembling the suspension strut mounting and the axial deep-groove ball bearing. The bar of the axial deep-groove ball bearing must be central in the groove of suspension strut mounting (Figure 2).
