# Technical Service Bulletin

## 64F3 UPDATE – Coolant Breather Line (NVLW)

November 30, 2018

Model(s)	Year	VIN Range	Vehicle-Specific Equipment
S8+	2016 - 2017	See Campaign/Action screen in Elsa	See Campaign/Action screen in Elsa

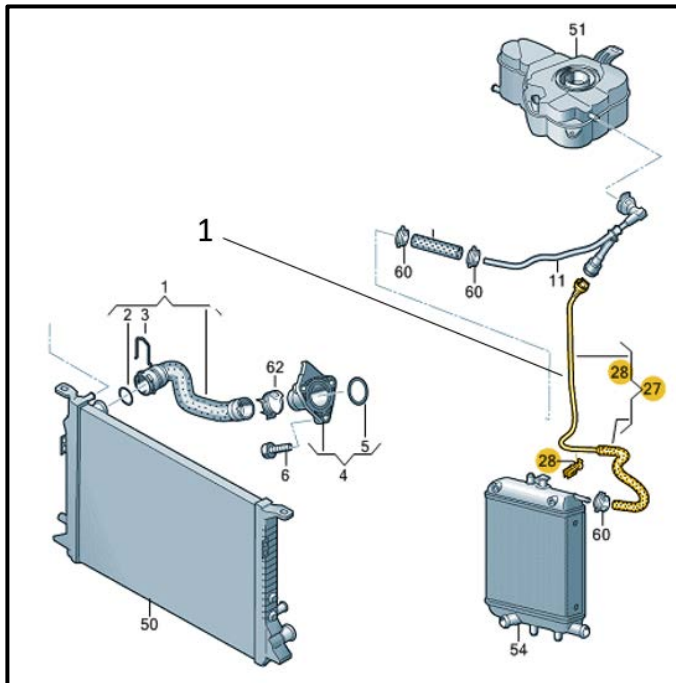
On Audi S8+ vehicles manufactured within a specific period, a non-return valve is not fitted in the breather line. As a result, the heating output inside the vehicle may be reduced.

- Wear safety gloves.
  - Wear protective eyewear.
  - Reduce the pressure by covering the coolant expansion tank cap with a cloth and carefully opening it.
- 
- Replace coolant breather line <1>.
- 
- Reinstall headlamp.
    - ELSA Repair Manual: *Repair Manual > Electrical System > Electrical Equipment > 94 Exterior Lights, Switches > Headlamps > Headlamp, Removing and Installing > Headlamp, Removing and Installing, Vehicles from MY 2014*
  - Reattach left front wheel housing liner.
  - Reinstall left front wheel and torque lug bolts to 140 Nm.
