Subject		Market	
Air Conditioning System – Improved Component Inspection		USA	
Service Category		Section	
Vehicle Interior		Heating/Air Conditioning	
Applicability			
Scion

In certain cases of leaking air conditioning systems, the root cause of the leak is inadvertently overlooked, causing a repeat repair. To improve customer satisfaction and repair A/C system leaks in one dealer visit, Toyota has developed a set of guidelines for evaluating A/C system components.

Air Conditioning System – Improved Component Inspection

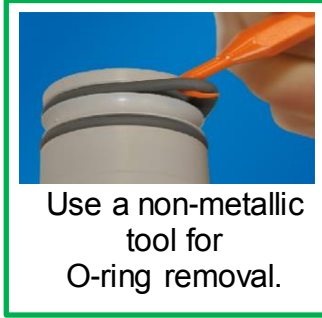
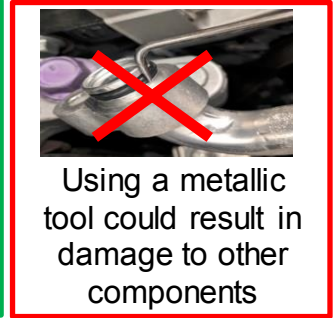
OK Part* - Line at middle of O-ring is straight with no deformation. No tears, or crushed areas.
 *O-rings should be replaced anytime they are removed from a pipe/component to prevent leaks and foreign material.

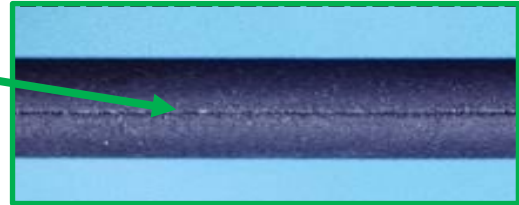
Twisted O-Ring – No Good Part
 Line at middle of O-ring is not straight.

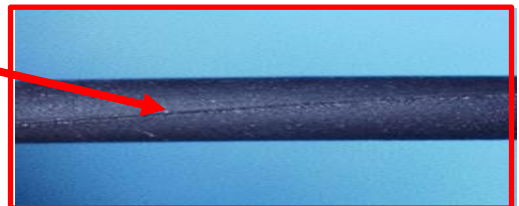
Cut/Dent/Crush – No Good Part
 O-ring damaged by another component. Replace O-ring, proceed with A/C Pipe Inspection.

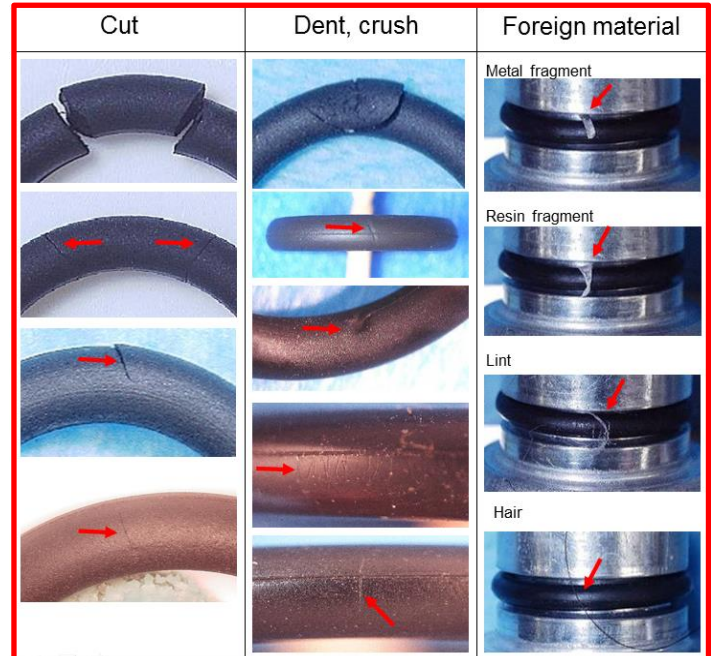
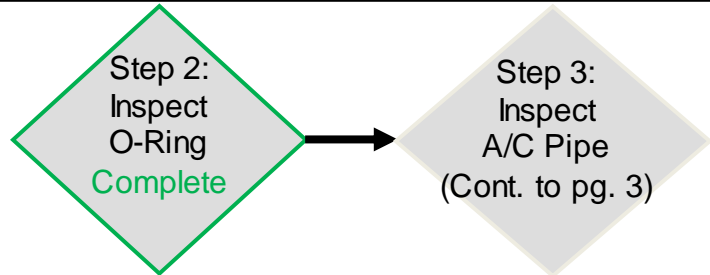
Foreign Material– No Good Part
 O-ring contaminated by material outside A/C system. Replace O-ring, proceed with A/C Pipe inspection.

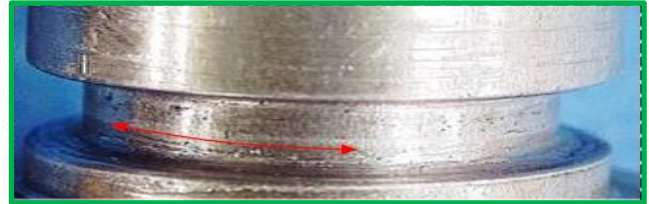
OK Part - Light scratching parallel with O-ring groove. This is caused by normal part processing. Pipe is ok to reuse.

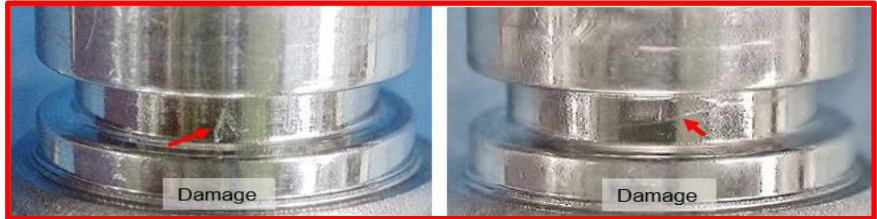
Damage – No Good Part
Pipe is damaged due to deep scratching or gouge of base metal. Pipe replacement is recommended to prevent repeat repair.

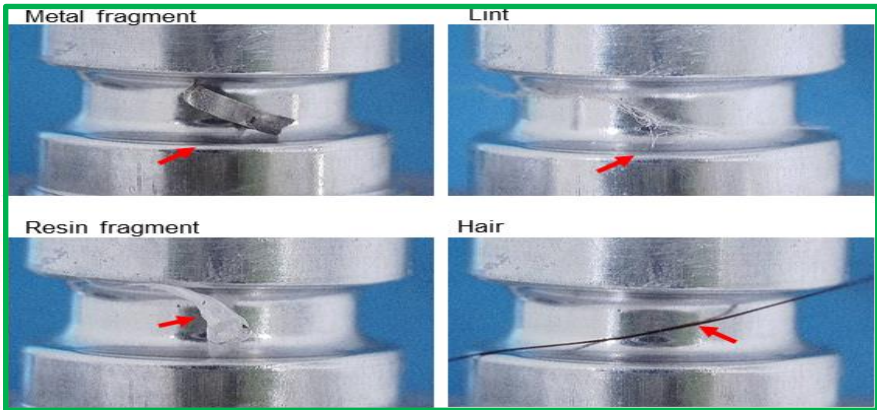
Foreign Material – OK Part
Pipe has foreign material stuck to it. Material can be cleaned off using a non-metallic tool and the pipe is ok to be reused.

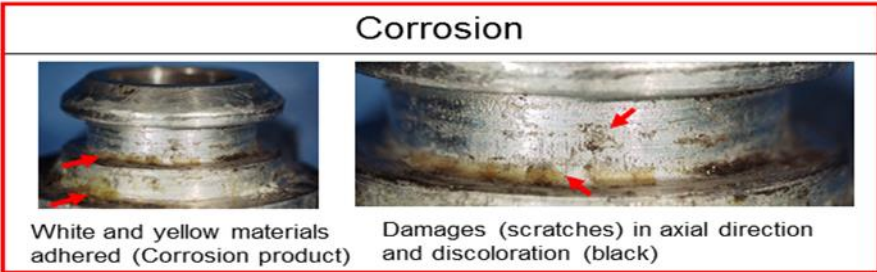
Corrosion – No Good Part
Pipe is damaged due to corrosion of base material. Pipe replacement is recommended to prevent repeat repair.

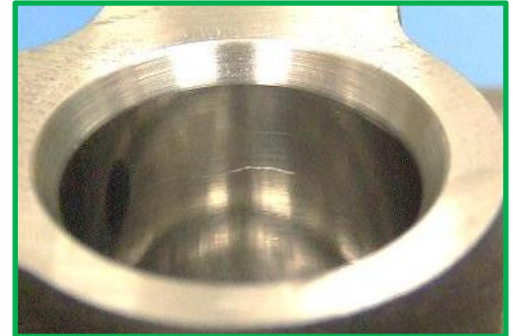
OK Part - Light scratching parallel with O-ring groove. This is caused by normal part processing. Compressor is ok to reuse.

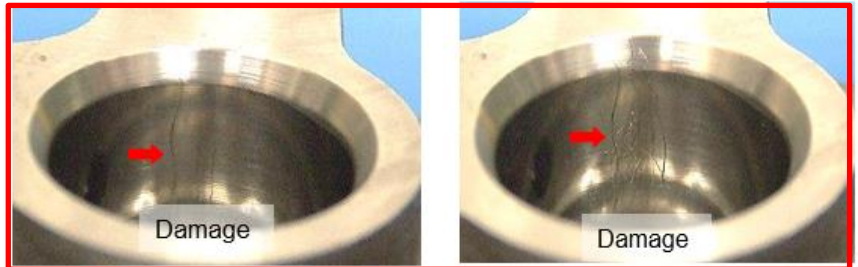
Damage – No Good Part
Compressor seal bore is damaged due to deep scratching perpendicular to O-ring groove.

Compressor replacement is recommended to prevent repeat repair.

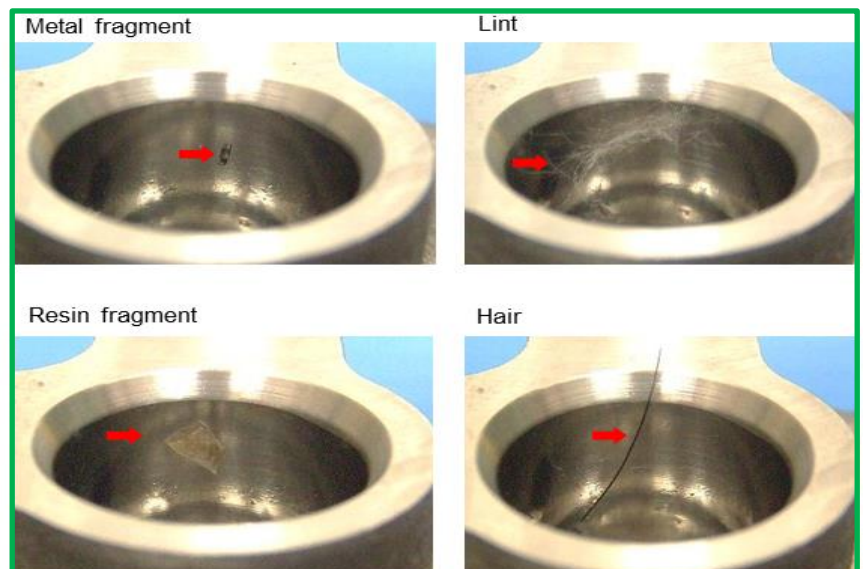
Foreign Material – OK Part
Compressor has foreign material stuck to seal bore.

Material can be **carefully** cleaned off using a non-metallic tool and the compressor is ok to be reused.

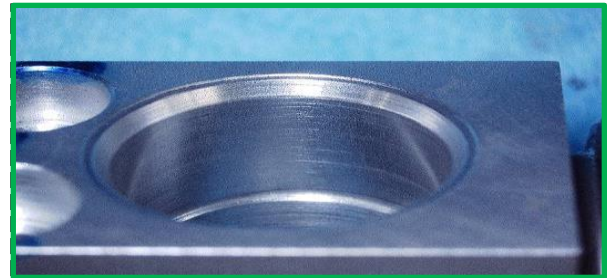
OK Part - Light scratching parallel with O-ring groove. This is caused by normal part processing. Expansion valve is ok to reuse.

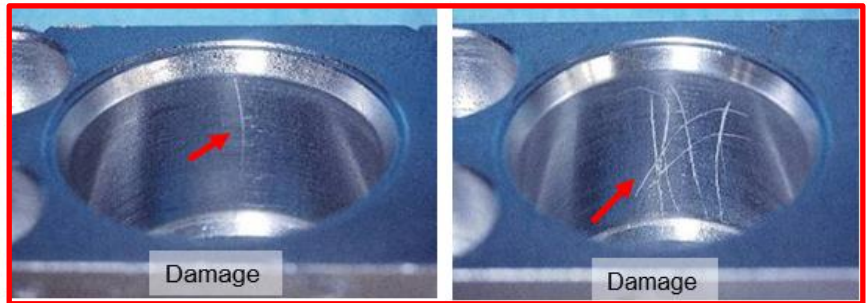
Damage – No Good Part
Expansion valve seal bore is damaged due to deep scratching perpendicular to O-ring groove.

Expansion valve replacement is recommended to prevent repeat repair.

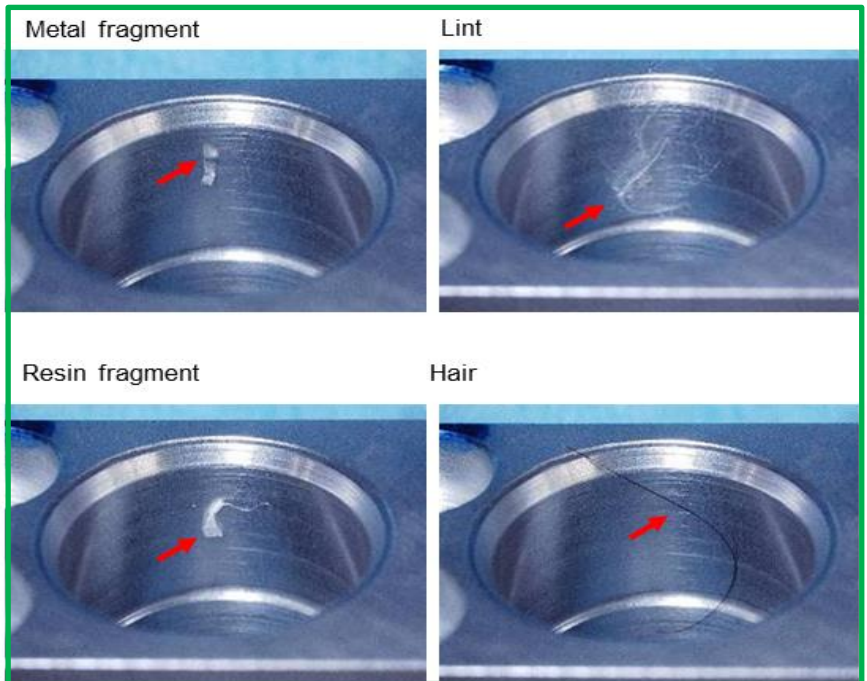
Foreign Material – OK Part
Expansion Valve has foreign material stuck to seal bore.

Material can be **carefully** cleaned off using a non-metallic tool and the expansion valve is ok to be reused.

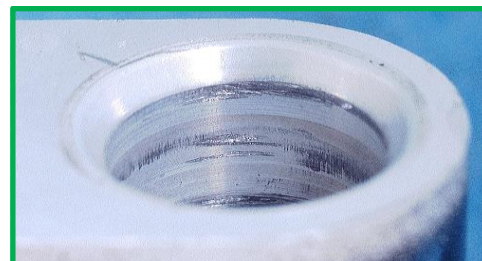
OK Part - Light scratching parallel with O-ring groove. This is caused by normal part processing. Condenser is ok to reuse.

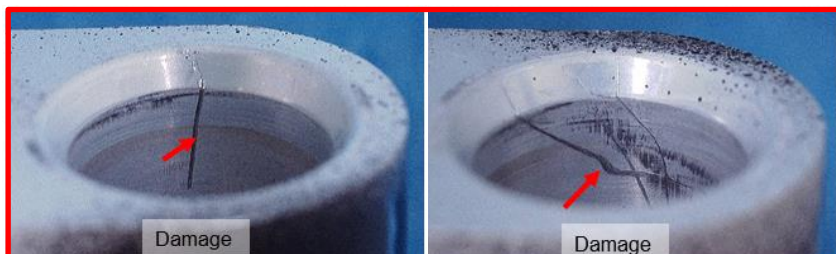
Damage – No Good Part
 Condenser seal bore is damaged due to deep scratching perpendicular to O-ring groove.

Condenser replacement is recommended to prevent repeat repair.

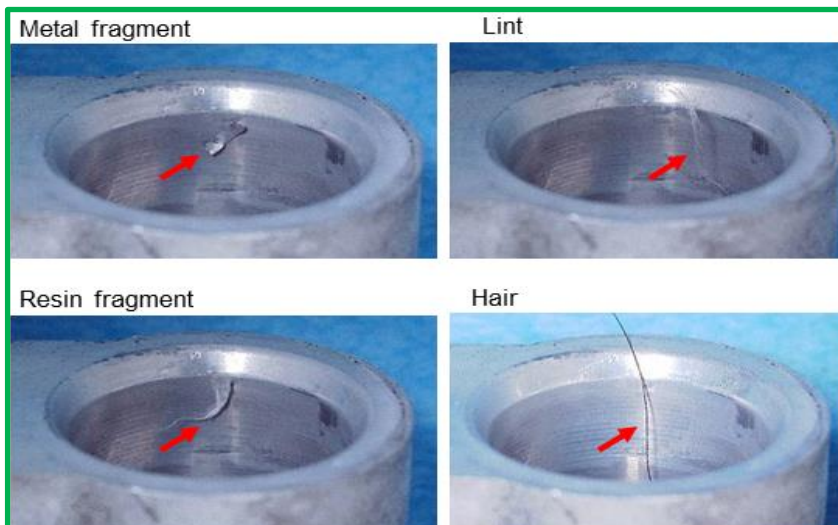
Foreign Material – OK Part
 Condenser has foreign material stuck to seal bore.

Material can be **carefully** cleaned off using a non-metallic tool and the condenser is ok to be reused.

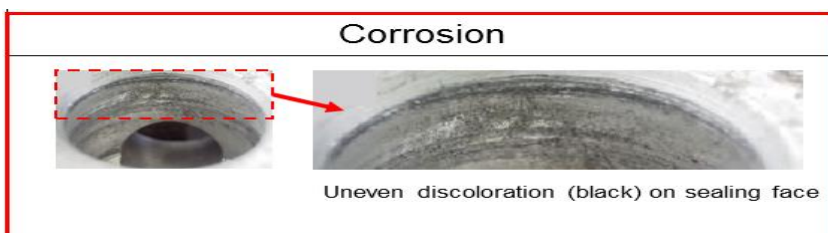
Corrosion – No Good Part
 Seal bore is damaged due to corrosion of base material.

Condenser replacement is recommended to prevent repeat repair.
