<b>Subject:</b>  <b>SHOCK ABSORBER REPLACEMENT GUIDELINES</b>	<b>Bulletin No.:</b> 02-001/19
	<b>Last Issued:</b> 01/02/2019

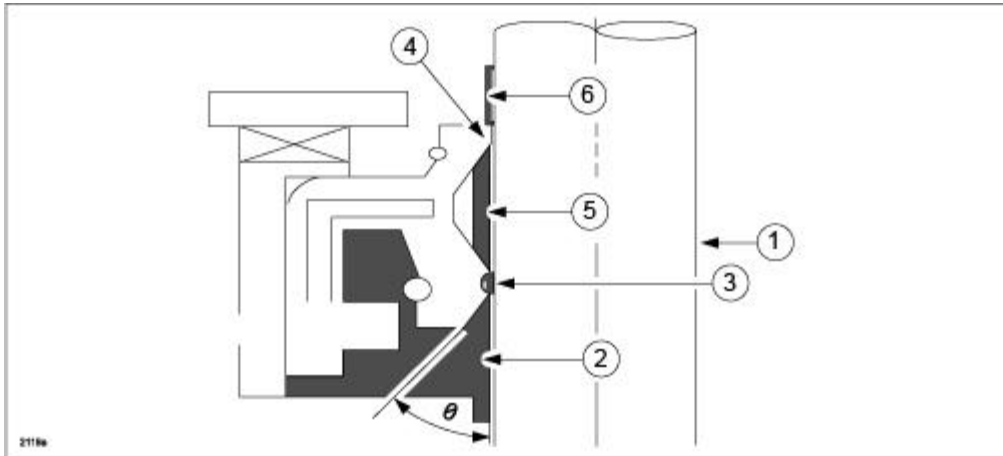
Oil seepage is caused by the following factors and is not a problem:

- A small amount of oil seeps outside through the dust lip during normal operation.
- The oil film thickness is uneven due to production variation of rod and seal.

When the rod (1) receives input from the road and extends upward, most of the oil (2) on the rod is scraped off by the main lip (3) and some remains inside the dust lip (4). When the rod extends further, then most of the remaining oil (5) on the rod is scraped off by the dust lip, and a small amount of oil seeps out (6).

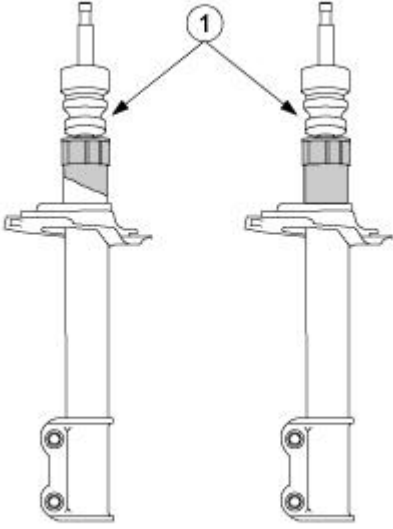
SYMPTOM	DESCRIPTION / REPLACEMENT CRITERIA
<p data-bbox="391 239 472 266">STRUT</p>

<p data-bbox="207 905 240 919">2119c</p>	<p data-bbox="678 239 1414 478">Oil seepage comes out below the bump cap (1) and may run down the sides, but does not run past the spring seat. The surface appears dirty due to oil and dust, but it is not wet with oil dripping / running down the sides. The damping function is still performing correctly. Dealer action: Clean and dry the unit as much as possible. NO REPLACEMENT NECESSARY.</p>
<p data-bbox="207 932 662 959">SHOCK ABSORBER WITH SPRING SEAT</p>

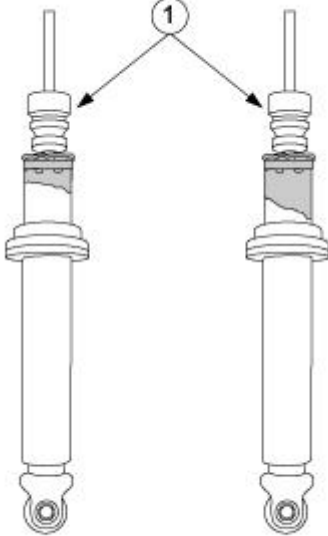
<p data-bbox="207 1598 240 1612">2119c</p>	<p data-bbox="678 932 1414 1171">Oil seepage comes out below the bump cap (1) and may run down the sides, but does not run past the spring seat. The surface appears dirty due to oil and dust, but it is not wet with oil dripping / running down the sides. The damping function is still performing correctly. Dealer action: Clean and dry the unit as much as possible. NO REPLACEMENT NECESSARY.</p>

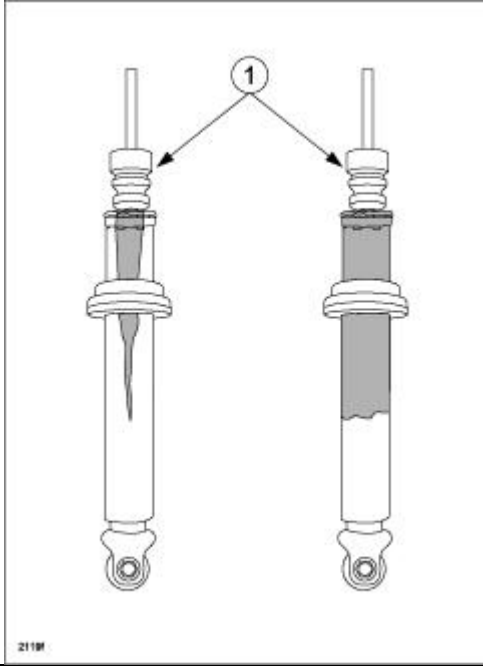
SHOCK ABSORBER WITH SPRING SEAT

Oil leakage comes out below the bump cap (1) and runs down the sides past the spring seat.  
 The surface appears wet with oil dripping / running down the sides.  
 Dealer action: REPLACE THE UNIT.

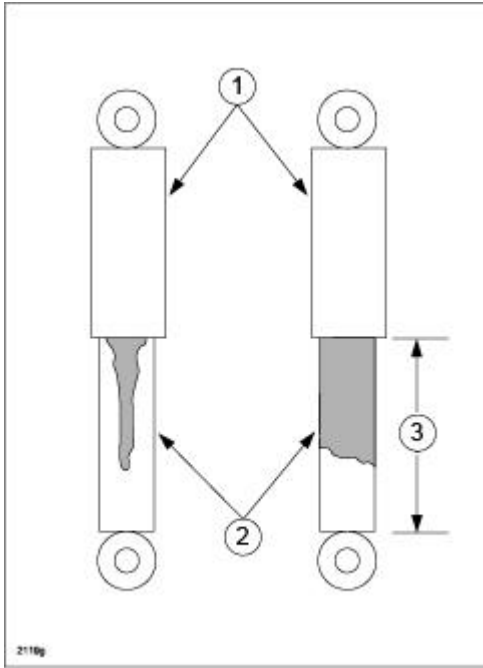
SHOCK

Oil leakage comes out under the dust cover (1) and covers 50% or more of the outer cylinder (2) length (3).  
 The surface appears wet with oil dripping / running down the sides.  
 Dealer action: REPLACE THE UNIT.
