September 2017
FL741AB
NHTSA #17V-451

Subject: FCCC XCR Chassis Battery Cables

**Models Affected: Specific Freightliner Custom Chassis
XCR chassis manufactured November 27, 2012, through
February 23, 2016.**

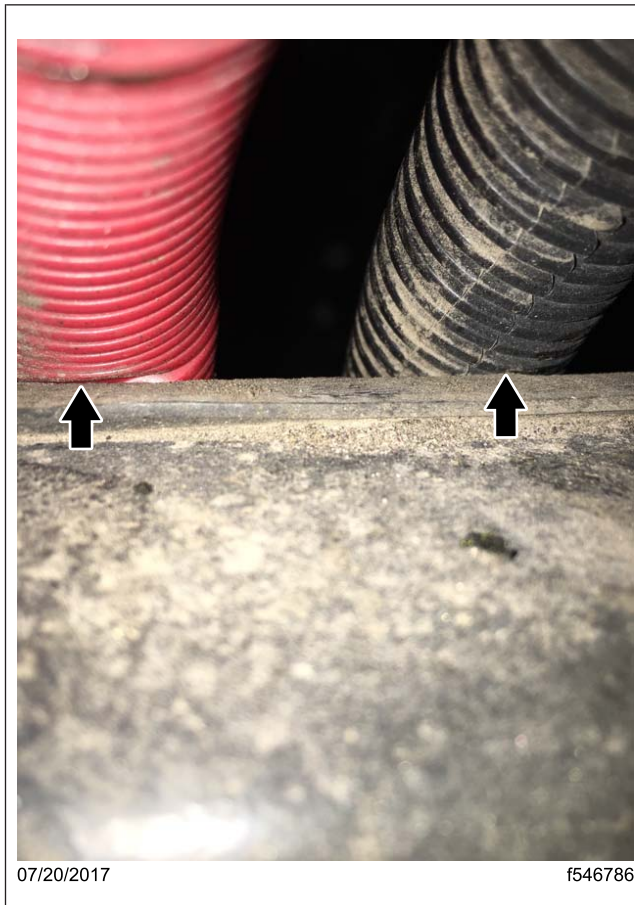
Fig. 2, Battery Cables Rubbing the Frame Rail

- If the battery cable bracket is incorrectly installed or missing, inspect the battery cables for damage. It is possible for the conduit that covers the cable to be damaged, but the battery cables are not damaged. Damage to the battery cables could include, but is not limited to, a cut in the battery cable or visible cable insulation. See [Fig. 2](#) and [Fig. 3](#). After inspection of the battery cable, go to 'Battery Cable Bracket Procedure.'

The battery cables were rubbing the frame rail but are not damaged, and do not require replacement.

IMPORTANT: If the battery cable(s) are damaged, replace the battery cable(s). It is possible for the conduit that covers the cable to be damaged, but the battery cables are not damaged. Damage to the battery cables could include, but is not limited to, a cut in the battery cable or visible cable insulation. See [Fig. 2](#) and [Fig. 3](#)
