## Mack Models

## Volvo Models

**Title** Diagnostic Trouble Codes (DTC) [P0087](#) Fuel Rail/System Pressure Too Low, [P016F](#) Closed Loop Fuel Pressure Control At Limit - Pressure Too Low, [P228F](#) Fuel Pressure Regulator Exceeded Learning Limits - Too High; Damaged Lip Seal On Secondary Fuel Filter; Possible Uneven Operation - [US17+OBD16 And Newer Emissions \(Common Rail Fuel System\)](#), [Model Year 2018 And Newer](#)

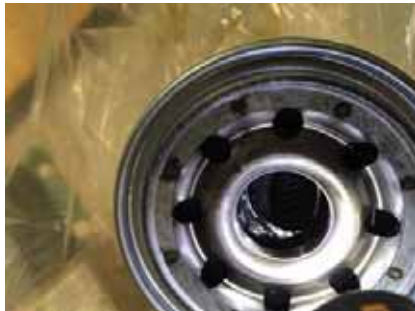
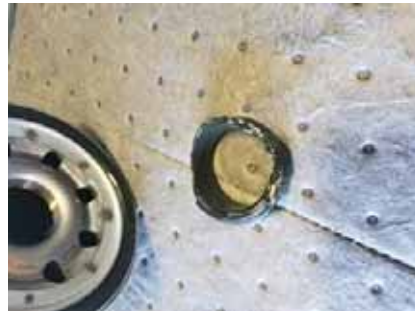
**Cause** A compromised lip seal on the secondary fuel filter may result in unfiltered fuel bypassing the filter and entering into the high pressure fuel system. This may result in fault codes or other symptoms related to fuel pressure.

3.3.1. Inspect the condition of the fuel filter lip seal. **Note findings in the eService case.** An example of a filter with a damaged lip seal and the lip seal appearance can be seen below:

3.3.2. **Take picture(s)** of the top of the filter with a clear view of the lip seal similar to the angle shown in the example above.
