Oil Loss/Leak on PDK Transmission: Observe different procedure (59/16)

Revision: This bulletin replaces bulletin Group 3, #59/16, dated October 26, 2018.

Model Year: **As of 2014 up to 2016**

Subject: **PDK transmission**

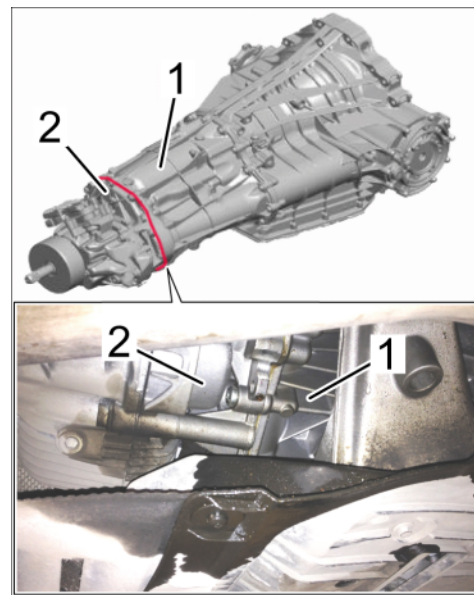
Information: **An oil leak can occur close to the connection point between the intermediate housing (⇒ Oil leak on PDK transmission -item 1-) and cover (⇒ Oil leak on PDK transmission -item 2-) on the PDK transmission due to manufacturing tolerances.**

If there is a leak between the intermediate housing and cover before the specified date of introduction, the transmission must be replaced.

Sealing measures will not work.

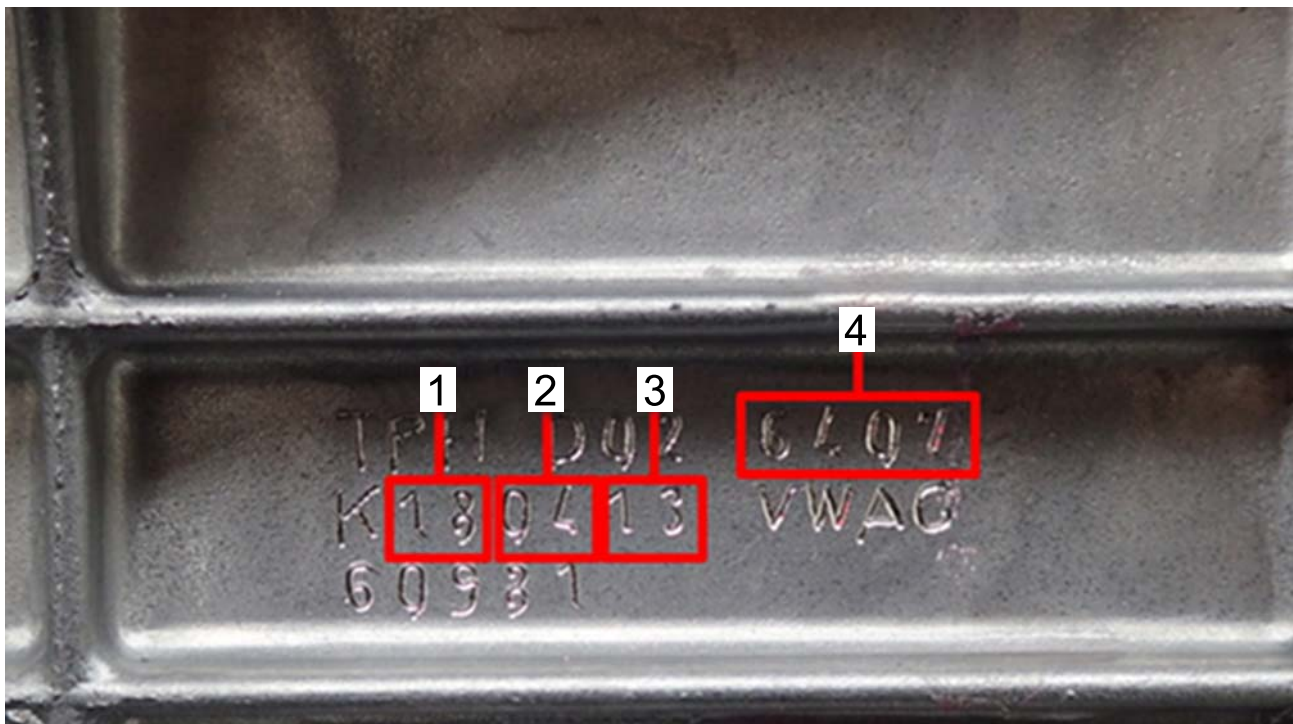
Explanation of cut-off value

On July 22, 2015, modified cross-sanding was introduced with the serial number 6340.

- 1 – Year
- 2 – Month
- 3 – Day
- 4 – Serial number

⇒ Transmissions **produced before this date of introduction and serial number** must be replaced, see ⇒ *Workshop Manual '373455 Replacing double clutch transmission'*.

⇒ Transmissions **produced after this date of introduction and serial number** must be sealed. **Carry out the following work, starting with Step** ⇒ as required.

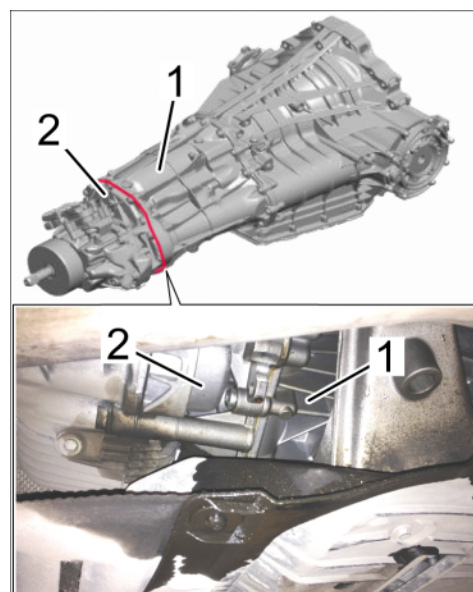
Oil leak on PDK transmission

- 2.2 Spray the area you have cleaned on the PDK transmission with leak-locating spray.
- 2.3 Perform a test drive and then find the leak:
 - If oil is leaking at the sealing face from the intermediate housing ⇒ *Oil leak on PDK transmission -1-* to the cover ⇒ *Oil leak on PDK transmission -2-*, **seal the PDK transmission**. See ⇒ *Workshop Manual '373751 Sealing transmission housing'*
 - If oil is leaking at a different place, the fault is not due of the cause described here. Find the cause of the fault and correct it.
