SERVICE BULLETIN

APPLICABILITY: 2017-18MY Impreza
 2018MY Crosstrek
 2018MY Legacy and Outback
 2018MY BRZ

NUMBER: 15-211-17R

SUBJECT: Reprogramming File Availability for Additional Optimization of Harman Gen 3 Audio and Navigation Head Units

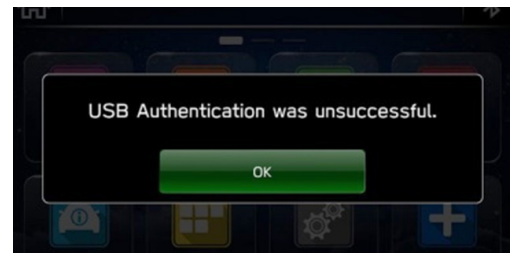
CAUTION: NEVER attempt to install this software on any 2019 MY vehicles as they are equipped with Gen 3.1 Audio/Navigation systems. This update is ONLY for models equipped with Gen 3.0 Audio/Navigation systems. Should an attempt be made to install any of these files into a Gen 3.1 head unit, the authentication error screen to the right will be displayed.

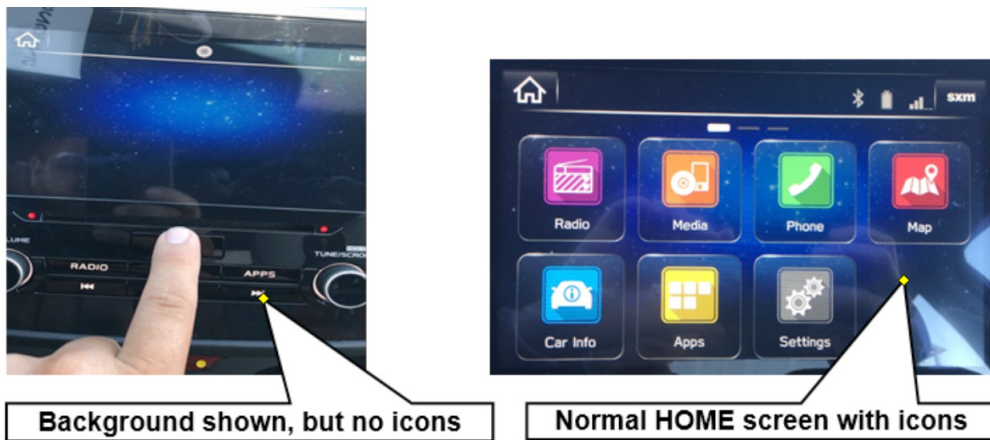
- Corrects for condition where only the star field background is displayed (without icons) after the HOME button is pressed.

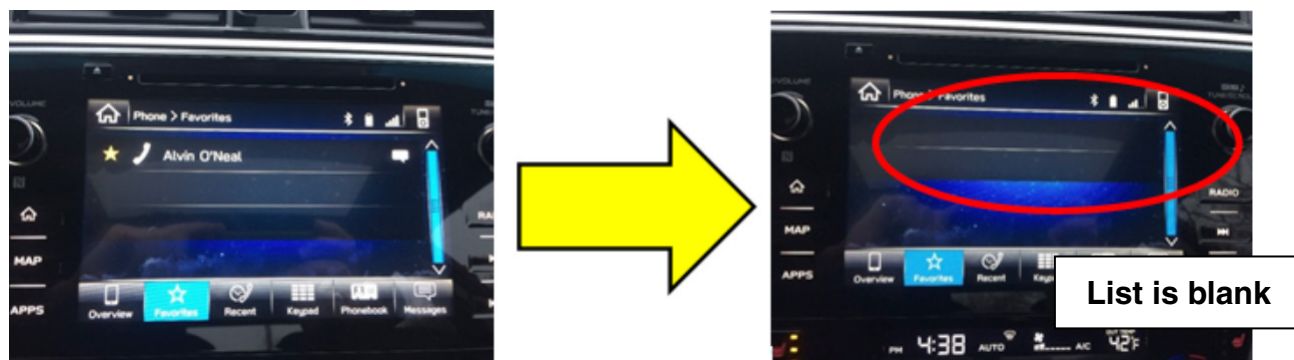
- Corrects for a “Pop” or “Crackling“ sound concern when listening to AM radio.
- Corrects for a concern of the head unit continually resetting itself.
- Corrects for a concern of after selecting a contact to be a “Favorite” and the “Favorite” list display is blank.
