SI B41 01 18  
Body

## CRACKING NOISE FROM THE UPPER DOOR HINGE WHEN OPENING

G15 (8 Series Coupe)	G14 (8 Series Convertible)
----------------------	----------------------------

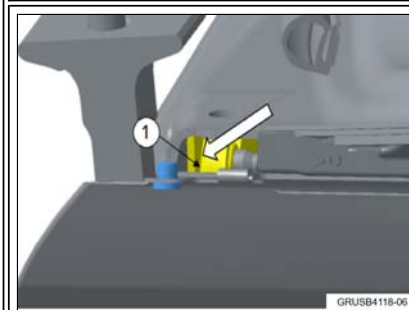
Interference between the inner door hinge support and the door. The interference is only present from the upper hinge supports of either door.

4. Loosen, but do not remove the top 2 door hinge screws (1) from the door (2).

5. Using the access hole from step 2, spray cavity protection spray PN 83 42 2 457 337 between the inner door hinge support and the door.

6. Re-tighten the door hinge bolts to 19Nm.
