Technical product information

Topic	W12 - Oil leak from engine
Market area	Bentley: worldwide (2WBE),Hongkong-Macau (5HK)
Brand	Bentley
Transaction No.	2053350/1
Level	EH
Status	Approval
Release date

New Continental GT

Bentayga

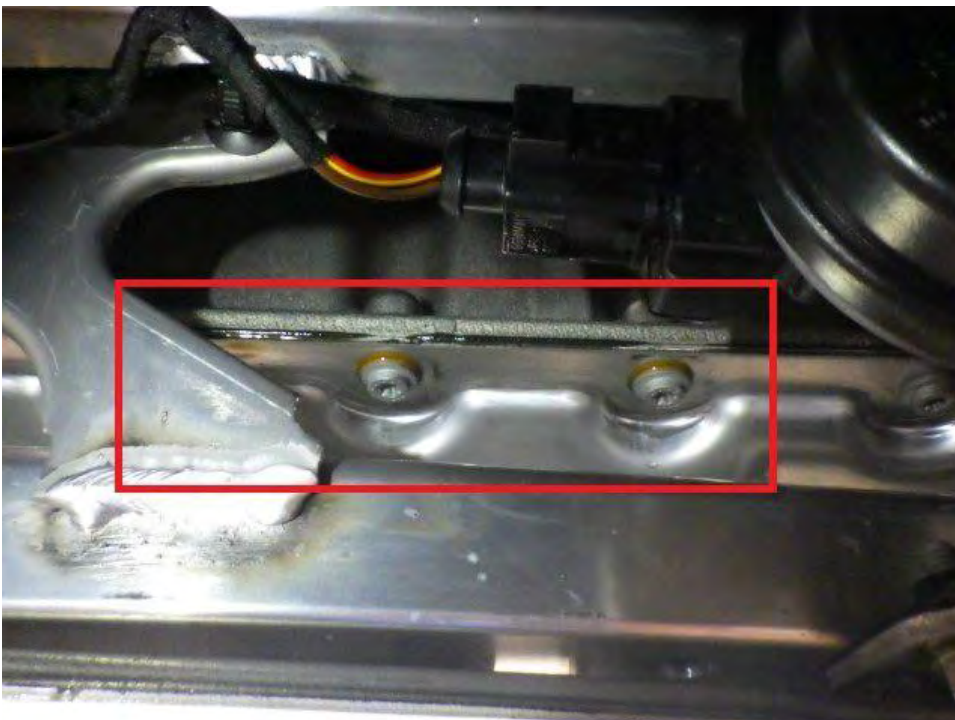
Figure 1

The breather return line and the oil dipstick tube O-rings can split causing an external oil leak.

This can be misdiagnosed as the engine sump leaking.

If an engine oil leak is found from the area shown in Figure 1, check the O-rings of both the breather return line and the dipstick tube for leakage. The oil can run down the engine and settle on the sump leading to misdiagnosis, Figure 1.

Should either of the O-rings be damaged or leaking replace according to ETKA.
