JTB00652NAS1

TECHNICAL BULLETIN

Exterior Door Handle(s) Not Fully Retracting When Locking The Vehicle

MODEL:	MODEL YEAR:	VIN:
I-PACE (X590)	2019	F60001-F60748

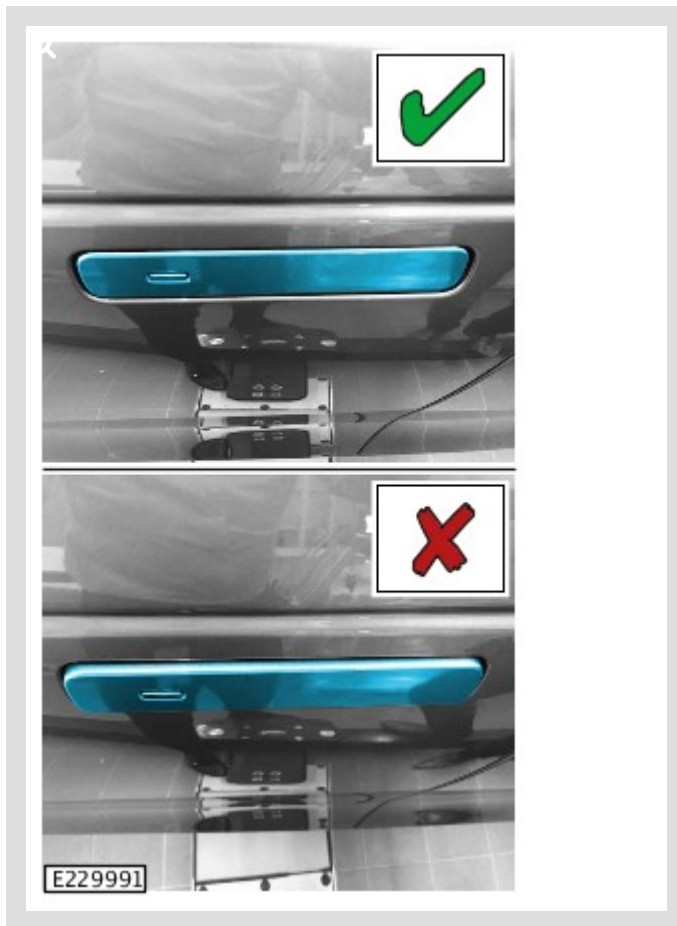
1

The door exterior handle(s) may not fully retract when locking the vehicle. Door handle(s) may also show signs of a 'clunky' type motion and/or noise when locking the vehicle.

This may be caused by the door handle(s) being manufactured away from the required specification.

Door handle fully retracted (✓) and not fully retracted (✗).

Lock the vehicle and inspect the position and operation of all exterior door handles.

- If all of the exterior door handles do fully retract to the correct position and do not show signs of a 'clunky' type motion and/or noise, do not continue with this Technical Bulletin as the customer's concern does not relate to its content.
- If any of the exterior door handles do not fully retract to the correct position and/or do show signs of a 'clunky' type motion and/or noise, go to the Workshop Procedure below.
