Fuel Injector Electrical Fault With Fault Codes

Topic number	LI07.16-N-069263
Version	1
Function group	07.16 Diesel injection system common rail
Date	01-08-2019
Validity	906 and 907 Sprinters with OM642 engine.
Reason for change	
Reason for block

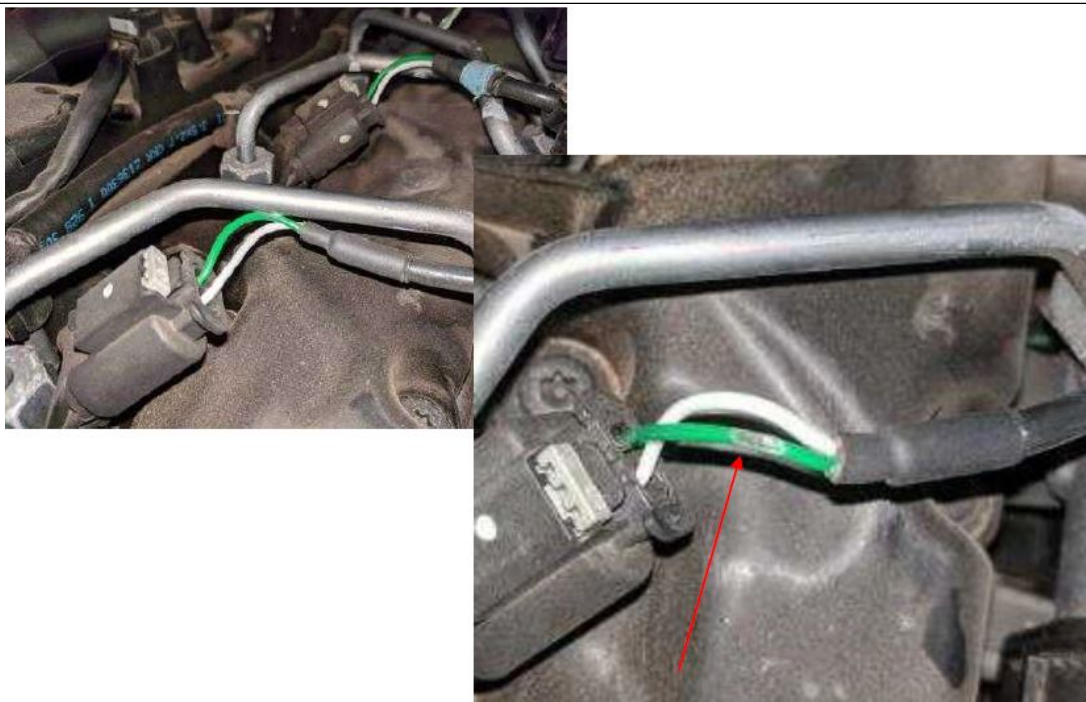
ShortedInjectorWire_
OM642.JPG:

Low power and poor throttle response. Potential hard start. Check engine light accompanied with P033600, P214600, or P027100 fault codes.

Injector wire potentially shorted against high pressure line.

Attachments	
File	Description
ShortedInjectorWire_OM642.JPG	Shorted Injector Wire

Perform a visual inspection of the injector wiring and ensure the wires do not contact any of the high pressure lines.

If contact is noticed, thoroughly inspect the wiring for damage.

Repair damage, if found, and reroute wires to prevent future contact.
