Corrosion at electrical connecting point between front bumper and interior (X174/1)

Topic number	LI54.18-P-056220
Version	9
Function group	54.18 Cable harnesses
Date	01-22-2019
Validity	Model 166
Reason for change	Text revised and validity adjusted.
Reason for block

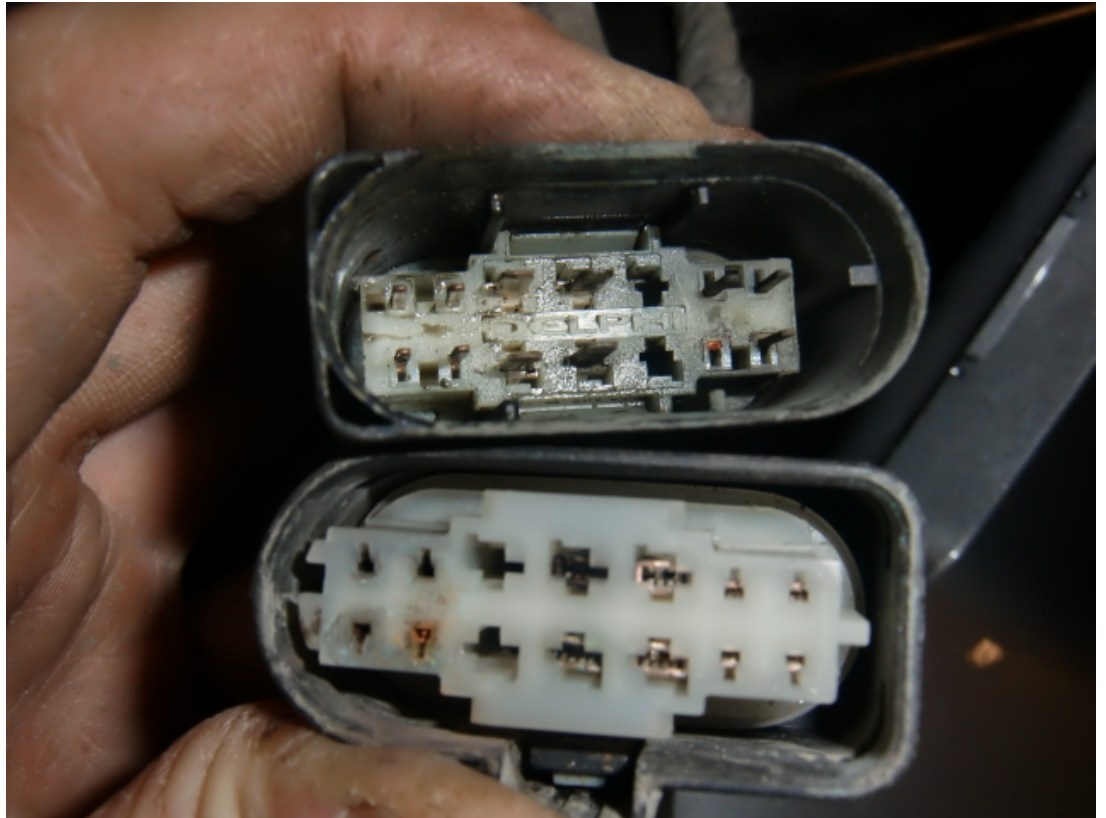
CIMG3906.JPG:

Corrosion may have occurred at the connecting point X174/1 from the front bumper to the interior wiring harness.

Attachments	
File	Description
CIMG3906.JPG	Corrosion at connecting point X174/1

1. Replace connecting point X174/1.
2. Reinstall all contacts and replace connector housing on interior wiring harness.
3. If the conductor in the line itself exhibits corrosion, cut it off until there is enough bare (uncorroded) copper for crimping. If the line length is no longer sufficient, lengthen it accordingly.
4. Replace bumper wiring harness. NOTE: Determine part number of bumper wiring harness in EPC in 88.030 under item 250, because this depends on the equipment installed.

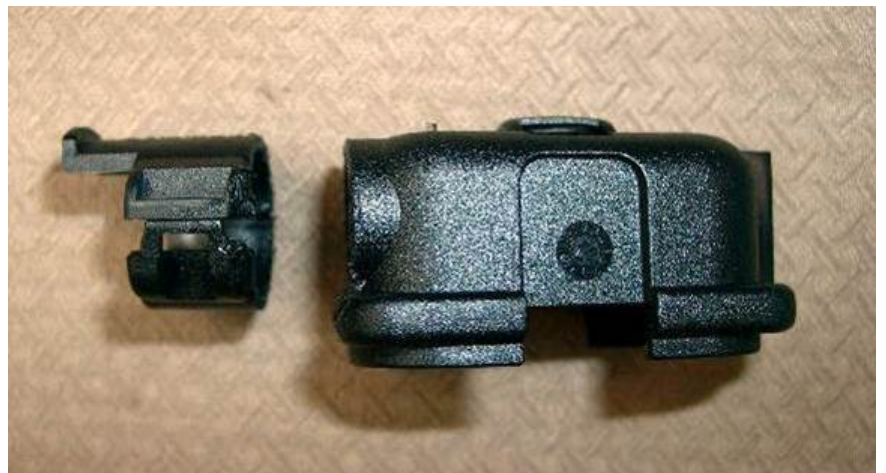
Cable duct.jpg:

Attachments	
File	Description
Cable duct.jpg	Modification of cap

- The corresponding cap should be adjusted as shown in the picture "cable duct.jpg".
- Due to its situation, the cable duct must be cut off and deburred as shown in the picture.
- After this, the cover can be placed at the appropriate connecting point (see picture: "Installation.jpg")

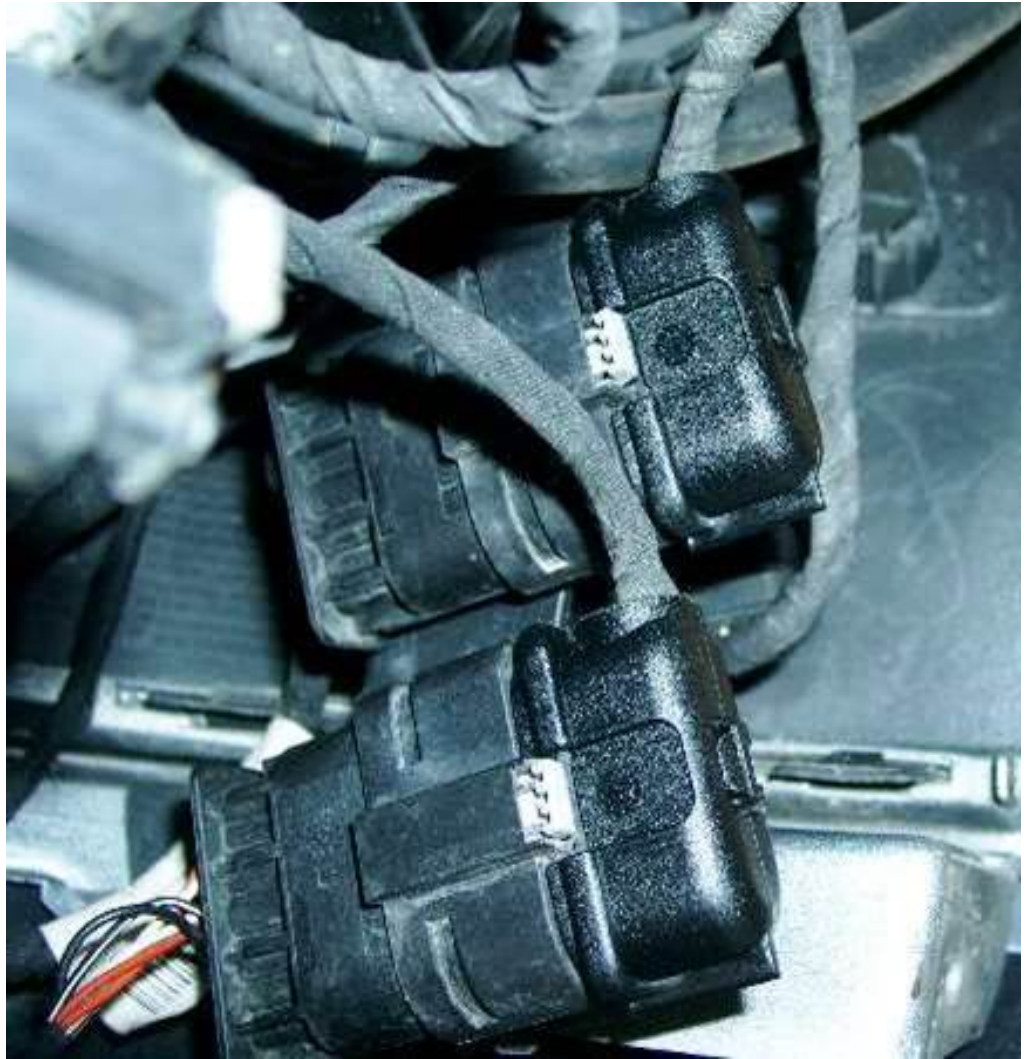
Installation.jpg:

Attachments	
File	Description
Installation.jpg	Installation of cap
