SERVICE BULLETIN

APPLICABILITY: 2017-18MY Impreza
 2018MY Crosstrek
 2018MY Legacy and Outback
 2018MY **BRZ***

NUMBER: 15-211-17R
DATE: 06/13/17
REVISED: 01/22/19

SUBJECT: Reprogramming File Availability for Additional Optimization of Harman Gen 3 Audio and Navigation Head Units

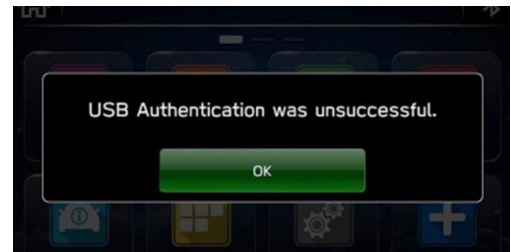
CAUTION: NEVER attempt to install this software on any 2019 MY vehicles as they are equipped with Gen 3.1 Audio/ Navigation systems. This update is ONLY for models equipped with Gen 3.0 Audio/ Navigation systems. Should an attempt be made to install any of these files into a Gen 3.1 head unit, the authentication error screen to the right will be displayed.

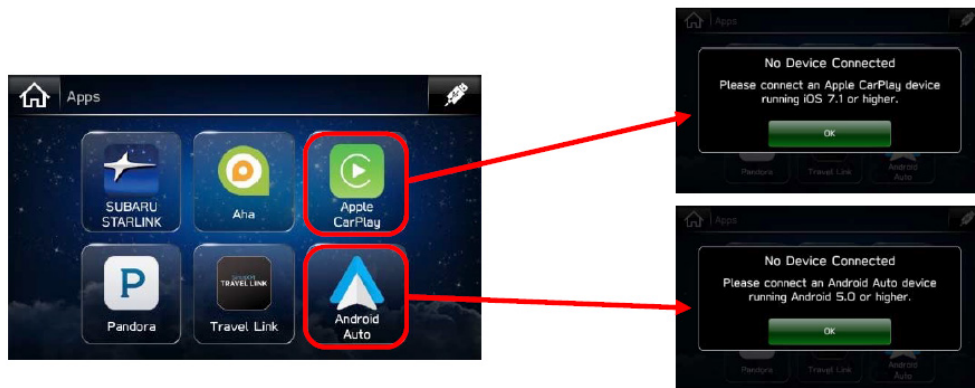
3- Apple Car Play / Android Auto function does not operate (“No Device Connected”).
