<b>Technical Service Bulletin:</b> TSB190014	<b>Released Date:</b> 28-Jan-2019
<b>Damaged Flywheel Housing: Nova Bus™ Chassis</b>

## Damaged Flywheel Housing: Nova Bus™ Chassis

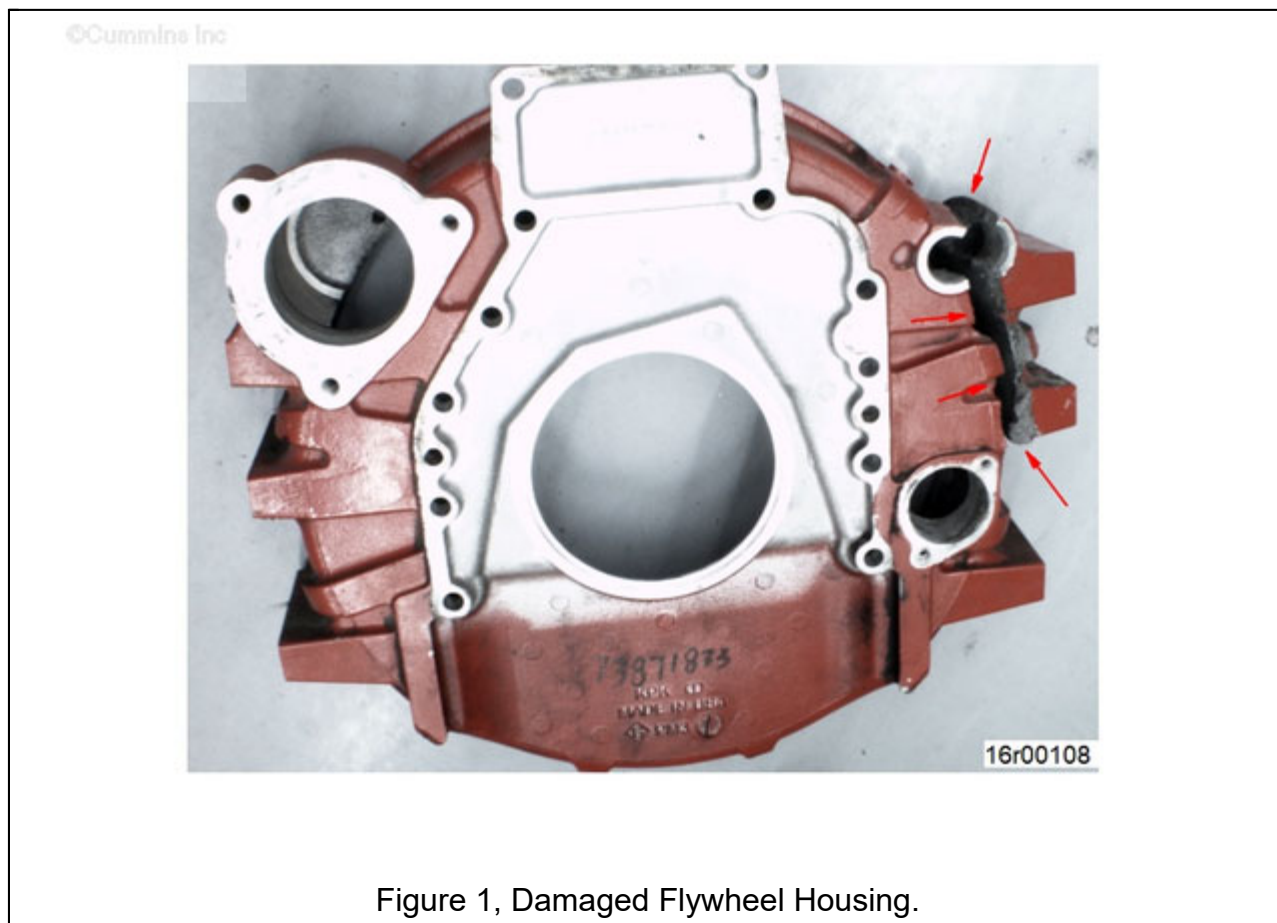
- Overloading of the flywheel housing.

Visible crack and/or damage of the flywheel housing at or near the flywheel housing mounting pad location. See Figure 1 below.

Replace existing flywheel housing with new Part Number 5477583.
