Mack Model LR , TE - TerraPro , AN - Anthem , GR - Granite , PI - Pinnacle

Volvo Model VNL , VNR , VNX , VAH , VHD

Title Assembled Camshaft - Injector Lobe Rotation Inspection; Diagnostic Trouble Codes (DTC) P0257-00, P2A17-00, Or P2A1F-00, Possible Lack Of Power – **US17+OBD16 and Newer Emissions**

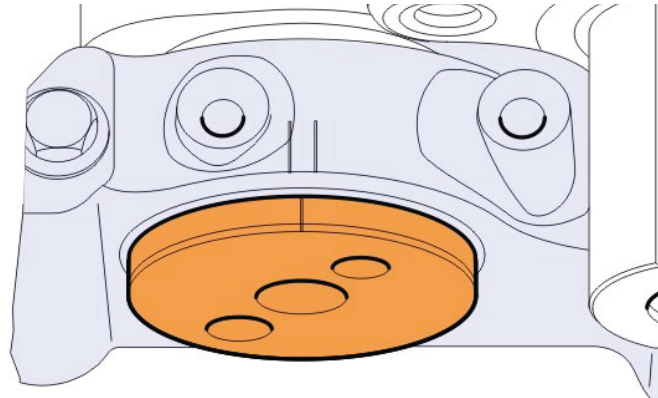
1. Rotate the engine with the turning tool in the normal direction of rotation until the timing marks are aligned for the Injector Pump(s). While the engine is being rotated, confirm each injector lobe is rotating with the camshaft and does not slip.

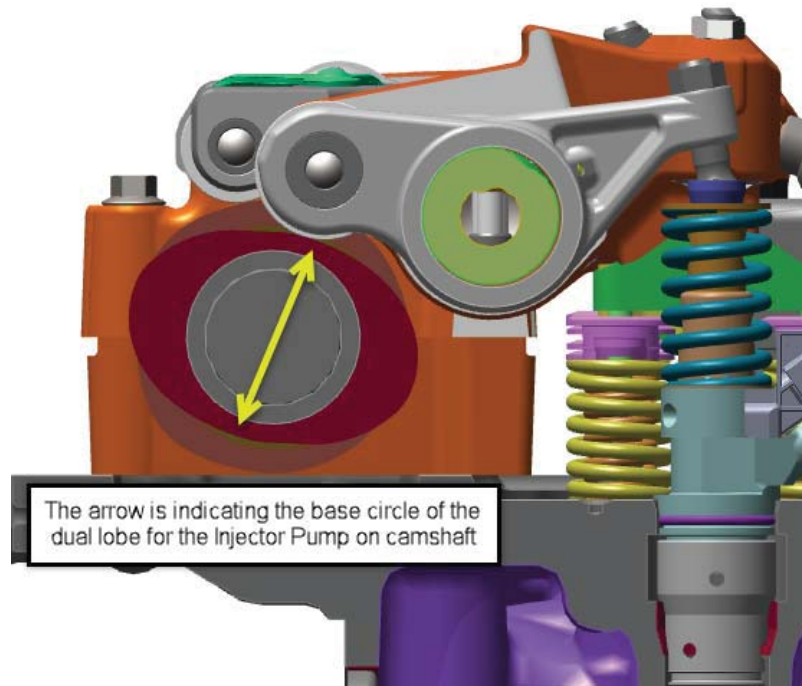
2. Once the timing marks are aligned for a specific Injector Pump, verify the injector rocker roller is on the base circle of the injector lobe. Refer to the illustration below.

Note: If an injector lobe rotates on the camshaft, the rotation is normally by 60 degrees. It takes approximately 15 degrees of rotation before potentially causing the faults codes listed previously or a fault for a pumping injector during the Common Rail Fuel System Test.

Solution **An eService case should be opened with a detailed description of the findings from the inspection steps below.**
